# Needs Assessment & Opportunity/Challenge Identification

History, Conditions Assessment, & Engineering Analysis

# **Existing Conditions Assessment - General Site Conditions**

7TH AVE. GYM - HELENA, MT

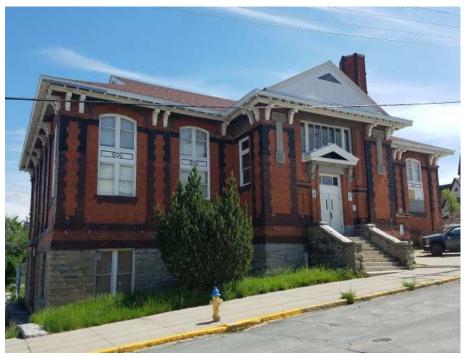
Steep slope and minimal landscaping along 7th Ave.

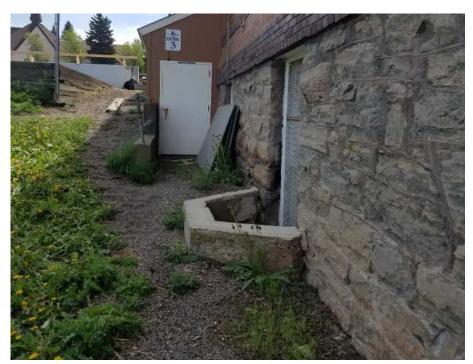
Slight negative drainage along north side of building

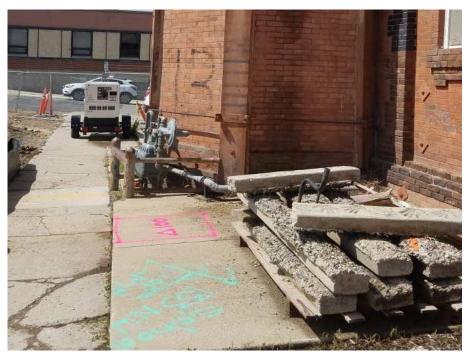
Deteriorated site concrete and construction debris along east side

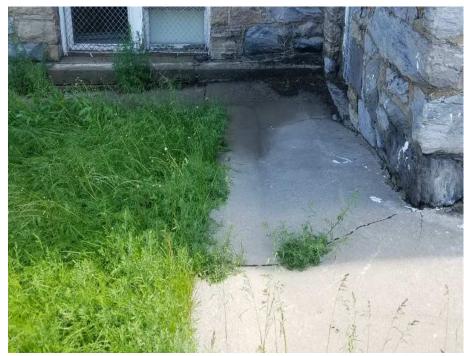
Drainage pan with potential issues along 7th Ave. side (downhill side of stairs)

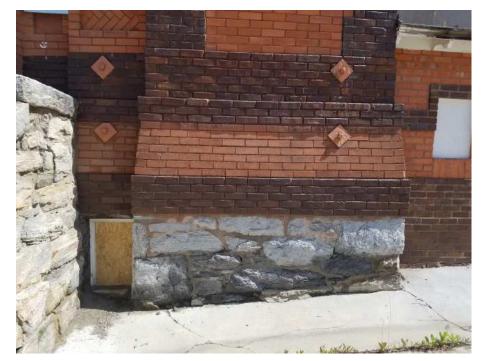
Drainage pan with potential issues along 7th Ave. side (uphill side of stairs)

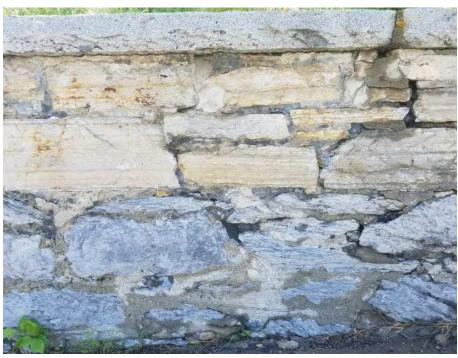
Deteriorated landscape wall w/ 2 eras of stone (north of Gym on Cruse)

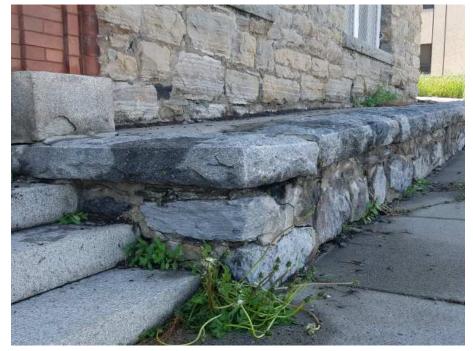
Stone steps at lower entry and low stone wall requiring some repointing

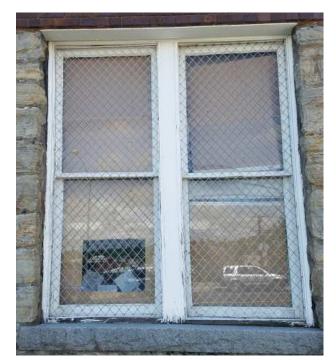
As noted above, the windows near grade show signs of moisture damage and require repair. The Lower Level windows along the streets also have an expanded metal screen to protect against intrusion.

Typical Lower Level window (damage @ bottom)

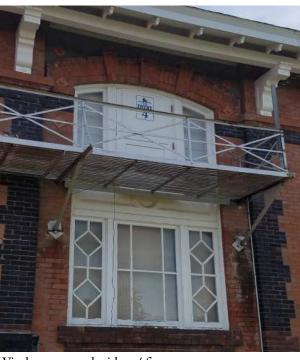
A metal fire escape on the north side provides egress from the center of the upper level to the ground at the northeast corner of the building below. The fire escape appears and feels sound and in good condition, however several areas of rust were observed.

Window on north side w/ fire escape

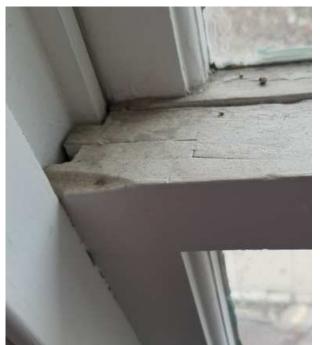
Typical condition of windows from interior

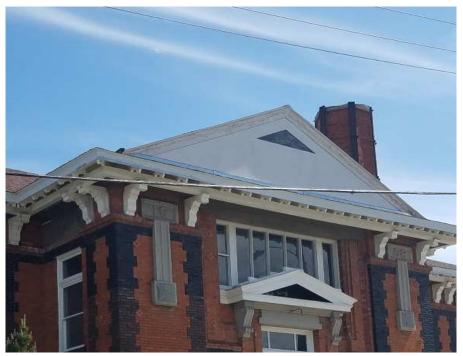
Infilled dormer above entry on 7th Ave.

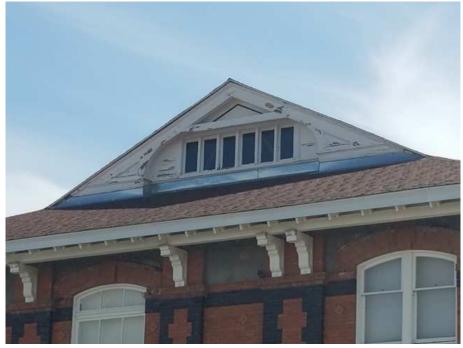
Deteriorated woodwork at Dutch-gables, note failing asphalt shingles

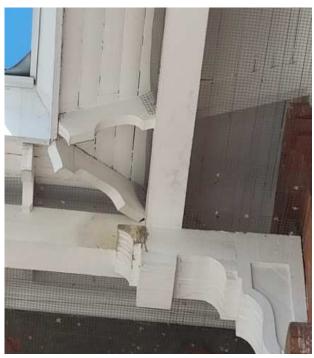
Typical eave condition (and bird netting)

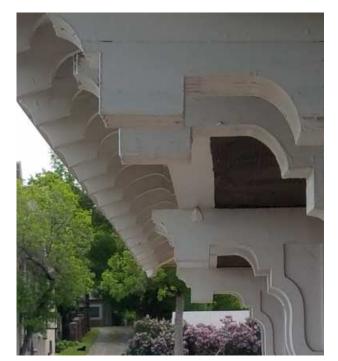
No attic ventilation was observed in the eaves, gables, or along the ridge.

Typical eave detail and condition

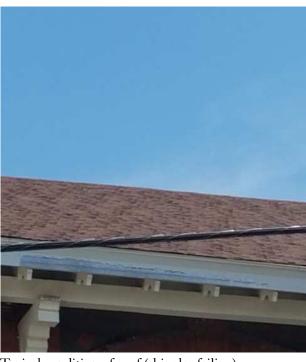
Typical condition of roof (shingles failing)

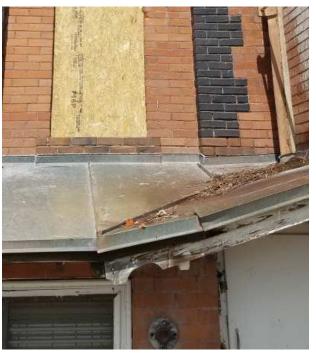
Typical condition of metal roof on historic lean-tos

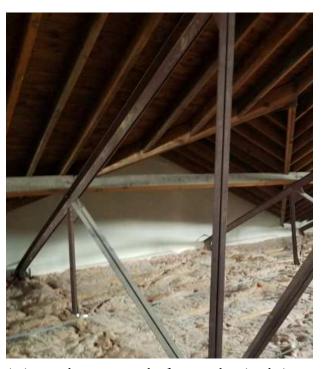
Attic: metal trusses, wood rafters, modern insulation

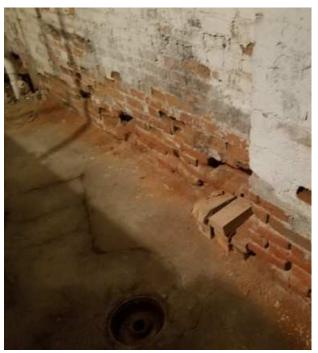
Isolated area of recent brick damage at base of wall

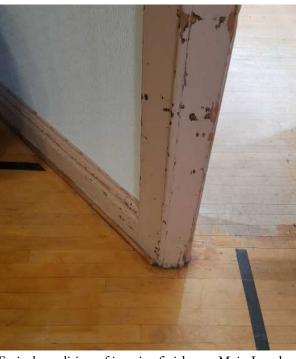
Typical condition of interior finishes at Main Level

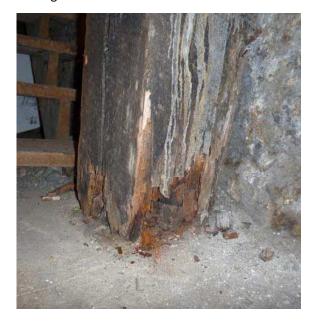
Because of the architectural ceiling finishes in the basement, most of the structural elements could not be inspected at this time. However, there were some elements that could be seen that showed signs of deterioration. There was a corbel supporting a floor beam above the boiler area that was composed of unreinforced brick. It showed signs of deterioration and can be seen in Figure 10, below. A few timber columns in the basement that supported floor framing above showed signs of rot and deterioration at their base, as seen in Figure 10. This is likely due to contact with water and the concrete slab on grade over time. It was also not clear whether these columns were supported by concrete footings in each location.

Figure 10: Deterioration at timber column base (left) and deterioration brick corbel (right).

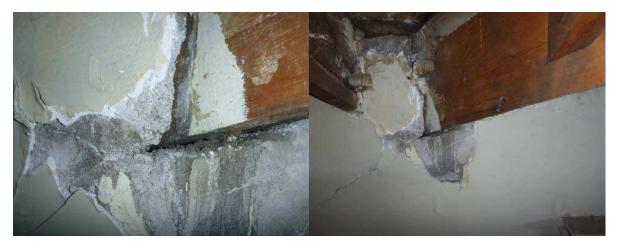
bearing connection only and does not provide any support for uplift or forces perpendicular to the wall in the event of an earthquake. Direct contact of the wood framing members to the concrete is not ideal because it can introduce moisture to the wood members and cause rot and deterioration as seen in the column bases in the basement. Because the portion of the wood members in the wall cannot be seen, the condition of these members in the concrete wall is unknown. However, there were a few select locations were the concrete around this connection has cracked and showed signs of deterioration, indicating that there could have been water introduced at some point in time. See Figure 12, below.

Figure 12: Deteriorated concrete at wood member-to-concrete wall connections.
