Helena School District Deferred Maintenance Report

January 31, 2022

RE: Deferred Maintenance Review
Helena Public Schools
Final Report

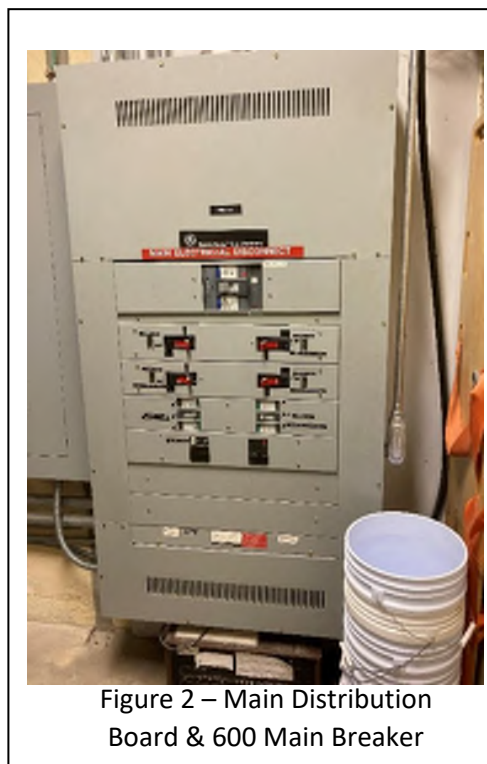
Figure 2 – Main Distribution Board & 600 Main Breaker

The secondary service conductors run underground to the building foundation and rise to a metering cabinet. Inside of the cabinet, the secondary penetrates the wall into the old boiler room and terminates in a 600A-2P main breaker in a distribution board. The distribution board is of newer construction. It is a GE Spectrum style panelboard with additional space for possibly up to four breakers (Figure 2). The highest recorded demand from Northwestern Energy was 62 KW in February, 2021. Based on this reading, the calculated demand is about 325 amps, meaning that the service has about 30% to 35% spare capacity after applying a 0.8 power factor and the demand at 125% per NEC Article 230.87.

Electrical Distribution: An upgrade to the electrical service will require replacing the existing single phase main distribution board, or possibly maintaining the board and installing a new main board either inside or on the building exterior if interior space is not available (See Jefferson Elementary School). The service voltage configuration will change from 120/240 volts single phase to 120/208 volts 3-phase. This should not be a major concern, but there may be a few items, i.e. old 240 volt motors that may need to be replaced. Additional branch circuit panelboards are recommended in the classroom wings to increase circuiting to the classrooms and workrooms. The obsolete panelboard is recommended for replacement. The other panelboards do not necessarily need to be replaced, especially since some of them are located in corridors or other locations where a larger panelboard will not have adequate clearances.

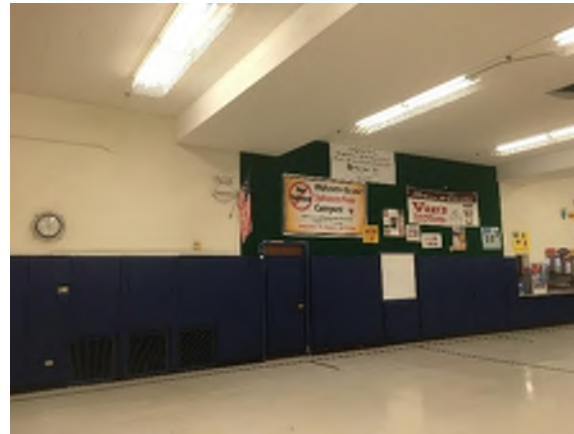
Figure 8 – Gymnasium Lighting

Lighting: Administrative areas that were remodeled in recent Safety-Security Upgrades are LED. 4 foot T8 fluorescent fixtures with wraparound acrylic lenses, mostly 4-lamp in most classrooms, except for the Library and west end classrooms in the lower level which are recessed parabolic troffers. Corridors, lobbies, restrooms, stairs, storage rooms and ramp areas are mostly 2-lamp, 4 foot T8 fluorescent with wraparound lenses, surface or suspended. Much of the building has been equipped with occupancy sensors, but only the areas with the LED lighting have dimming capability. The Gymnasium lighting is 4 foot T-8 fluorescent with wire guards (Figure 8).

Lighting: Replacement of fluorescent with LED fixtures and controls is recommended. The energy savings combined with improved occupancy sensors and dimming controls is substantial. Rebates are available from Northwestern Energy and NCAT to help offset the cost of replacement. Replacement of the original exit signs with new LED signs with battery backup is recommended. After removal of the interiors of the old exit signs, the new exit signs would be mounted directly over the old to cover the opening.

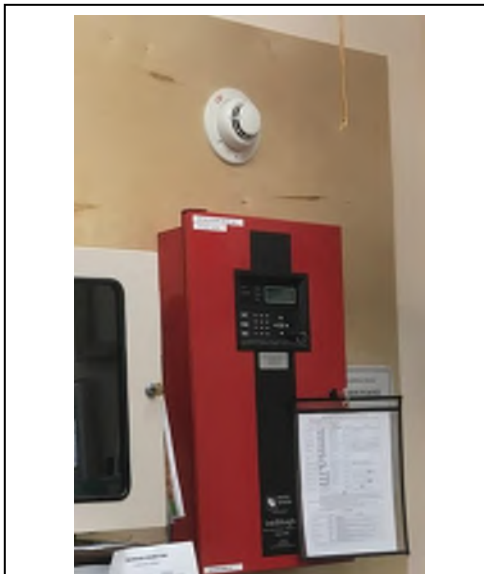
Figure 10 – Fire Alarm Control Unit
Prior to Safety-Security Upgrades

The Fire Alarm System, as classified in the International Fire Code, is a manual detection system with manual pull stations at exit pathways, horns and strobes in all rooms and corridors and smoke detectors in elevator lobby. The Control Unit is a Silent Knight. Magnetic holders were added to some doors during the Safety-Security Upgrade, but they are not for fire; only security during lockdown situations. There are no known issues with the system at this time, but it should be noted that the AHJ will require this system to be upgraded to Voice Evacuation and additional automatic detection coverage if the building is significantly upgraded. One minor issue is that the Control Unit is physically located in the Principal's Office (Figure 10), making it difficult for the maintenance staff to troubleshoot.

Relocation of the Control Unit to a more assessable location for maintenance is recommended.

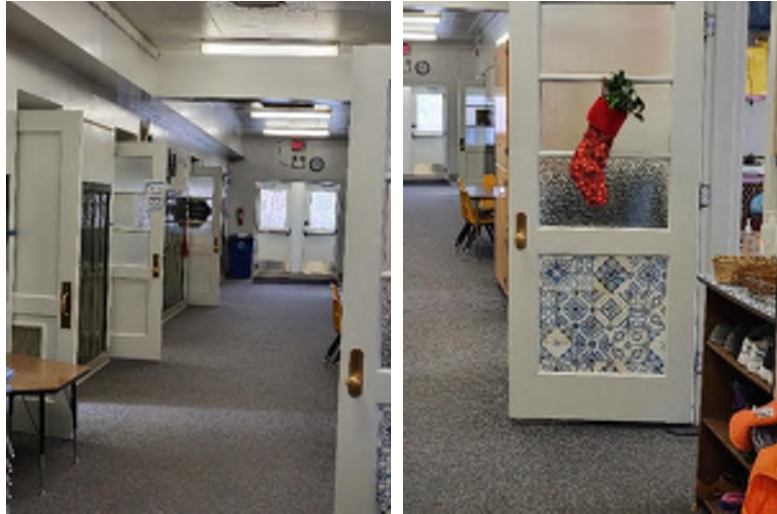
Exterior Doors: There are a half dozen exterior doors that are wood slabs and are not able to hold up to the exterior elements. These doors are in dire need of being replaced.

Interior Doors: Most of the interior doors have knobs and not handles. These need to be upgraded with lever sets for better life safety and accessibility.

Exterior Doors: Replace the half dozen old/wood doors with new insulated galvanized hollow metal doors and frames. **(Medium Cost, High Priority)**

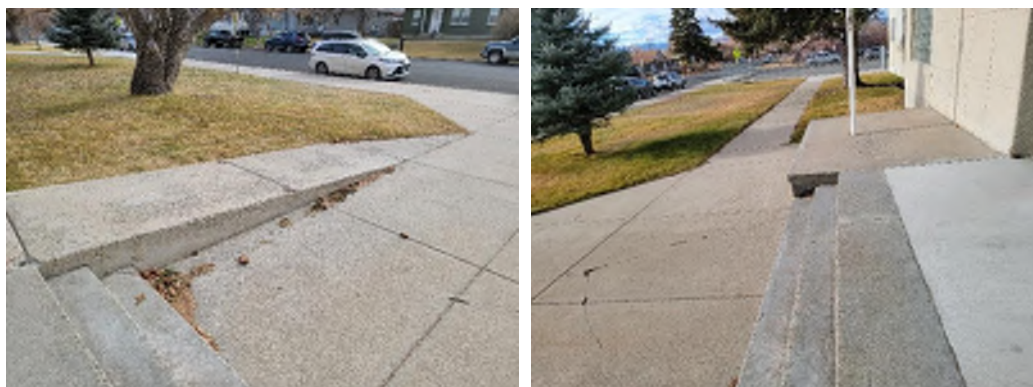
Entry Ramp and Stairs: The ADA ramp and stairs does not have an acceptable handrailing and the concrete is beyond repair.

Entry Ramp and Stairs: The ADA ramp and stairs does not have an acceptable handrailing and the concrete is beyond repair. **(Medium Cost, Medium Priority)**

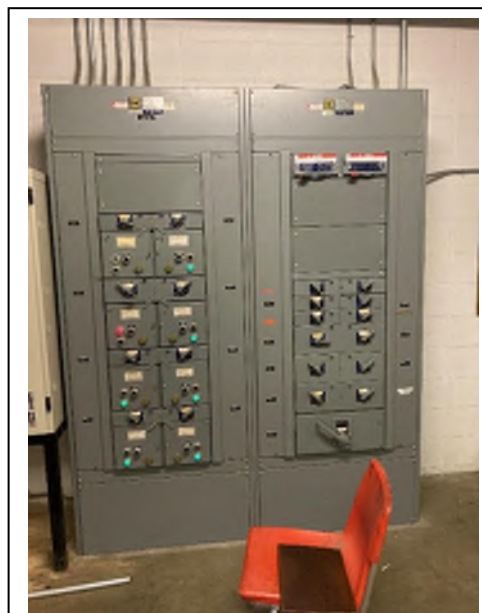
Figure 4 Main Distribution Board

The secondary service conductors run under the building foundation, then up to the Boiler Room on the Mezzanine level above the Gym. At this point, they terminate in a 600 amp, 2-section Main Distribution Board. The Main Distribution Board is a Square D Power-Style (Figure 4). Section 1 of the board contains 12 original QMB fusible switches and 2 newer switches that may have been added for a recent boiler upgrade. Section 2 contains eight NEMA Size 1 combination fusible switch/motor starters. They serve the air handler, fan motors and pumps. The maintenance staff has indicated that parts for the motor starters are hard to obtain and may be obsolete. The original QMB fusible switches in Section 1 also appear to be obsolete; but the newer QMB fusible switches that were recently installed indicate that a replacement solution is available.

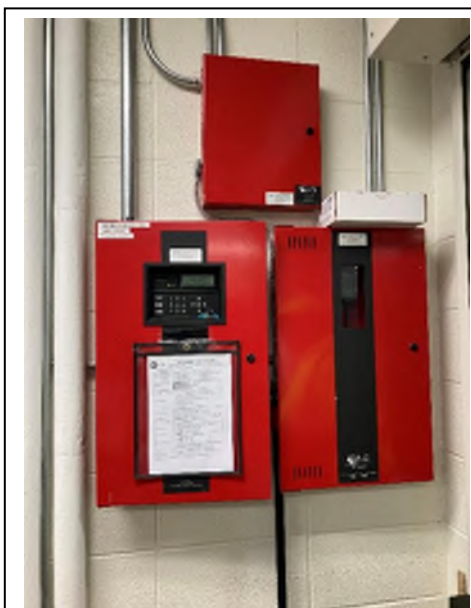
Figure 10 – Fire Alarm Control Unit
Prior to Safety-Security Upgrades

The Fire Alarm System, as classified in the International Fire Code, is a manual detection system with voice evacuation. The Control Unit(s) are located on the east wall of the Reception Office (Figure 10). There are manual pull stations at exit pathways, speaker/strobes in all rooms and corridors, and smoke detectors in the corridors for release of magnetic door holders. The Control Unit is a Silent Knight Model 5808. The Voice Evacuation Unit is a Silent Knight Model SKE. There are no known issues with the system.

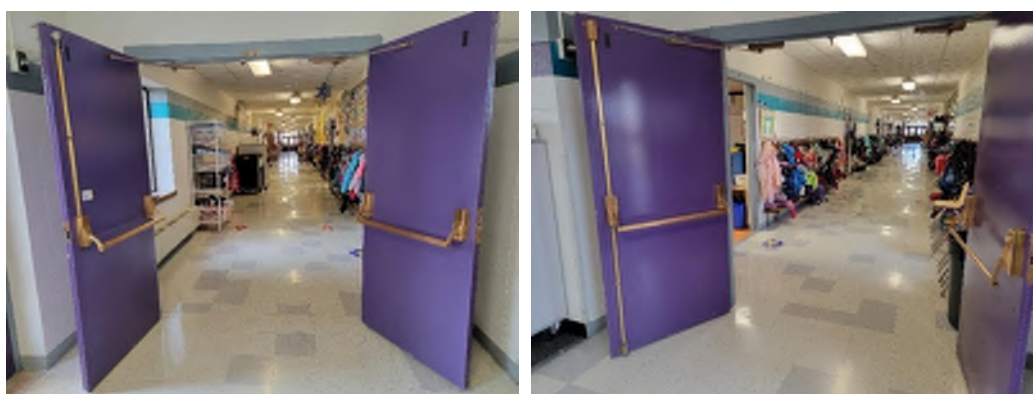
Interior Fire Doors: The two double fire doors in the school are constantly needing adjusted and one door currently does not have a bottom rod or fire pins. These two doors should be replaced.

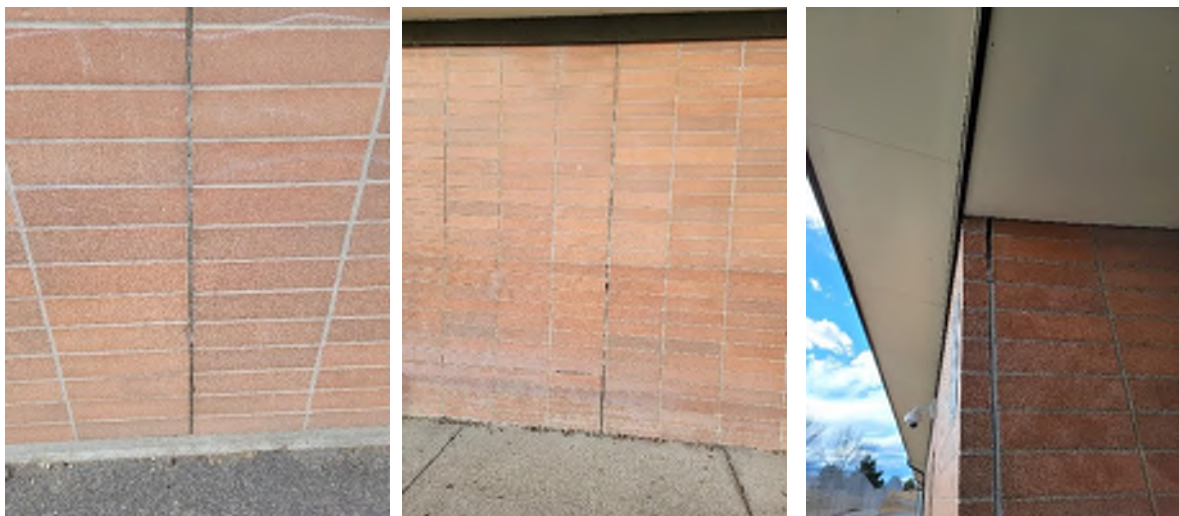
Masonry: The exterior face brick is good shape. However about 10% of the mortar joints need being repointed. In addition, all the control joints need new sealant.

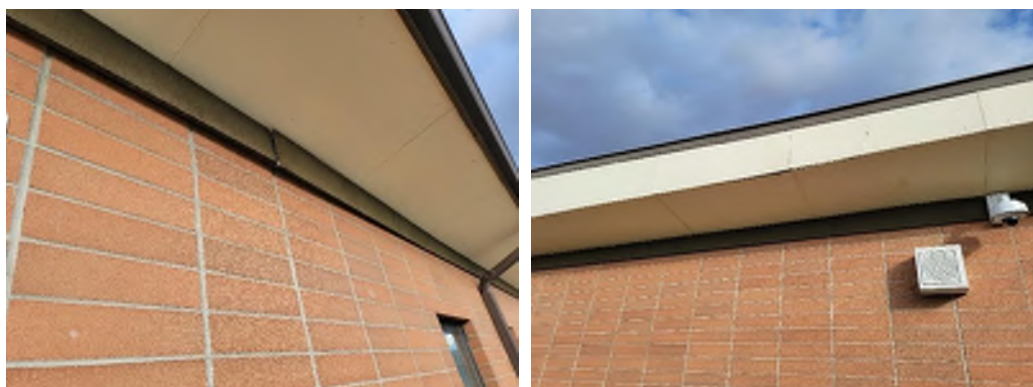
Fascia and Soffit: The soffits and fascia on the south exposure is breaking down and needs to be replaced.

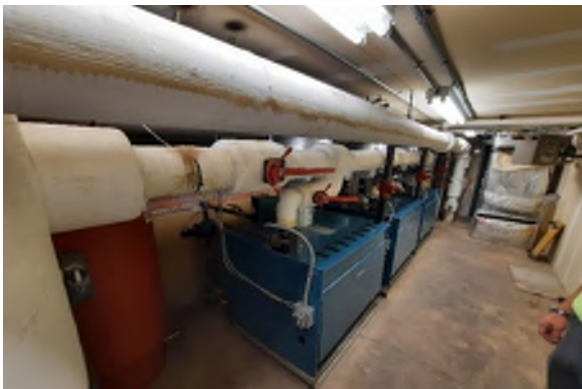
Abandoned steam boiler in basement of Library Building. Unit should be removed. As a portion of the Safety and Security building upgrades radiant slab snow melt was added at the building entrances. This system utilizes ceiling mounted circulation pumps near the building exterior wall to circulate glycol solution through the slab.

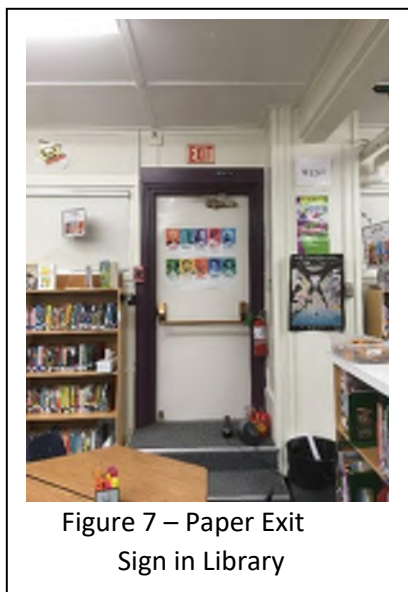
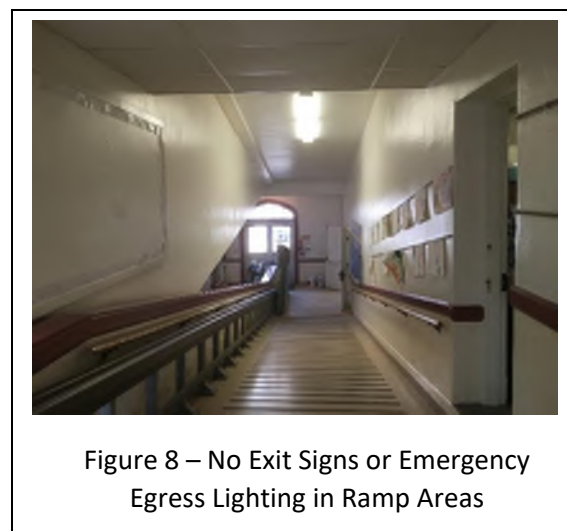
Most of the exit signs in the main building are newer LED (Figure 6). The Library and Music Classrooms are cardboard; not powered or self-illuminated (Figure 7). Codes do not allow this, unless the face of the sign is illuminated with five foot candles of emergency lighting, for which they do not appear to be. Emergency egress lighting is very sparse in all the buildings. There are a few wall mounted battery units but overall there does not seem to be adequate levels of egress illumination during a power failure, particularly on the ramps and stairs (Figure 8). The new exterior ADA ramp is equipped with emergency egress lighting and battery backup.

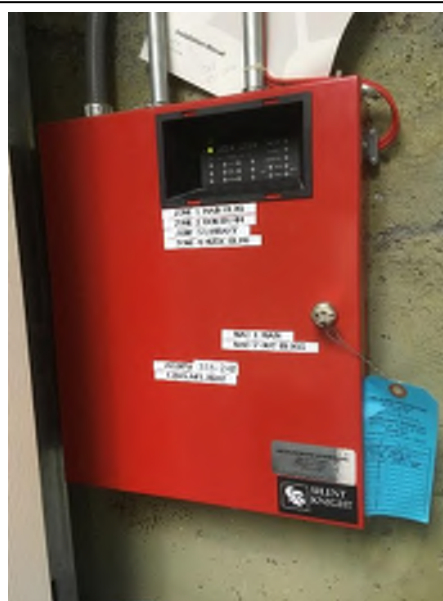
Figure 9 – Fire Alarm Control Unit

The Fire Alarm System, as classified in the International Fire Code, is a manual detection system. The Control Unit(s) is located next to the Main Distribution Panel in a closet in the northwest corner of an office near the center of the building (Figure 9). It is a Silent Knight Model SK-4224. There are four addressable initiating zones; Main Bldg, Boiler Room, Library and Music, and two notification circuits; Main Bldg and Out Bldgs. There is a remote annunciator located in the main entry lobby (Figure 10). There are manual pull stations at exit pathways, horn/strobes in the corridors, common areas, the Gym, Auditorium, Library and Music Classroom. There are a few heat detectors in the Old Boiler Room under the Library and a smoke detector near the Fire Alarm Control Unit.

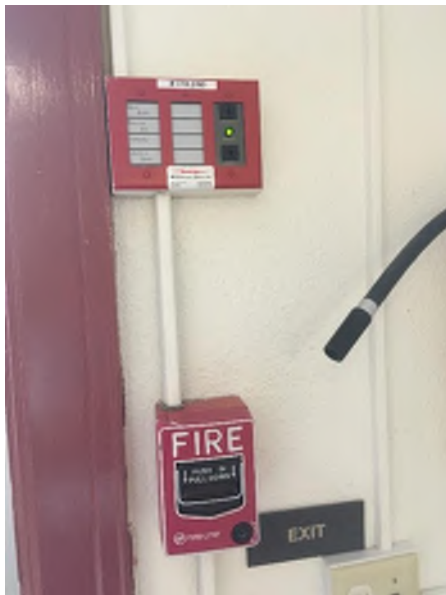
Figure 10 – Fire Alarm Remote Annunciator and Pull Station

There are no known issues with the fire alarm system. In the future, a major renovation may require replacement of the fire alarm system with a new addressable voice evacuation system, but that seems unlikely.

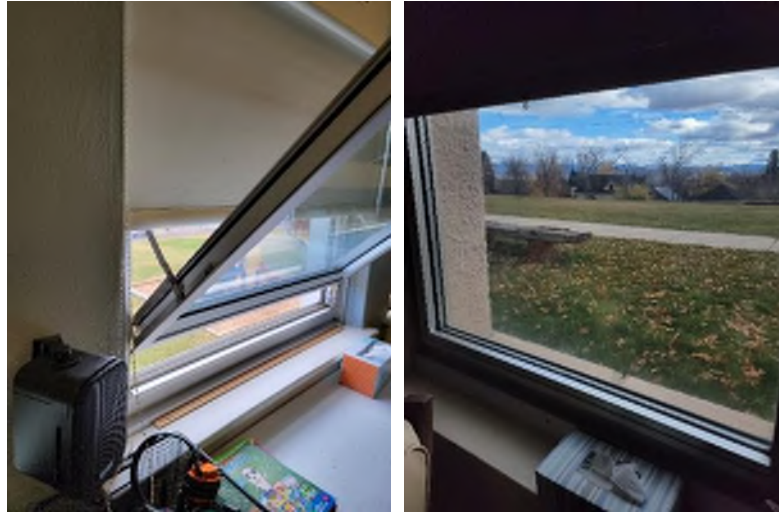
Some of these windows have fixed glazing but the vast majority are operable hopper style windows that open interior to the room. None of these operable windows currently have bug screens and during the shoulder heating season can allow pest into the building.

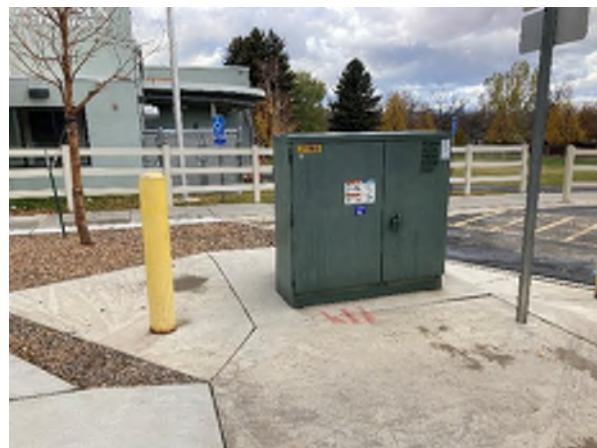
Figure 1 – Pad Mounted Transformer

The highest recorded demand over the last two years from Northwestern Energy was 54.8 KW in November, 2021. Based on this reading, the calculated demand is about 238 amps, meaning that the service would have about 50% spare capacity after applying a 0.8 power factor and the demand at 125% per NEC Article 230.87. However, an air conditioning upgrade is currently being constructed and the recorded value does not give an accurate depiction of what the peak demand will be during the next cooling season. Using the highest peak demand prior to November and adding the additional demand load for the current air conditioning upgrades, show that the new connected load will be approximately 500 amps, but the connected load is often much higher than the actual recorded demand. The demand seen in the coming cooling season is estimated to be 80 to 100 kW.

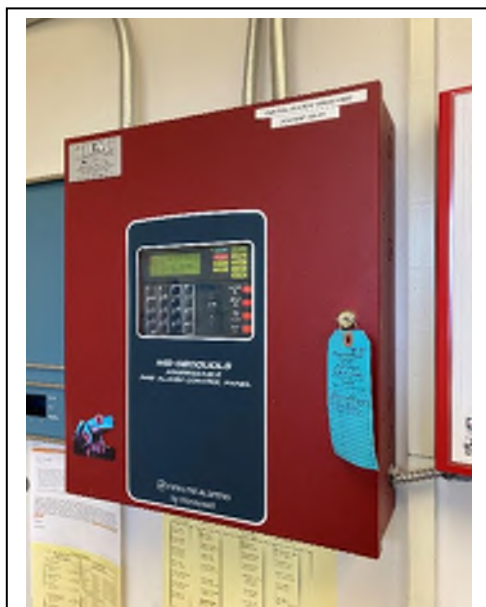
Figure 10 – Fire Alarm Control Unit

The Fire Alarm System, as classified in the International Fire Code, is a manual detection system. The Control Unit(s) is located on the south wall of Workroom located off of the entry ramp at northeast entry. It is a Fire Lite Model MS-9200UDLS. There is a remote annunciator located in

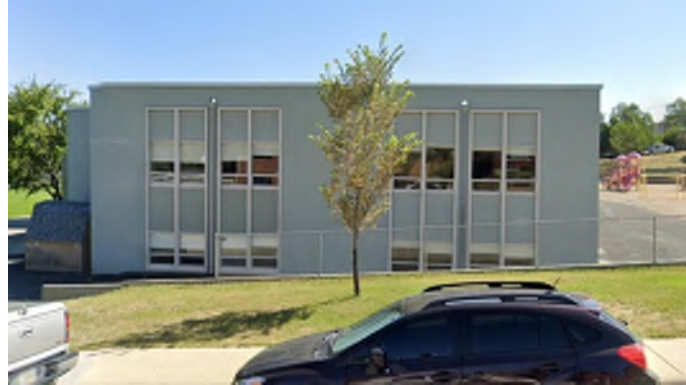
The existing windows are all non-thermally broken frames with insulated glazing. They are in relatively good shape, but will eventually need to be replaced.

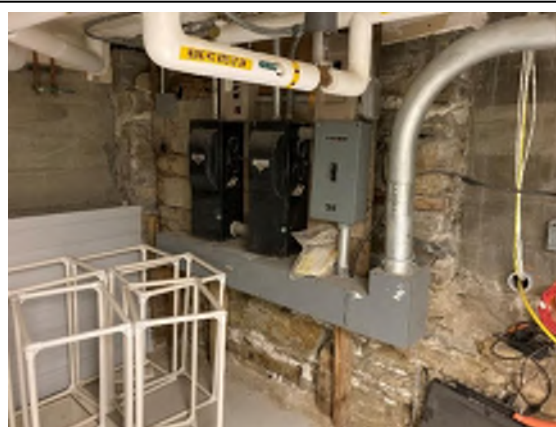
Figure 4 – Wiring Gutter and Disconnects in Basement

Distribution: One of the 400 amp main disconnects feeds a wireway in the basement. Above the wireway, there are two 200A fusible disconnect switches, a 100A circuit breaker and two load centers (Figure 4). It is assumed that some of this equipment is a hold-over from the original electrical service, which was 120/240 volts, single phase. None of the disconnects is labeled for the load controlled, which is a safety concern and a possible code violation. It is assumed that they serve branch panelboards, miscellaneous loads and possibly a well pump.

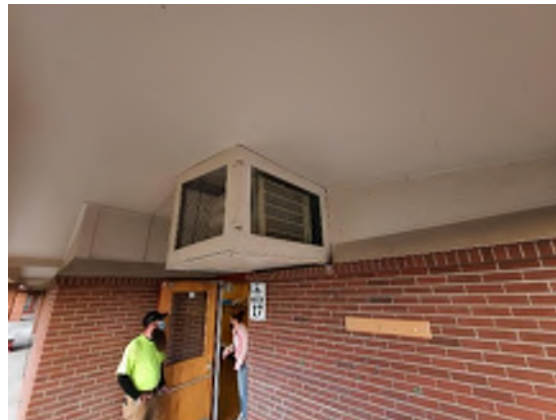
Air Conditioning: The office and limited classroom area are equipped with ducted evaporative cooling units. These provided a limited amount of space cooling. The units are obsolete and required service and spare parts are becoming difficult to obtain.

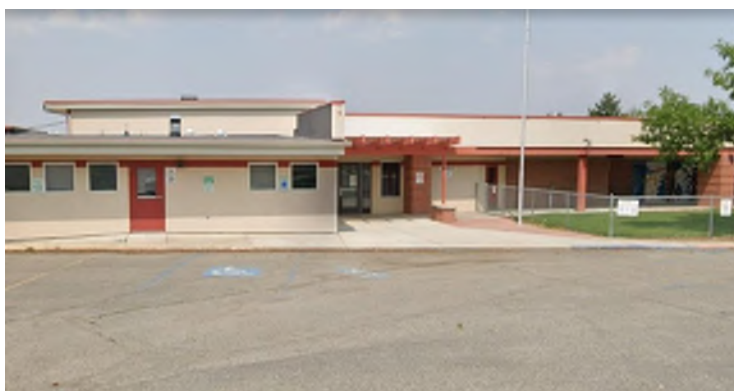
Parking: The Parking is steeper than allowed. In addition, the ADA curb ramp is not very close, and the cross slope would also be too steep.

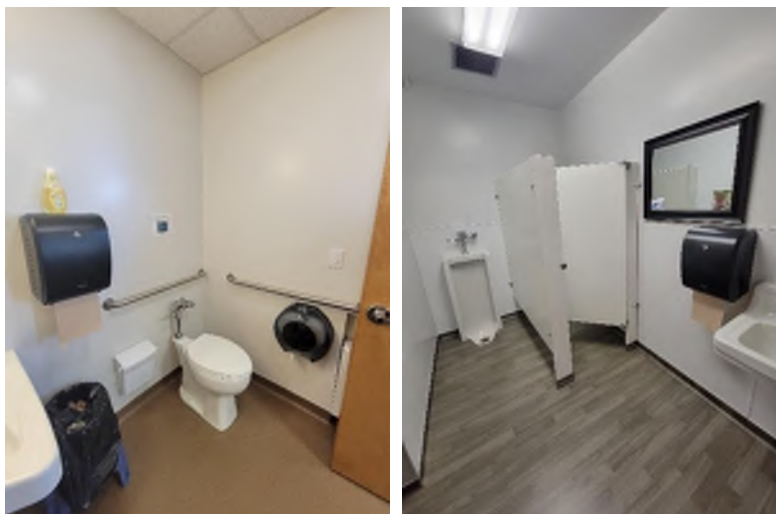
Restrooms: Most of the restroom facilities do not meet ADA. There is one restroom near the front office that could be renovated to be a single user ADA restroom fairly easily if the stalls were removed and grab bars be installed.

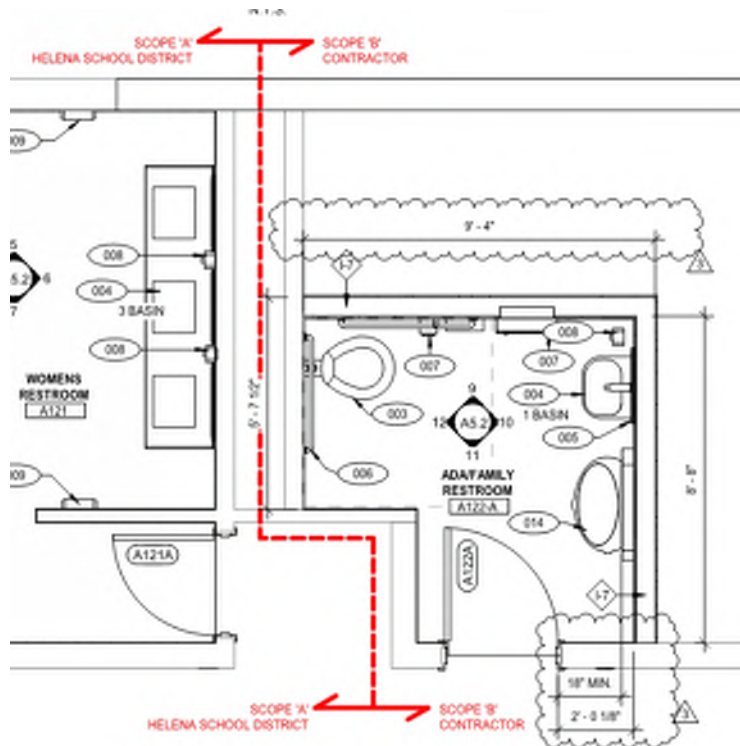
Shop Building: There is currently no ADA restrooms located in the shop building. At some point accessible facilities in this building should be added.

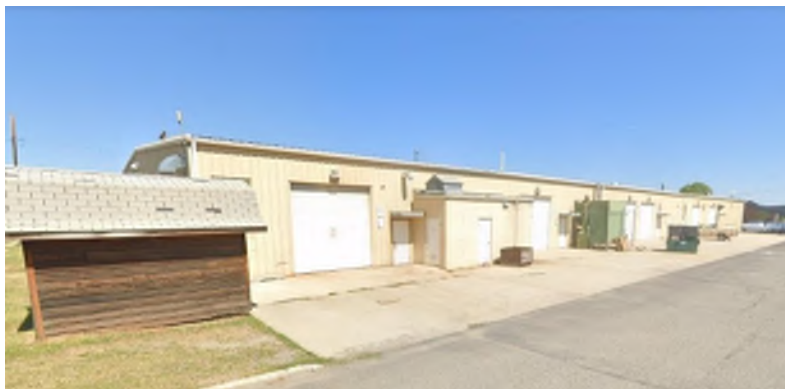
Shop Outbuilding Exterior Man Doors: The exterior man doors have deteriorated past their usefulness and need to be replaced.

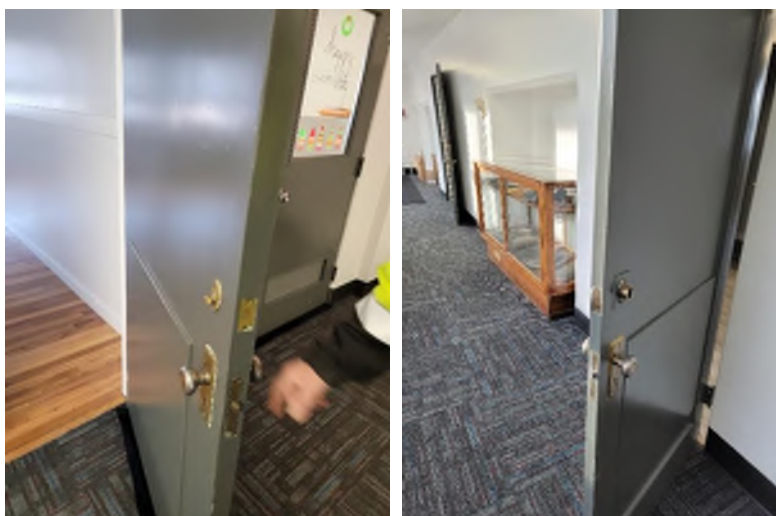
Main Building Exterior Doors: The exterior doors at Lincoln are older Hollow Metal Doors and are also in need of being replaced.
