THE 7th AVENUE GYMNASIUM

Preliminary Architectural Report

Prepared for **Helena Public Schools**

March 2019

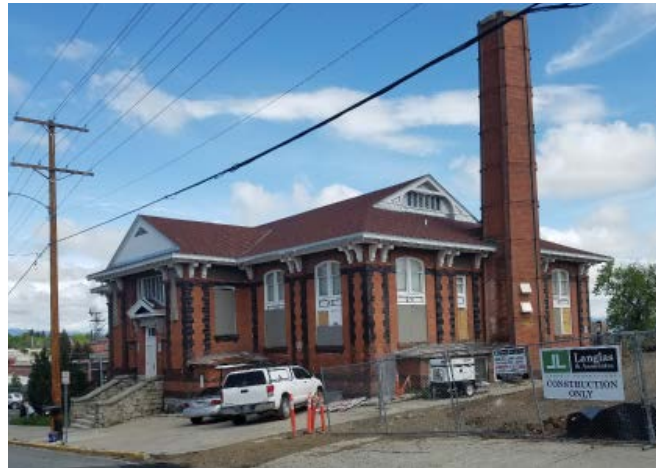
Access/accessibility issues and smoke stack

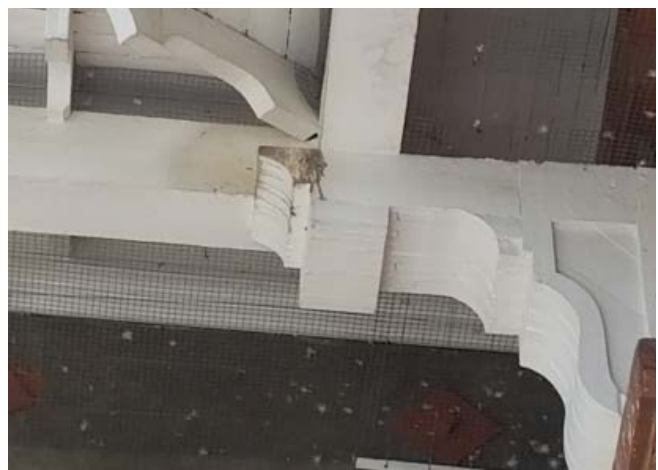
Additional health hazards exist throughout the building. Due to the age of the building, hazardous materials (ACM's and LBP) are present and must be addressed where new work is conducted. A pigeon infestation is evident along the eaves around the building. And remnants of a variety of hazardous, or unhealthy, materials are present in the old boiler rooms that once served the entire school campus.

Bird damage and mitigation

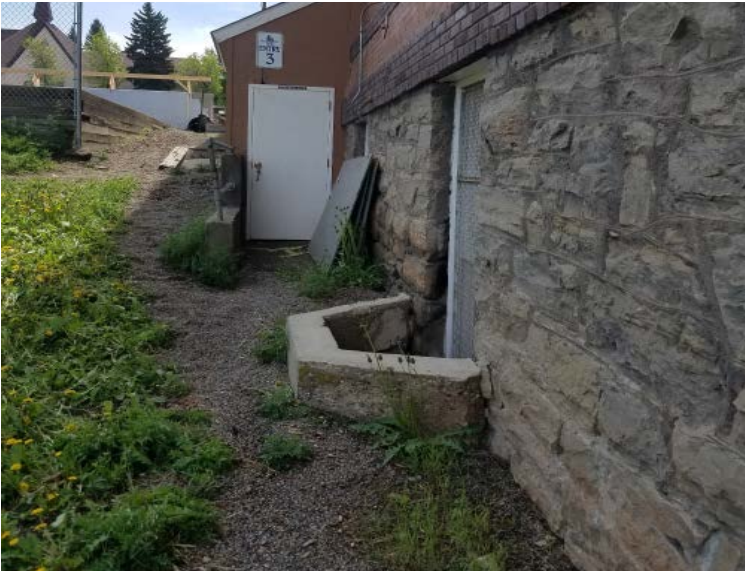
Slight negative drainage at north side of building

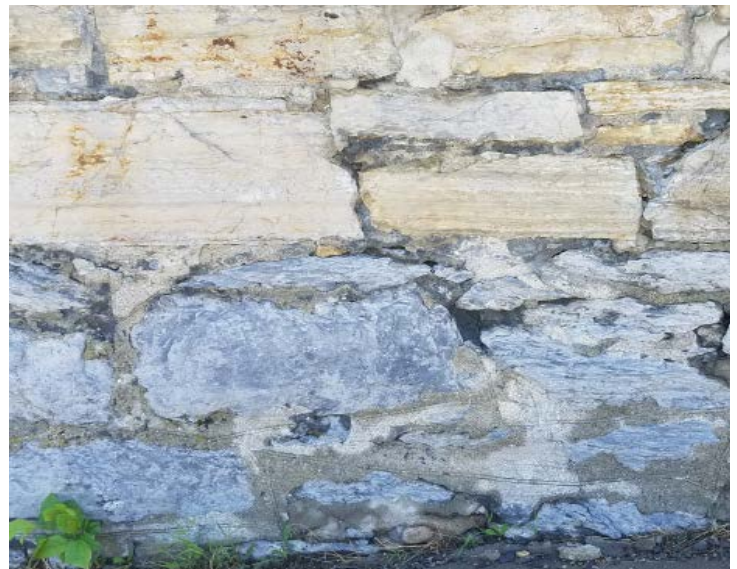
Deteriorated landscape wall w/ 2 eras of stone

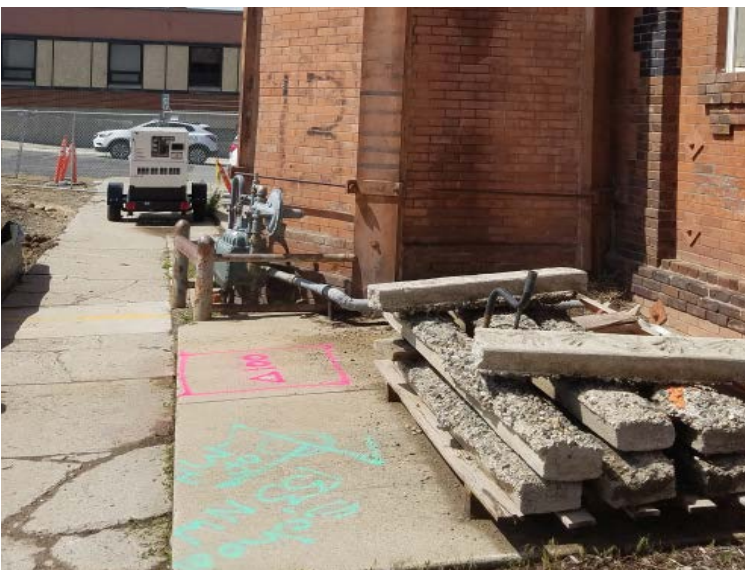
Deteriorated site concrete along east side

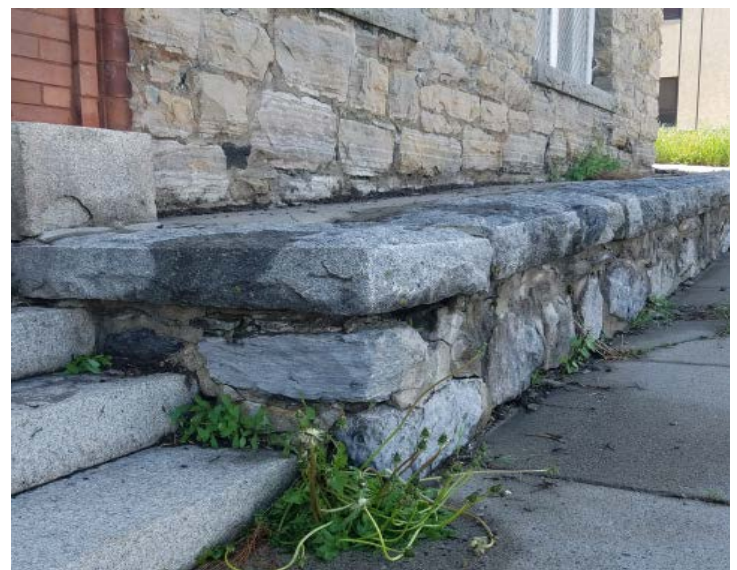
Stone steps at lower entry and low stone wall

The uncoursed local stone masonry water table/foundation was observed to be in good condition, with approximately 10% to 20% of the area requiring repointing (mostly within 24" of the ground). The mortar was observed to be of a softer lime-rich mix typical of the age, with full joints. Small areas are observed to have beaded joints, although it is too limited to determine if the technique was used throughout the building. Several areas of repointing were observed, indicating regular maintenance. Isolated areas, particularly on the west wall, require more significant repointing work to repair minor cracks and areas of missing or deteriorated mortar. See Structural Letter for further information on the masonry foundation. Stone lintels above the two entries were observed to be in fair condition with some signs of water damage on their bottom face. Landscape walls are in fair/poor condition and require significant repointing. Entry stair walls and steps are in good condition with some repairs and repointing required.

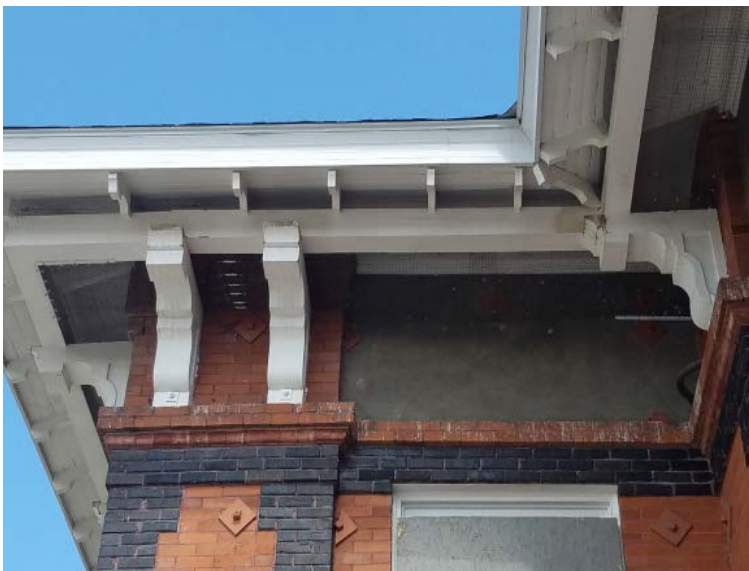
Typical eave condition

The eaves of this building on all four sides are a significant architectural element and are comprised of built-up decorative wood brackets, a wood beam supporting decorative exposed rafter tails that all appear to be original, in good condition, and well maintained. The drip edge flashing and fascia appear to be of newer vintage and exhibit signs of failing paint and a less than satisfactory level of craftsmanship. All soffits are painted wood slats in fair condition, showing some signs of historic water damage but with significant usable life left.

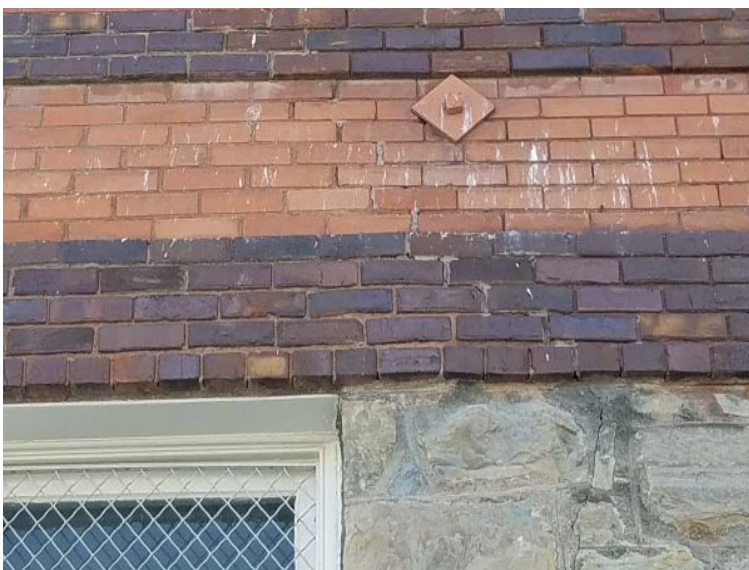
Exterior walls are assumed to be multi-wythe unreinforced brick masonry. Brick masonry was observed to be in good condition throughout the building with approximately 10% requiring repointing. Brick joints are finished full with a soft historic mortar that appears to be colored red to match the bricks. The field bricks are a smooth orange-ish red with a rhythmic detailed pattern out of dark klinker bricks, and simple decorative corbel detailing at the water table and around the main entry. See Structural Letter for further information on brick masonry.

Typical condition of brick and stone

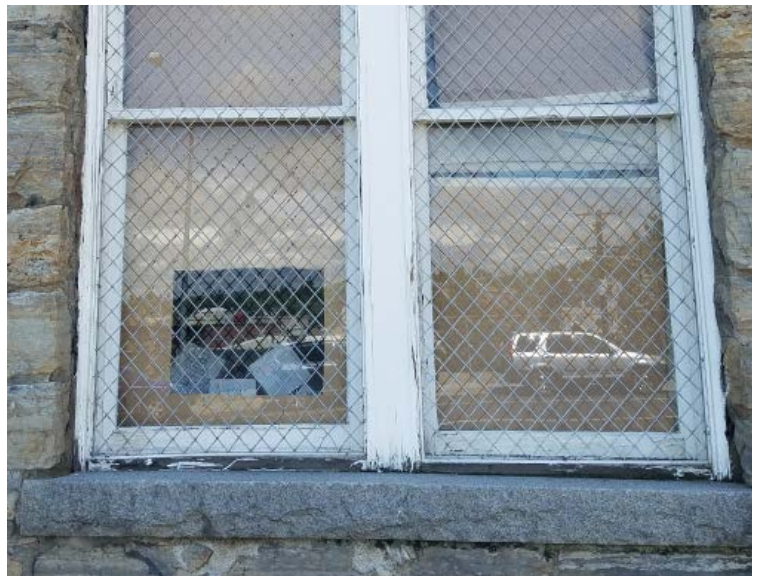
As noted above, the windows near grade show signs of moisture damage and require repair. The Lower Level windows along the streets also have an expanded metal screen to protect against intrusion.

Typical Lower Level window (damage at bottom)

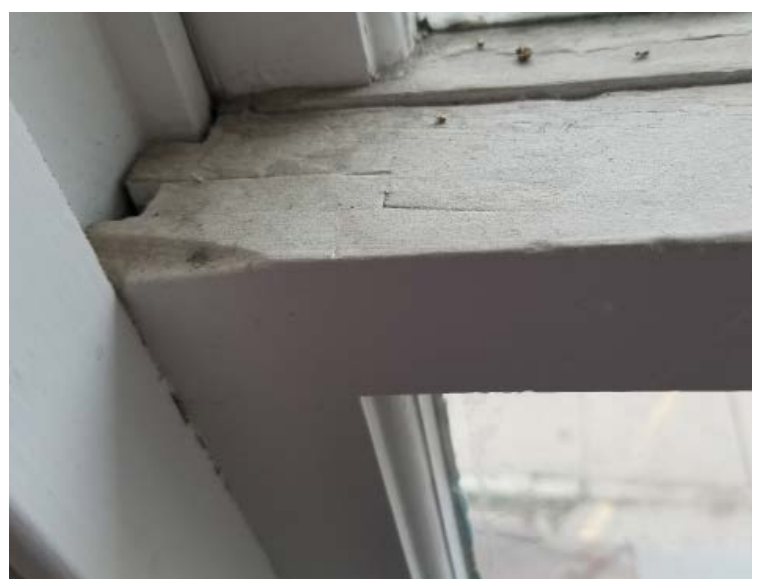
Original painted wood windows appear to be in place throughout the building and were observed to be in good condition. The Lower and Main Level windows are primarily 1/1 double-hungs, with a decorative window at the center of the north elevation and a transom above the main entries. The Upper Level windows have a similar configuration but the top sash is fixed with an arched head. The windows on the Main and Upper level are aligned and have detailed decorative wood trim to appear as a single feature. Deterioration of glazing and historic glass were observed throughout. Upper Level windows have an added metal screen for fall protection.

Typical condition of windows from interior

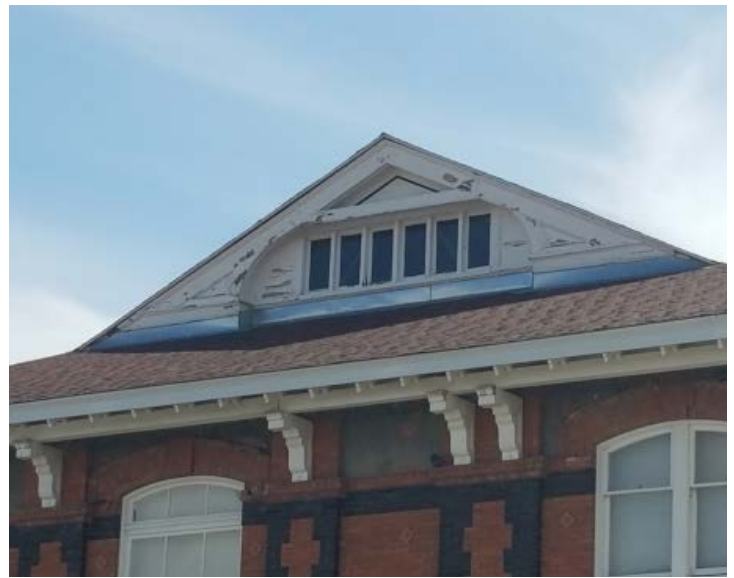
While limited in terms of area, the white-painted wood accent elements are essential to the character of the Gym. These elements include decorative wood trim around and between wood window units, decorative wood brackets and beams below the eaves, and exposed wood rafter tails and soffit material at the eaves. Intricately detailed woodwork was observed in the Dutch-gables at the east and west elevations. These details/materials appear to be covered at the dormer above the main entry. All wood components above the water-table throughout the building appear to be well maintained and in good condition. While the wood windows and trim located on the Lower Level are well maintained, significant deterioration was observed due to their proximity to grade.

Deteriorated woodwork and note failing shingles

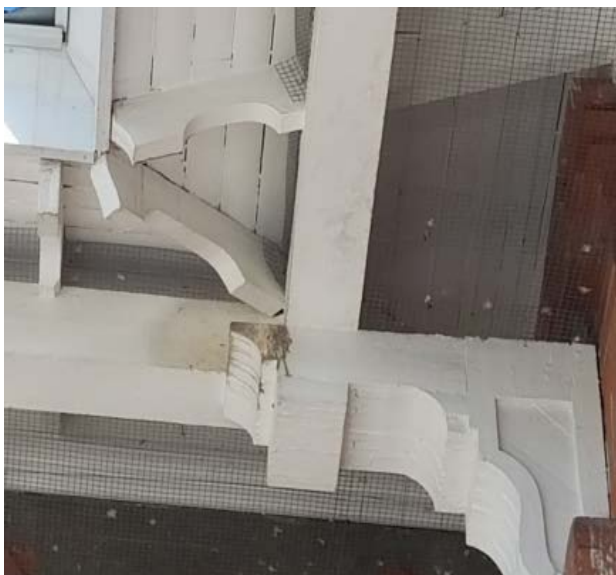
Typical eave condition (and bird netting)

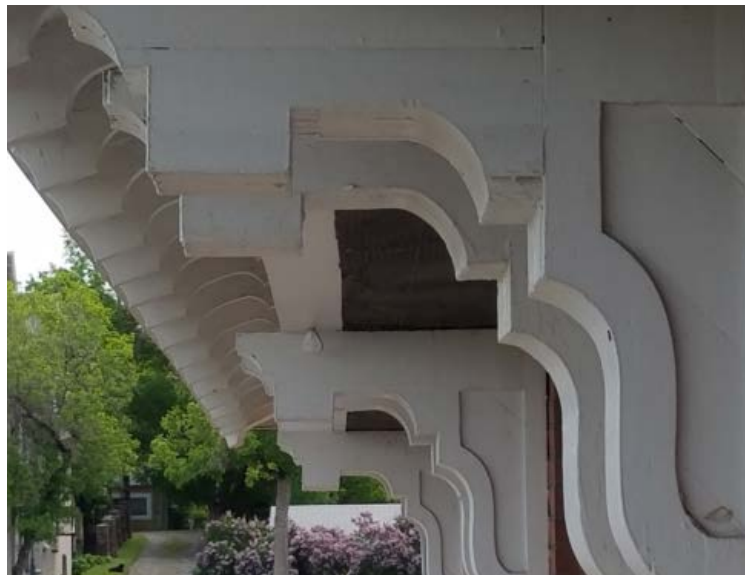
Typical eave detail and condition

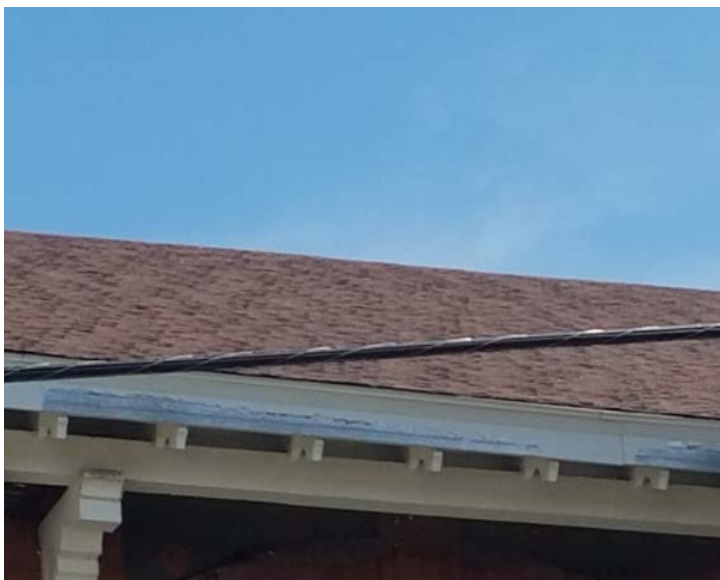
Roofing over the main body of the building was observed to be relatively new asphalt shingles that appear to be in poor condition. The shingles were observed to be failing by peeling up in a manner typical of overheating in a poorly vented attic.

No attic ventilation was observed in the eaves, gables, or along the ridge.

Typical condition of roof (shingles failing)

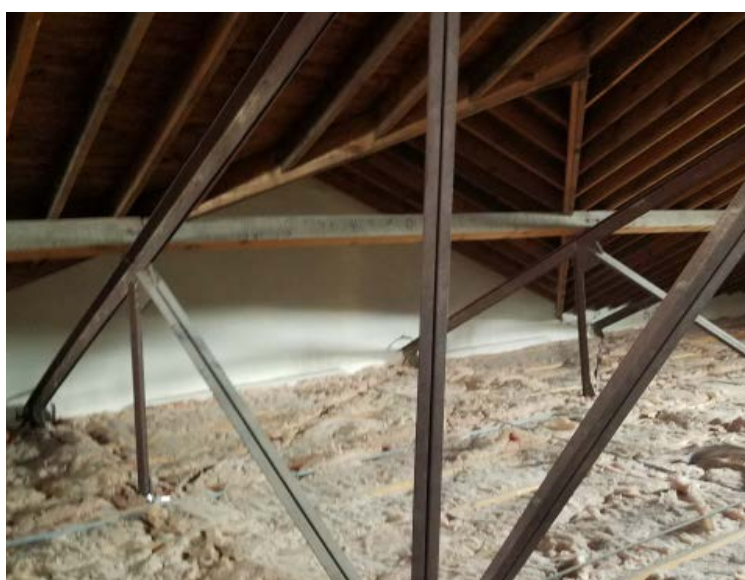
The attic is one single space over the entire footprint of the building, accessible by one small hatch in the ceiling at the center of the east side.. It was observed to be in good condition with no areas of significant or problematic water damage noted. The primary structure is steel trusses with wood purlins and wood rafters, with additional wood ceiling members on the trusses. Modern blown-in insulation was observed to the depth of the ceiling framing members.

Attic: metal trusses, wood rafters, modern insulation

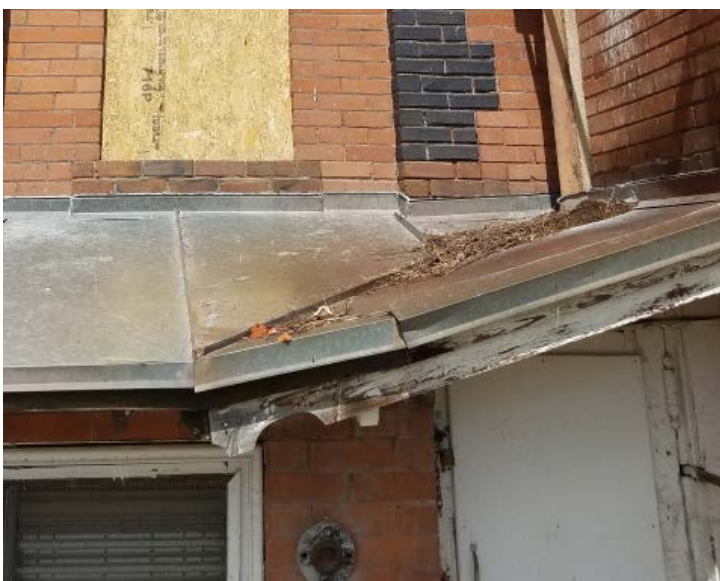
Metal roofing was observed on the low lean-to elements on the south and east sides. This roofing appeared to be in fair condition. Asphalt shingles on the service entrance lean-to on the north side appeared newer and in good condition.

Typical condition of metal roof on historic lean-tos

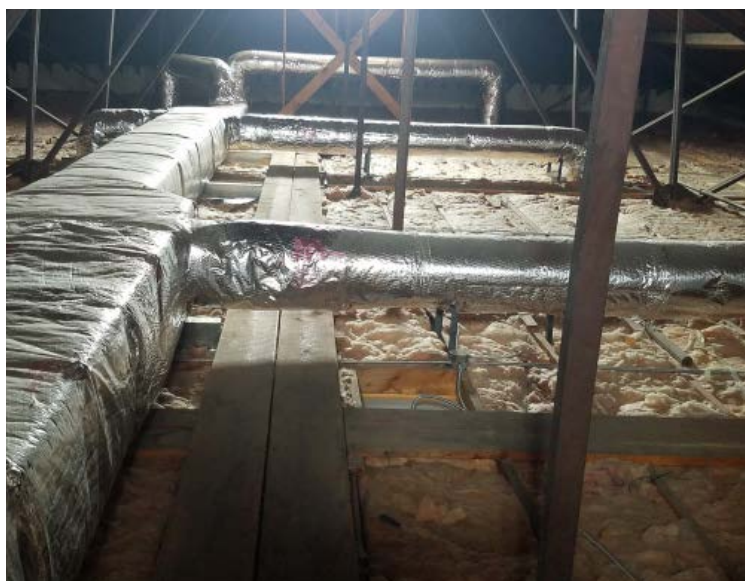
Insulated mechanical ducting in attic

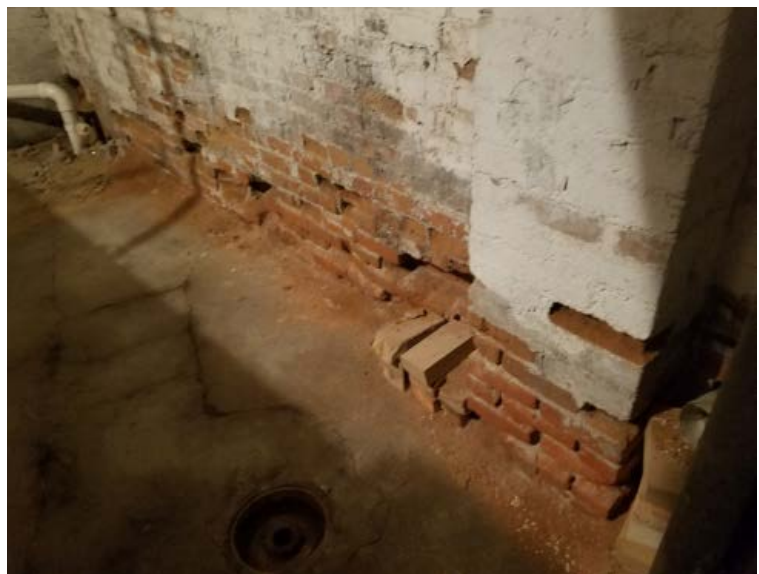
Isolated area of recent brick damage at base of wall

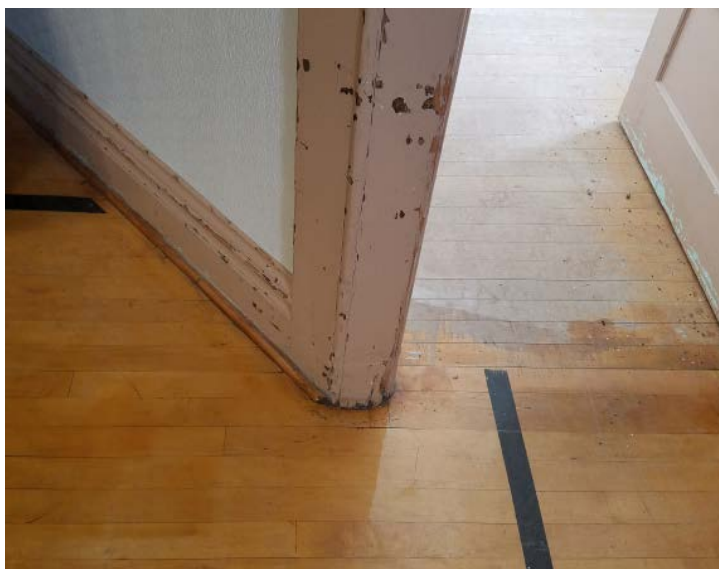
Typical condition of interior finishes at Main Level

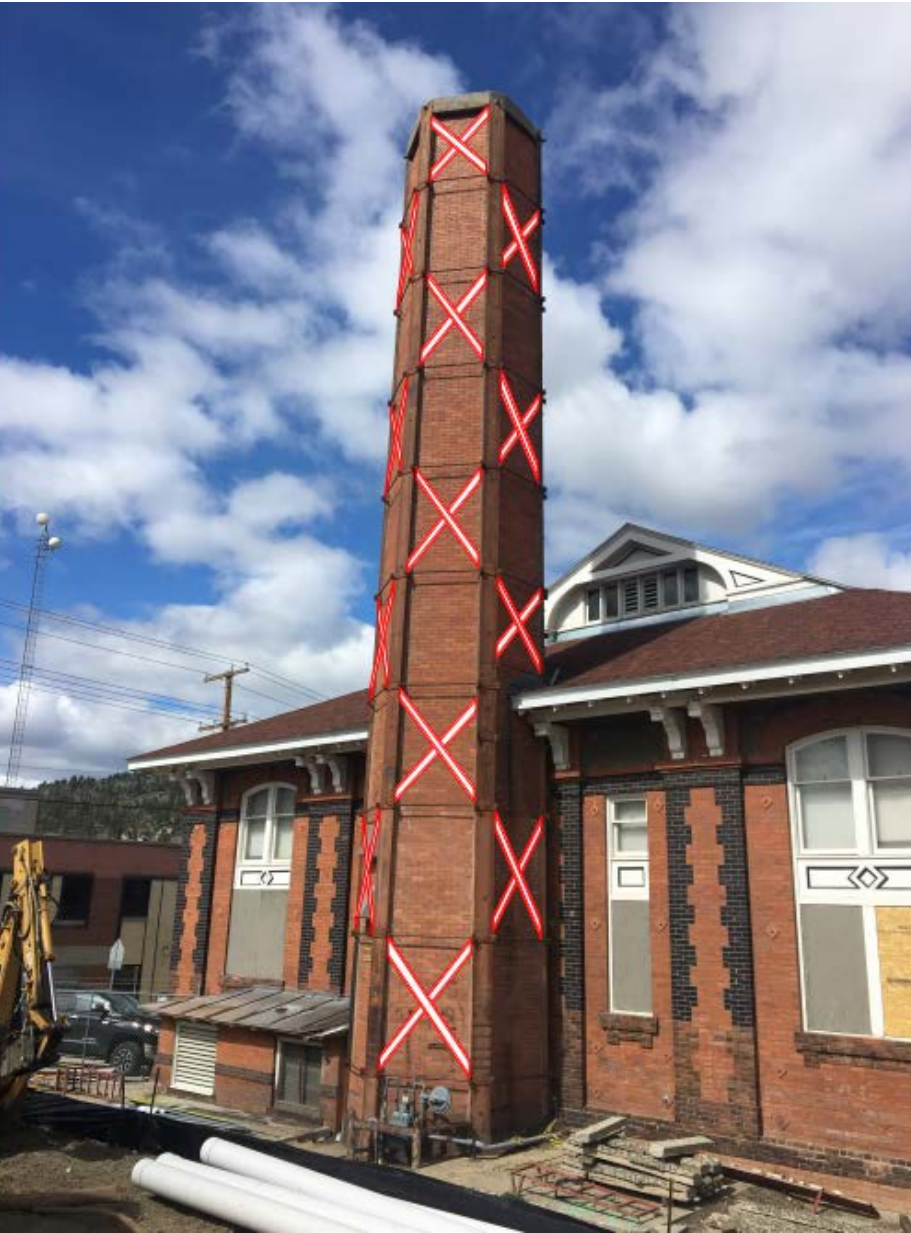
Figure 1. Bracing at Every Other Bay - Conceptual

7th Avenue Gym was first examined by a Structural Engineer in 2013. This same engineer conducted the analysis for this Report and updated their findings and cost estimates. The Gym was found to be structurally sound and easily stabilized. And, after deeper analysis it was found that some potentially challenging issues, such as the suspended track and the smokestack, are reasonably solved. While there is a significant scope of structural improvements to address life-safety and seismic stability requirements of the current code, the work is reasonable to execute and costs about \$280,000. These structural improvements represent 8% of the overall cost, which is significantly less than a typical retrofit or even structural costs for new construction. The scope of structural improvements includes stabilization of exterior masonry, the smokestack, wood floor framing, roof framing, and miscellaneous structural work.

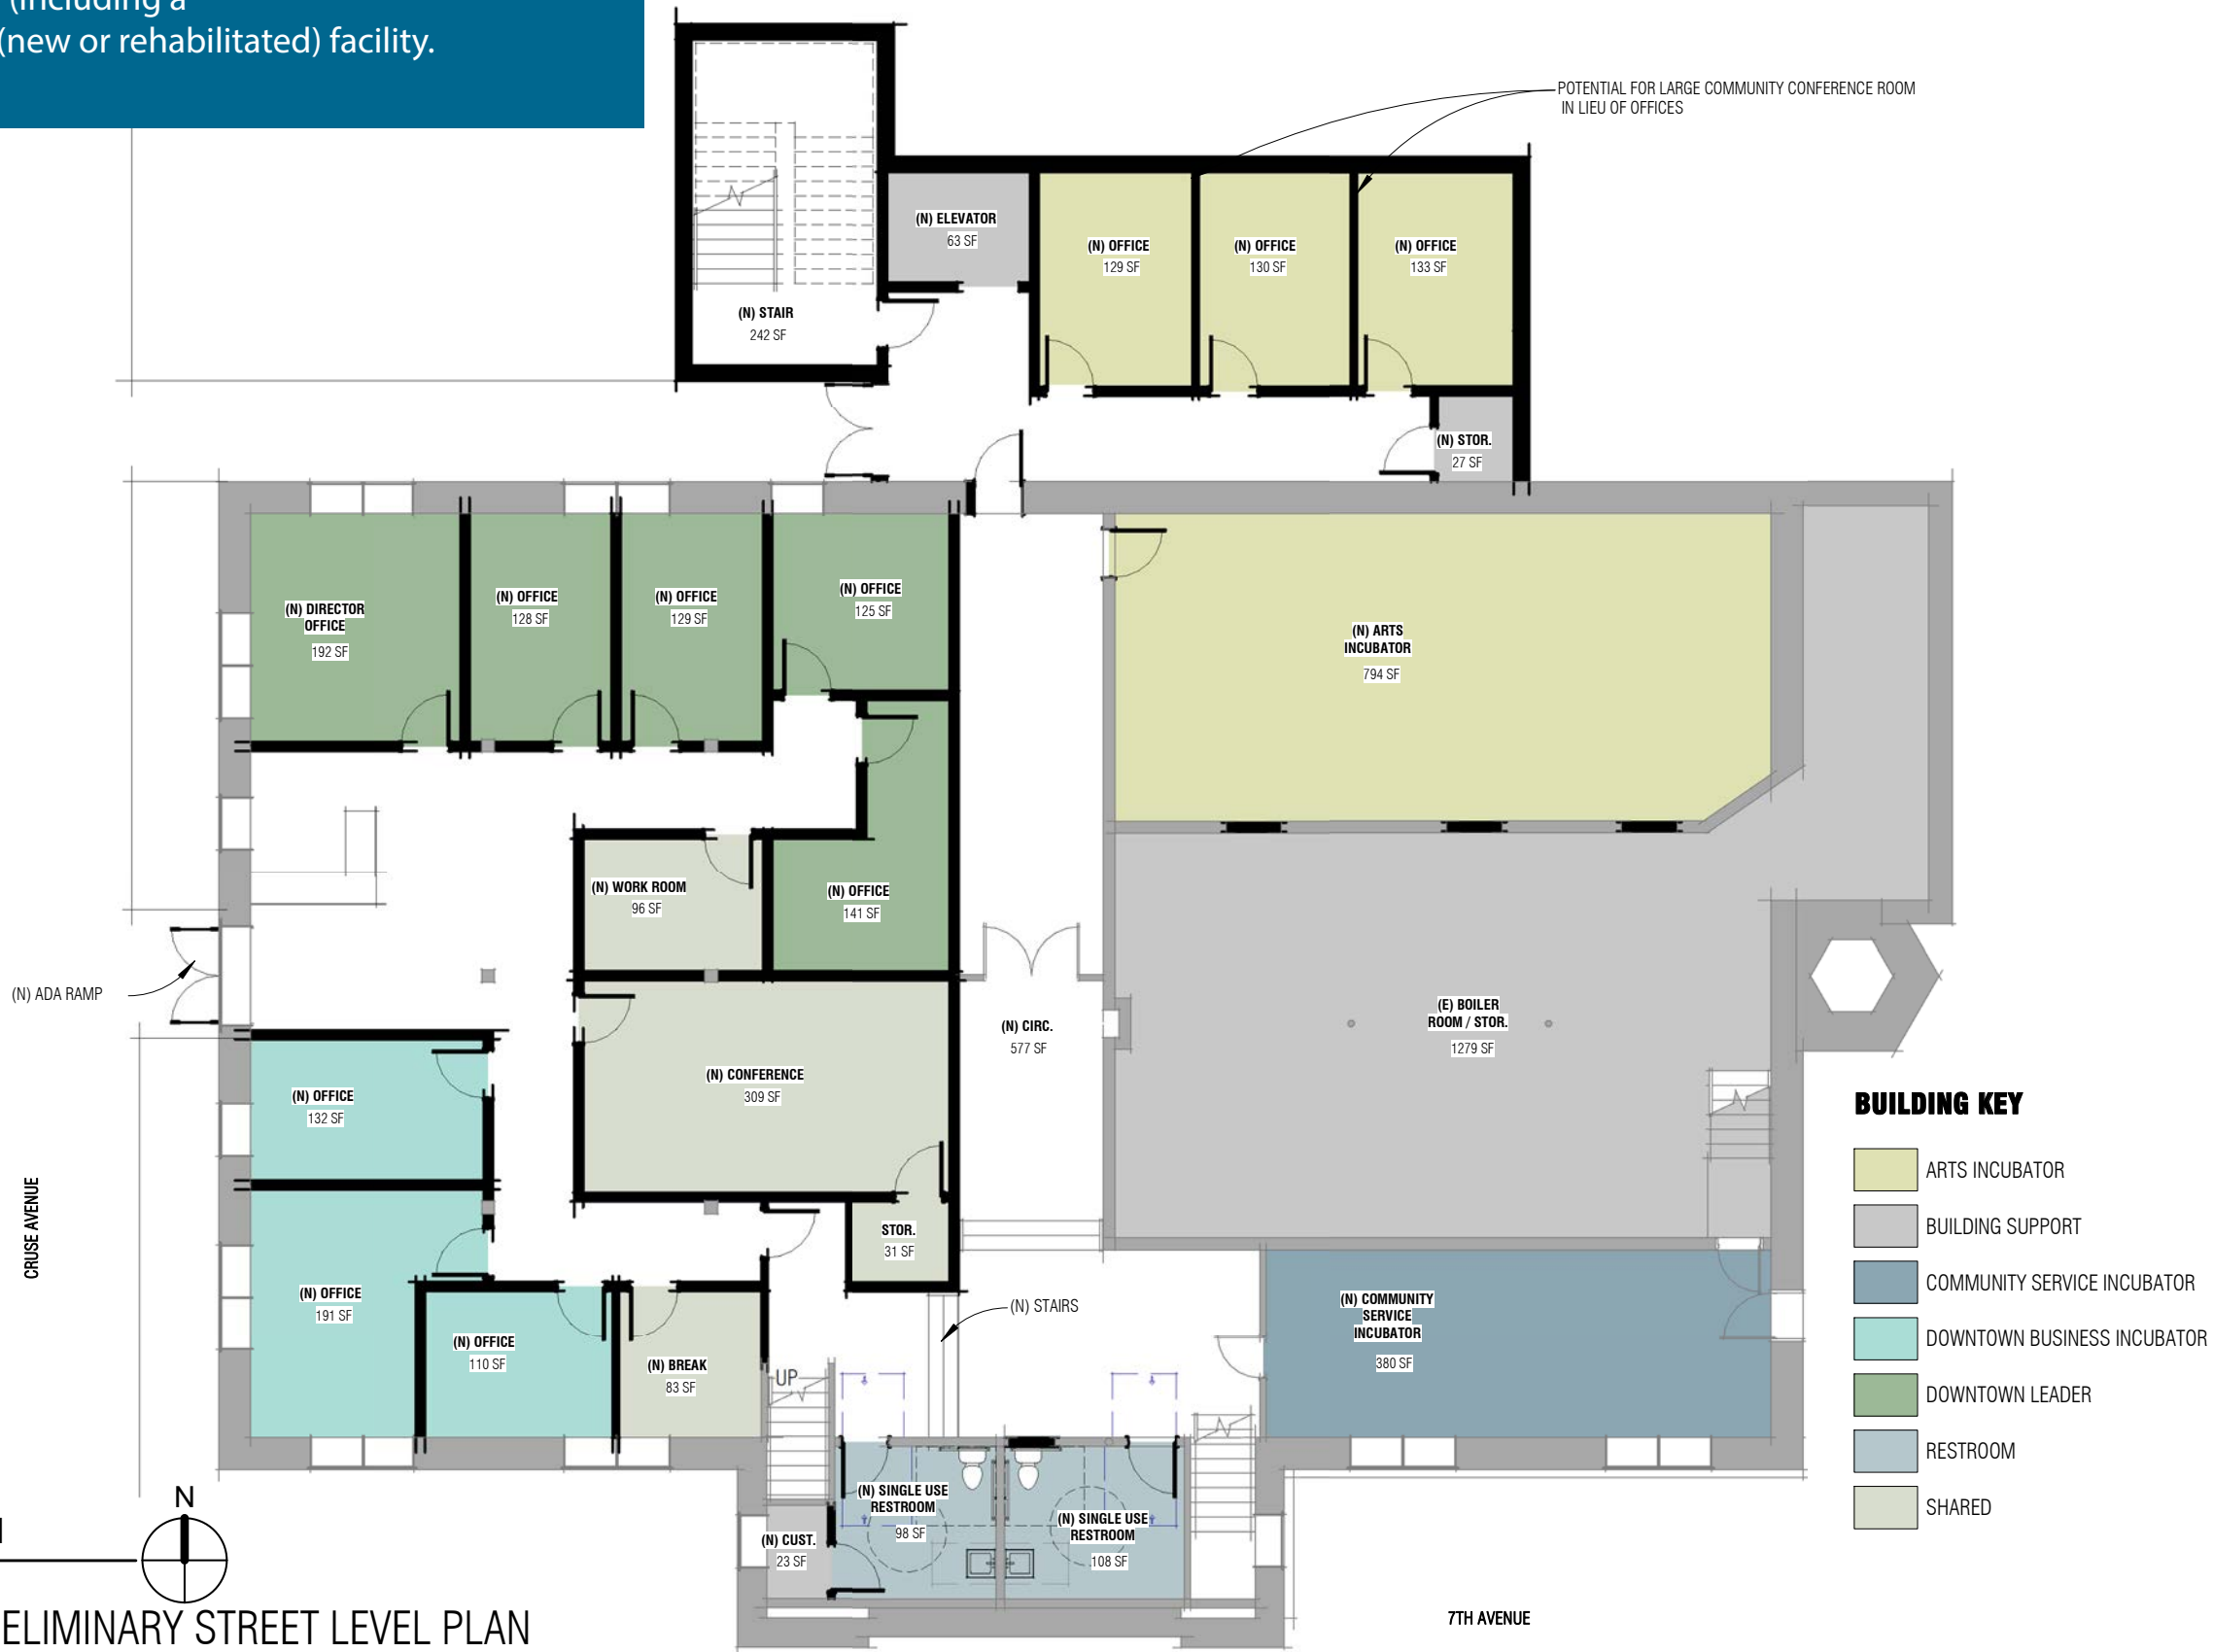
1
SD-A4

PRELIMINARY STREET LEVEL PLAN

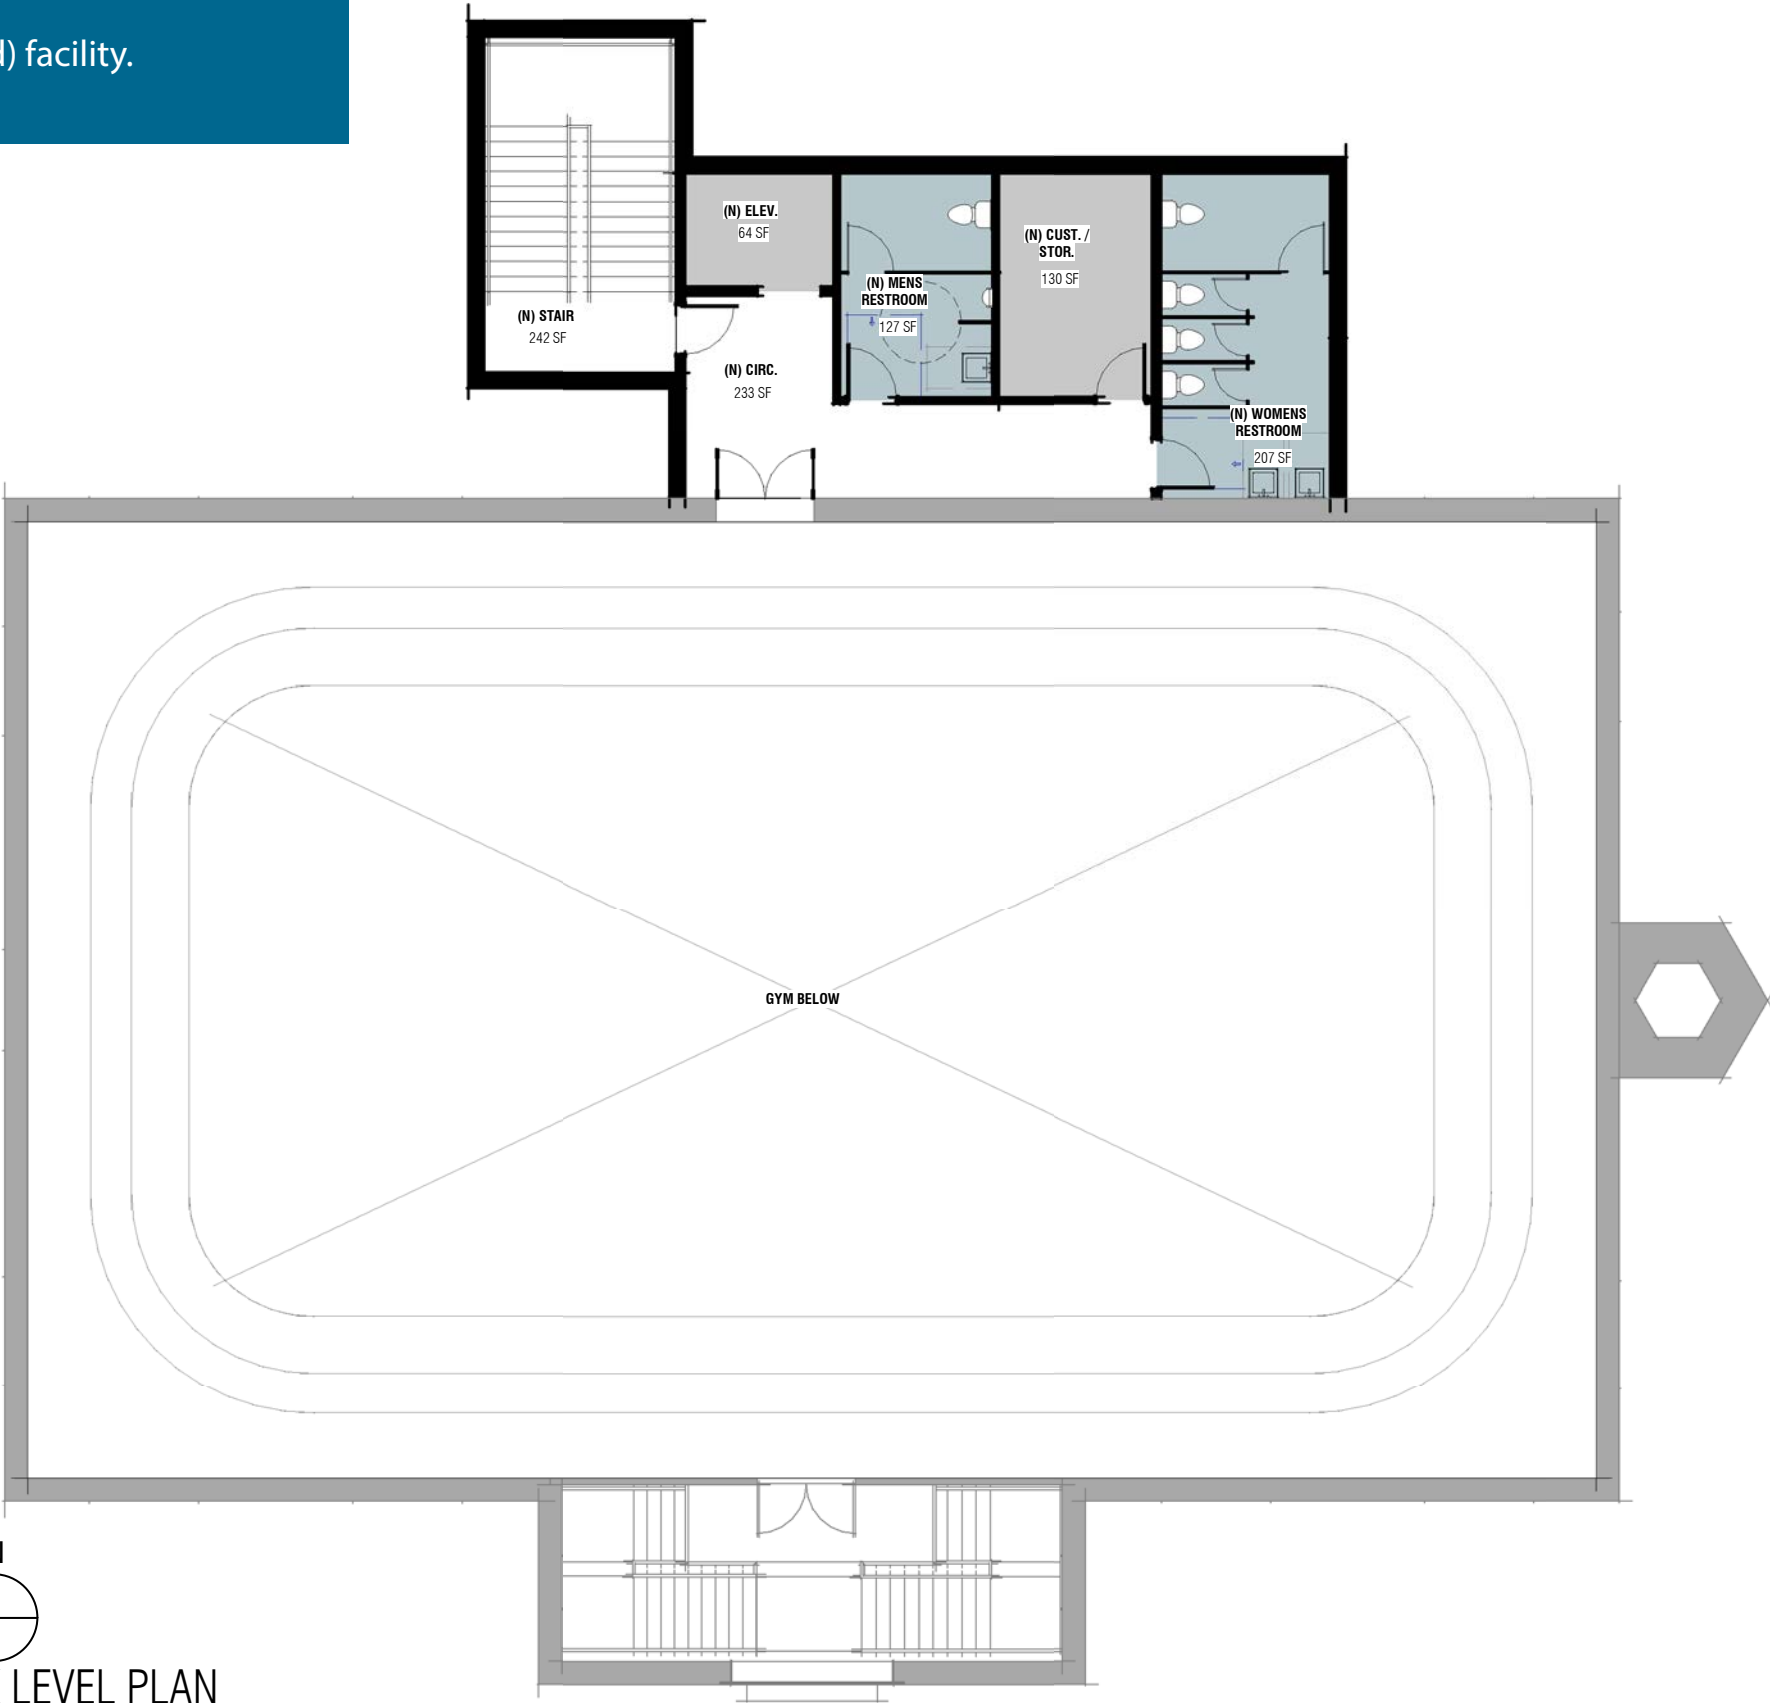
1
SD-A6

PRELIMINARY TRACK LEVEL PLAN
