# Needs Assessment & Opportunity/Challenge Identification

History, Conditions Assessment, & Engineering Analysis

# **Existing Conditions Assessment - General Site Conditions**

7TH AVE. GYM - HELENA, MT

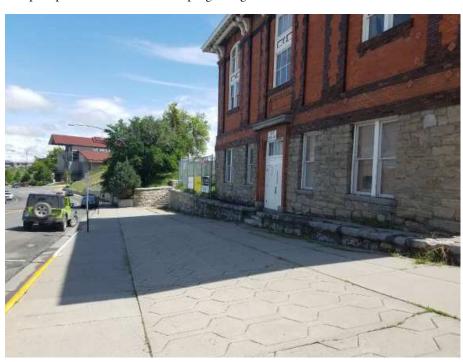
Slight negative drainage along north side of building

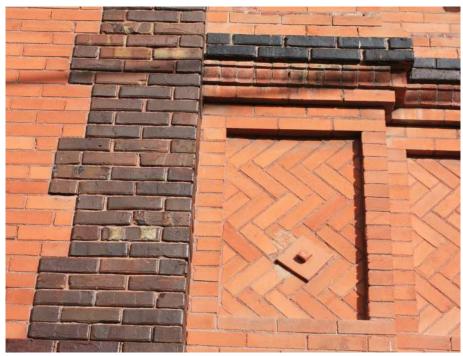
Typical brick detailing

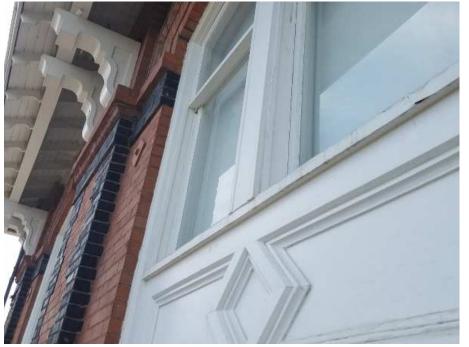
Typical wood detailing

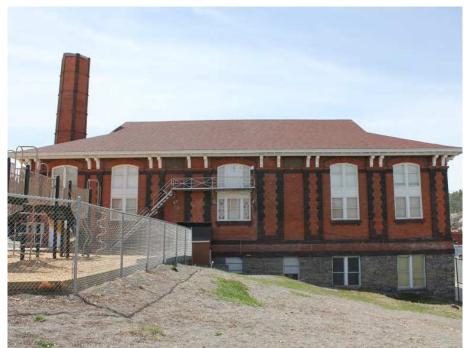
North Elevation

A metal fire escape on the north side provides egress from the center of the upper level to the ground at the northeast corner of the building below. The fire escape appears and feels sound and in good condition, however several areas of rust were observed.

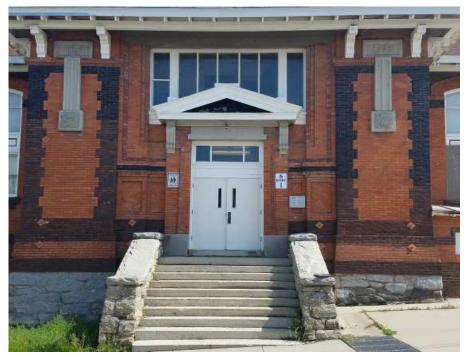
All three exterior doors were observed to have been replaced with modern metal doors and hardware in the historic wood frames. The doors and hardware are functional, although well into their usable life and visually incompatible with the historic character of the building. The wood frames (including transom windows) appear to be in good condition and well maintained.

The 7th Street double-door entrance is approached up a half-flight of stone steps with stone walls approximately 30" high and a deep landing. The Cruse Avenue double-door entrance is accessed by three stone steps with no walls and no landing. The back exit at the northeast corner is accessed from a walk at grade and is of similar configuration and condition. The egress exit to the fire escape from the second level likewise is a modern metal door in a historic wood frame, both in good condition.

Main Entry to Main Level on 7th Ave.

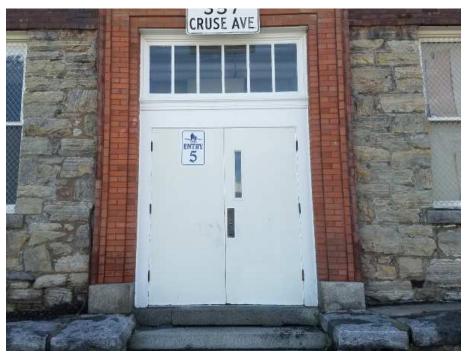
Main Entry to Lower Level on Cruse St.

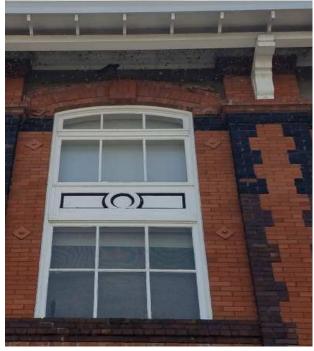
Original painted wood windows appear to be in place throughout the building and were observed to be in good condition. The Lower and Main Level windows are primarily 1/1 double-hungs, with a decorative window at the center of the north elevation and a transom above the main entries. The Upper Level windows have a similar configuration but the top sash is fixed with an arched head. The windows on the Main and Upper level are aligned and have detailed decorative wood trim to appear as a single feature. Deterioration of glazing and historic glass were observed throughout. Upper Level windows have an added metal screen for fall protection.

Typical window configuration and detail

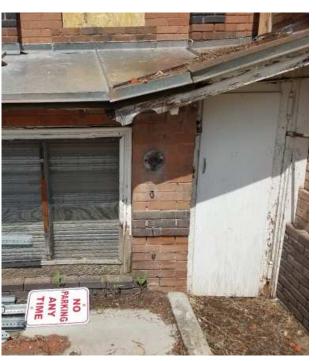
The utility entrance/exit in the lean-to on the north side is a similar metal door in a modern metal frame. A small wooden door in a wooden frame provide utility access in the lean-to on the east side. This door and frame are in poor condition due to their location and a small landing that is about 6" below the adjacent grade/walk.

Utility door and louvers at east side

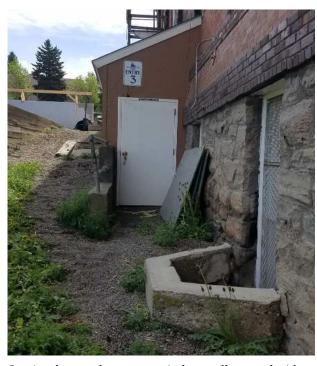
Service door and concrete window well at north side

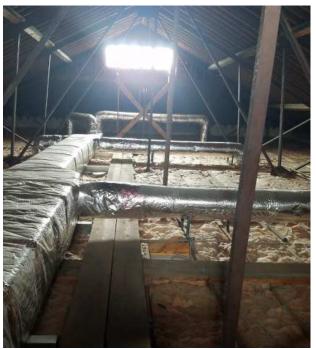
Insulated mechanical ducting in attic

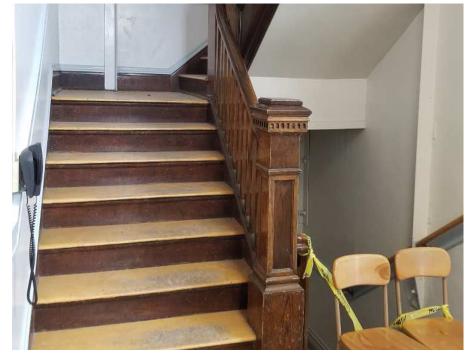
Upon entering the Main Entry to the Main Level, the large landing leads to the Gymnasium and a staircase at each side. These wooden stairs are worn but in good and sound condition, and appear to be historic wood work in its original configuration. Each staircase appears to be of adequate width. No handrails were observed. The historic wood guardrails at the center of each stair are in good condition. However, their height should be verified and compliance with the IEBC provisions shall be coordinated with the requirements for handrails.

Stair from Main Level to landing above

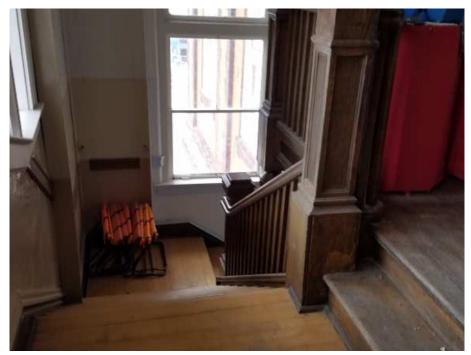
Landings at Upper Level

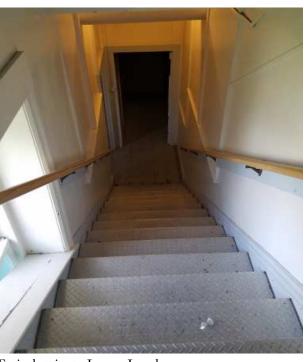
Wood finishes throughout both stairs are in fair condition, with significant wear on the inside side of the treads. Plaster finishes and painted wood appear to be in good condition throughout the space.

Typical stairs to Lower Level

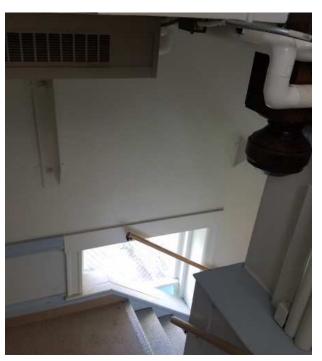
Mechanical unit, piping, and stair at window

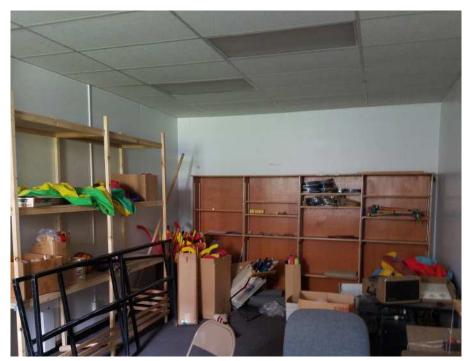
Signs of rodent activity were apparent in both classrooms, especially near the exit. And moisture damage through the masonry of the exterior wall was evident in a small area at the base of the wall between the vestibule and adjacent window.

Classroom space at bottom of west stair

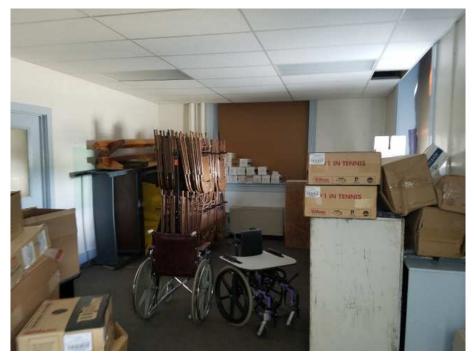
Classroom space at southwest corner

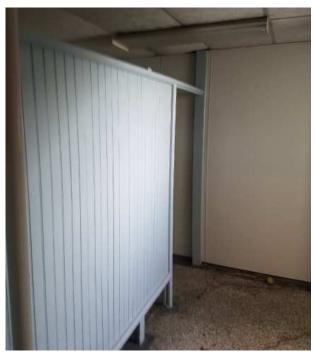
Occupying the southwest quadrant of the building, the locker room and bathroom areas appear to have been modified several times over the years, in terms of both configuration and finishes. The few areas of remaining exposed terrazzo flooring appear to be in poor condition with much cracking, the modified areas contain a newer slip-resistant tile. The larger rooms maintained the pressed-tin ceiling tiles, and the small bathrooms had a dropped ACT ceiling. Plaster walls and ceilings were observed to be in fair condition throughout, and most wood trim remained intact in good condition. The locker rooms appeared to be heavily used and in fair/poor condition with severe damage noted in the actual shower room where a recent arson event occurred (no structural damage).

Bathroom area with terrazzo floor and ACT ceiling

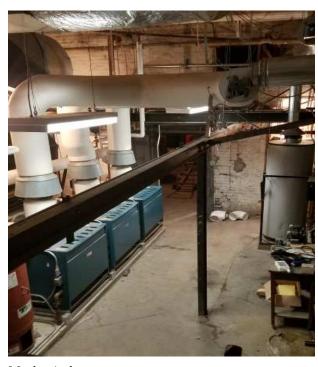
The mechanical area occupies the northeast quadrant of the Lower Level and consists of an unfinished space that holds the boilers and water heating equipment. The interior masonry in this room has been painted and shows signs of minor damage from moisture throughout the room. A small area of severe damage at the bottom of the rear wall was noted, as was deteriorated stone masonry near the smokestack.

Mechanical room

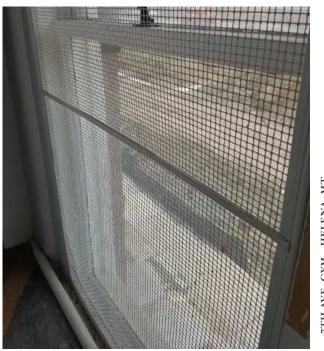
The windows throughout the Upper Level are very near the floor and have expanded metal screens as fall protection. Some of the windows have latching covers. The attic is accessed via a crude wooden ladder and small access hatch at the east side of the building, directly from the running track.

Fall protection at windows

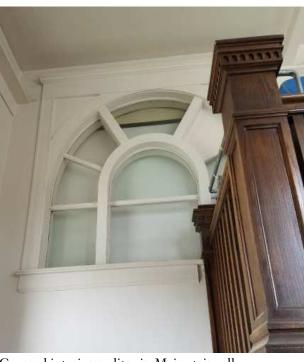
Covered interior re-lites in Main stairwell

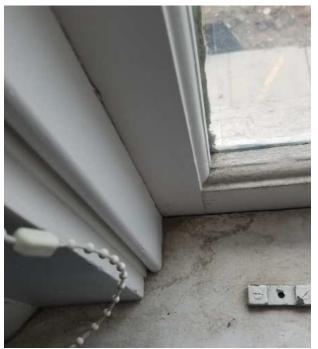
All windows (even those that have been covered) appear to be in good, or easily repairable, condition and are excellent examples of the high-quality wood sash windows of the period.

Intact wood windows, frames and trim

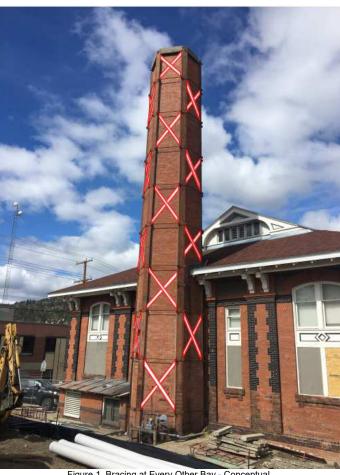
Figure 1. Bracing at Every Other Bay - Conceptual

New diagonal bracing members are required to stabilize the existing smokestack. If two diagonal bracing members are provided at every other bay for the entire height of the channel, a 6-inch channel can be used. These channels would need to be anchored into the existing masonry at approximately 12" on center and welded to the existing vertical channels. Figure 1 shows the location of the braces on one side of the chimney. The bracing would need to occur on each side (6 sides total) of the chimney.

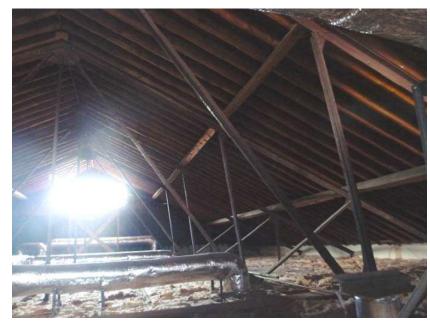
The main roof structure consisted of steel trusses spanning in the East-West direction with wood purlins and rafters as seen in Figure 3, below. The steel trusses consisted of angle members forming the top and bottom chords and the angle members. The connections consisted of steel plates and rivets. There were a total of six trusses spaced anywhere from 11-feet to 15-feet on-center. Timber purlins span between the steel trusses at approximately 10 ft on-center. 2x8 rafters span between the brick wall and purlins and from the uppermost purlin to a 1x ridge board at approximately 16-inches on-center. The hips on either end of the building and the gable facing Seventh Avenue are all wood framed.

Figure 3: Roof framing as seen from the attic.

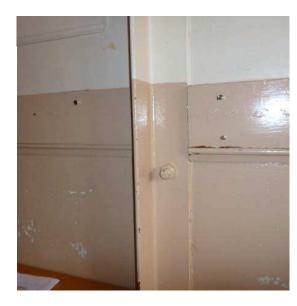
Some retrofits were observed in select areas of the structure that were presumably added after the earthquakes of 1935. In the entry stair, lateral bracing in the form of steel angles had been added some time after construction, as seen in Figure 6. Throughout the building, full-height steel angles have been added to the inside face of the exterior bearing walls at an average spacing of 8 feet on-center. These angles were bolted to the wall with 7/8-inch diameter bolts and square washer plates. (Figure 7) Their connection to the floor is unknown

Figure 7: Wall retrofits-steel angle at interior of the wall (left) and connection to wall exterior (right).

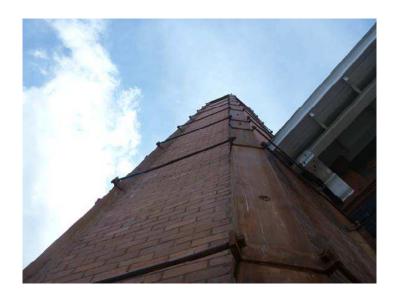
at this time. Some steel-framing members have been added sometime in the past to the exterior of the smokestack. The smoke stack is six-sided, and at each corner, steel channels have been added to the full height of the stack. These channels are supported by a pseudo tension rod around the circumference of the stack at regular intervals long the entire height. See Figure 8 below.

Figure 8: Steel framing retrofits at exterior smokestack.
