Helena School District Deferred Maintenance Report

January 31, 2022

RE: Deferred Maintenance Review
Helena Public Schools
Final Report

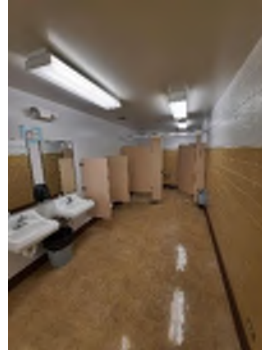
Plumbing: Fixtures are older but functional with no operational issues reported regarding the building piping systems.

The building domestic system is not equipped with a required water tempering valve. Device is required by code. The devices maintain the temperature of domestic water discharge from the water heater to a code designated range.

Kitchen sanitary sewer system is not equipped with a means of removing grease from the waste stream prior to exiting the building. The required grease interceptor protects the building waste piping from kitchen waste and grease. The device is required on all three compartment sinks.

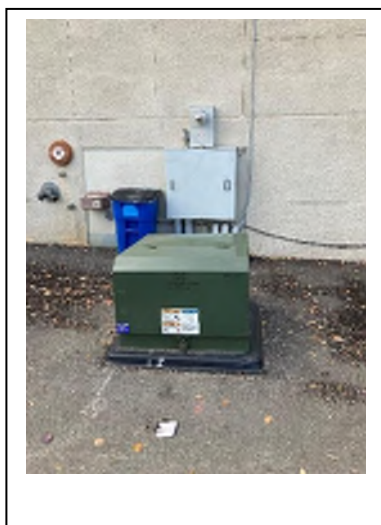
The secondary service conductors run underground to the building foundation and rise to a metering cabinet. Inside of the cabinet, the secondary penetrates the wall into the old boiler room and terminates in a 600A-2P main breaker in a distribution board. The distribution board is of newer construction. It is a GE Spectrum style panelboard with additional space for possibly up to four breakers (Figure 2). The highest recorded demand from Northwestern Energy was 62 KW in February, 2021. Based on this reading, the calculated demand is about 325 amps, meaning that the service has about 30% to 35% spare capacity after applying a 0.8 power factor and the demand at 125% per NEC Article 230.87.

Electrical Distribution: An upgrade to the electrical service will require replacing the existing single phase main distribution board, or possibly maintaining the board and installing a new main board either inside or on the building exterior if interior space is not available (See Jefferson Elementary School). The service voltage configuration will change from 120/240 volts single phase to 120/208 volts 3-phase. This should not be a major concern, but there may be a few items, i.e. old 240 volt motors that may need to be replaced. Additional branch circuit panelboards are recommended in the classroom wings to increase circuiting to the classrooms and workrooms. The obsolete panelboard is recommended for replacement. The other panelboards do not necessarily need to be replaced, especially since some of them are located in corridors or other locations where a larger panelboard will not have adequate clearances.

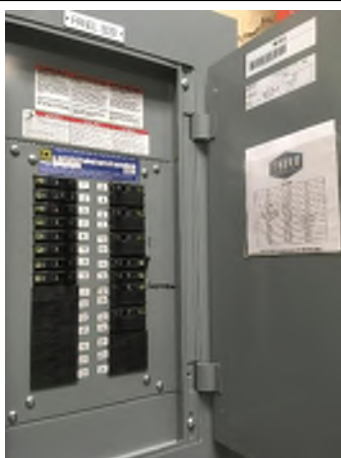
Figure 3 – A Newer Panelboard with Spare Capacity

Electrical Distribution: A newer branch panelboard, with spare capacity, is located in the Old Boiler Room adjacent to the distribution board (Figure 3). There are also two panelboards in the new Boiler Room, one with 20% spare capacity and five additional panelboards in the Classroom Wings for which there are few spare circuits available.

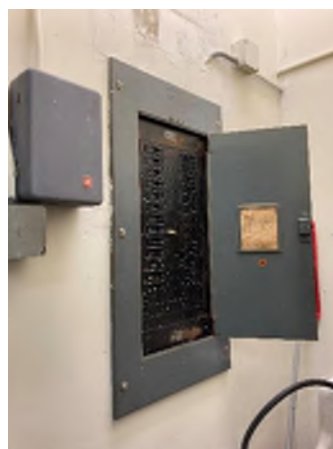
Figure 4 – An Original Panelboard

At least one of the panelboards (Figure 4 - Panel B4 in the 1949 Addition at the west end of the school) is obsolete and replacement parts are not available. The remaining original panelboards appear to have been upgraded in the 1970's or 80's, and are not obsolete, but are lacking in space for additional circuit breakers (Figure 4).

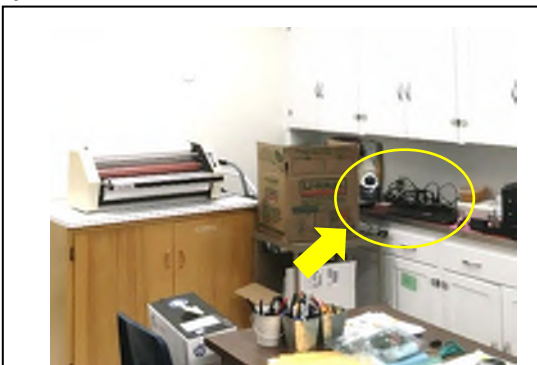
Branch Circuiting: Classrooms and Workrooms are not adequately provided with sufficient quantities of convenience receptacles and circuiting to meet today's needs. Most classrooms have four to six receptacles in usable locations often resulting in the need for two or more power strips. In some cases, power cords are run along walls, around cabinets or even on the floor in a protective cover. New receptacles and circuits were added with the Safety-Security Upgrades project in 2019.

Figure 6 – Numerous Appliances in Workroom Using Power Strip for Connection

Branch Circuiting: Additional receptacles and circuits are badly needed in the classrooms and workrooms, particularly near the teacher's desks. Replacing existing receptacles and adding up to 8 additional and increasing branch circuiting to a minimum of two dedicated circuits per classroom and one for workrooms is recommended. The wiring could be installed in a concealed manner if the cost of cutting and patching walls is acceptable. Otherwise exposed Wiremold raceway or possibly even conduit would be used.

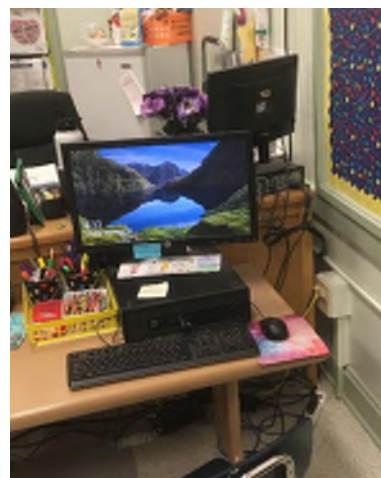
Figure 7 – Typical Classroom Clustering of Appliances Near Teacher Desk

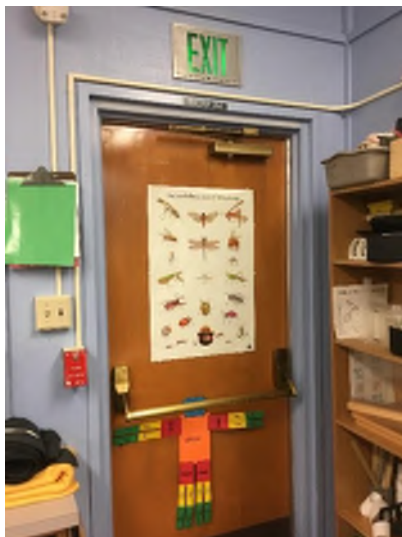
Nearly all of the exit signs have been retrofit with LED. Many of the exit signs contain internal emergency battery packs to provide code required illumination during a power failure, but there are a few of the original recessed exit signs that don't appear to have backup (Figure 9). Replacement with new is recommended.

Figure 9 – An Original Exit Sign LED Upgrade Without Emergency Backup

Lighting: Replacement of fluorescent with LED fixtures and controls is recommended. The energy savings combined with improved occupancy sensors and dimming controls is substantial. Rebates are available from Northwestern Energy and NCAT to help offset the cost of replacement. Replacement of the original exit signs with new LED signs with battery backup is recommended. After removal of the interiors of the old exit signs, the new exit signs would be mounted directly over the old to cover the opening.

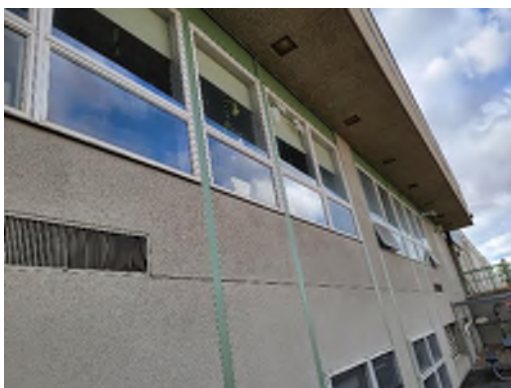
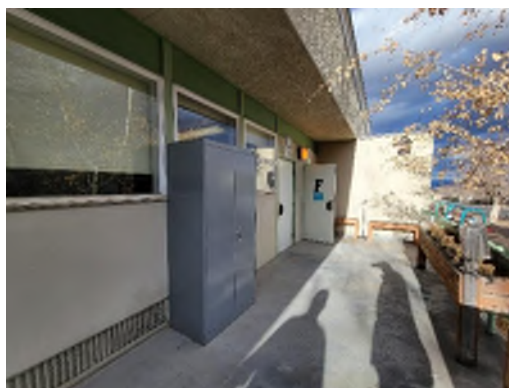
Vinyl Windows: The additional 1/3 of the building has older vinyl windows that appear to be nearing the end of their useful life.

Vinyl Windows: Replace all the vinyl windows with new thermally broken aluminum frames and double pane low-e glazing. **(High Cost, Low Priority)**

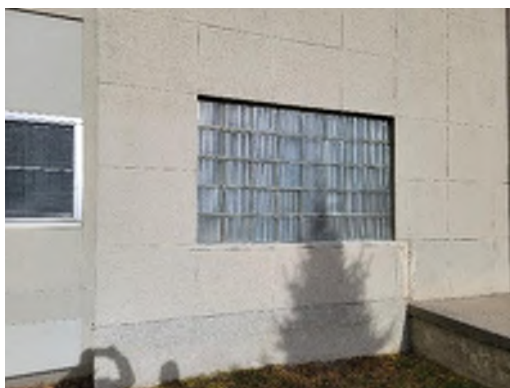
Glass Block: There is a small section of glass block in the girl's restroom that has broken cells and is in need of being replaced.

Glass Block: Remove and replace the glass block. I would be recommended to use a thermally broken window with double pane low-e glazing in place of new glass block. As this is a restroom there would need to be a window film installed so the glazing is translucent. **(Low Cost, Medium Priority)**

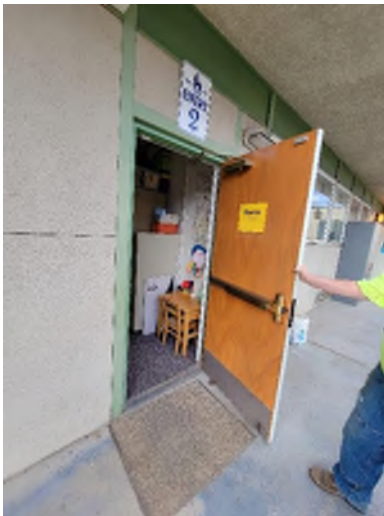
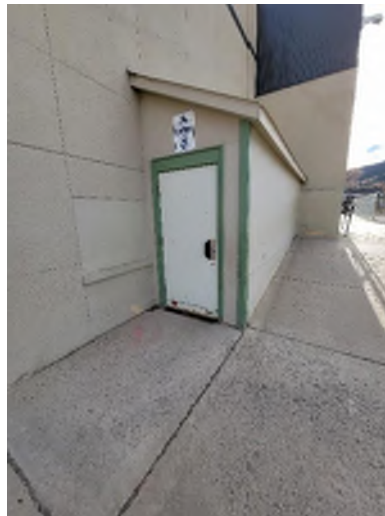
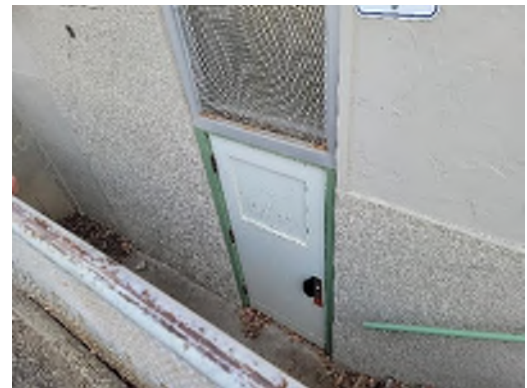
Exterior Doors: There are a half dozen exterior doors that are wood slabs and are not able to hold up to the exterior elements. These doors are in dire need of being replaced.

Exterior Doors: Replace the half dozen old/wood doors with new insulated galvanized hollow metal doors and frames. **(Medium Cost, High Priority)**

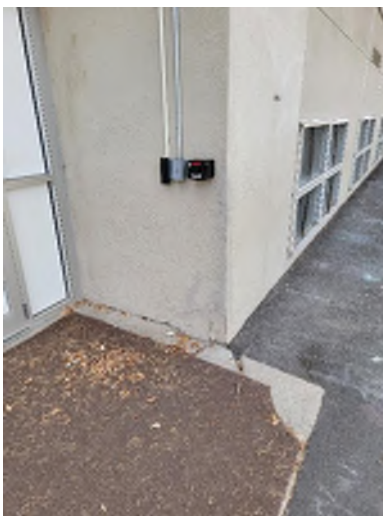
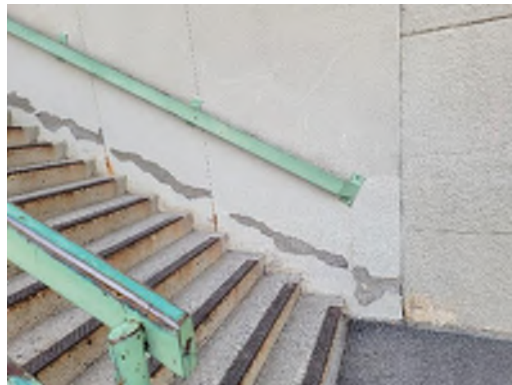
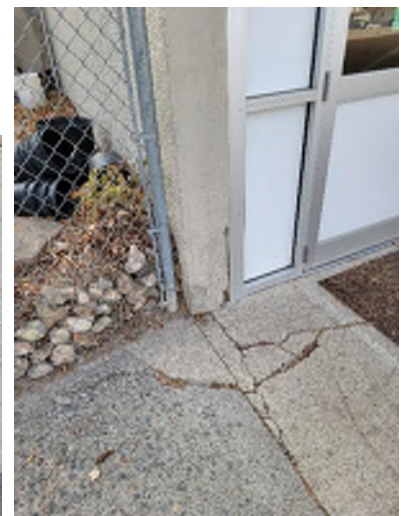
Cladding: The exterior cladding is primarily a stucco system and is in good shape. There are a few areas that should be patched and repaired. This system is not an EIFS system and so does not have the bird issues.

Cladding: Touch up the exterior stucco. **(Low Cost, High Priority)**

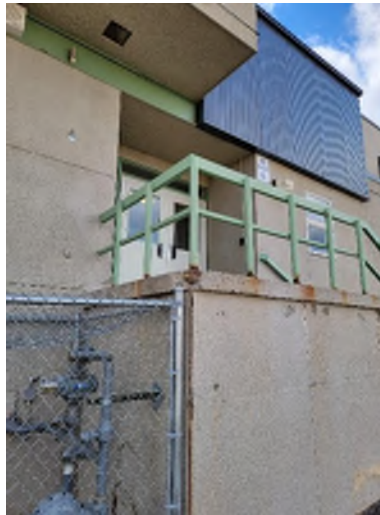
Exterior Stair and Guard Railing: The main level exterior stair is deteriorating and the existing railing that was installed is rusting at the base. The railing does not have adequate fall protection and should be replaced.

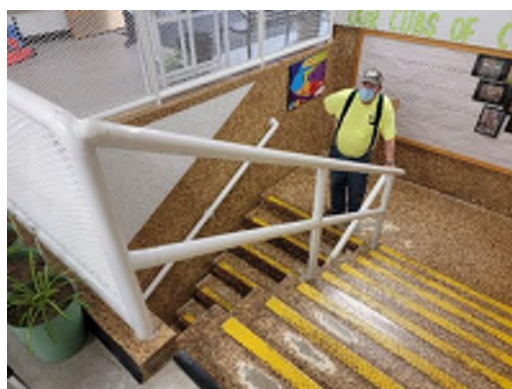
Interior Stair Railing: The interior main stair does not have the acceptable fall protection. With this being a K-5 School it is critical to protect the younger kids.

Interior Stair Railing: Replace the existing railing with a Guard Railing 42" tall and that will not allow a 4-inch sphere from passing through. **(Low Cost, High Priority)**

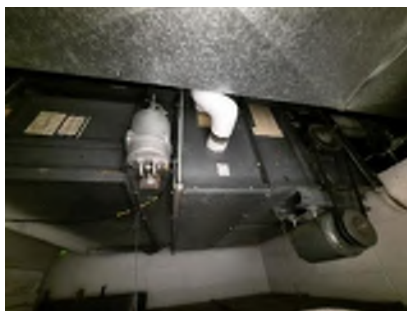
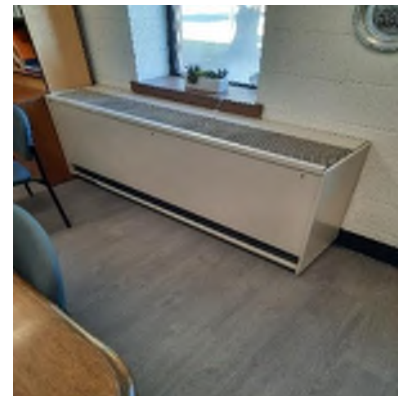
Ventilation: Classroom spaces are primarily served with floor mounted unit ventilators. The unit ventilators are original to the building. The central spaces in the original building are served with small fan coils located in the ceiling cavity of the janitor spaces.

Ventilation: Classroom unit ventilator should be replaced with new equipment to improve space comfort, improve indoor air quality, and reduce equipment noise within the teaching environment.

The ceiling mounted fan coils should be replaced with roof mounted equipment to improve service access, relocate equipment noise outside the learning environment and improve indoor air quality.

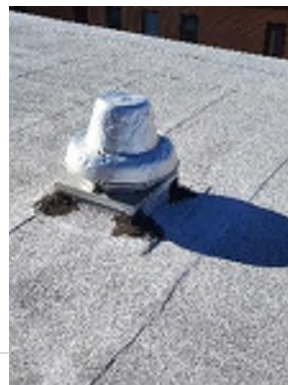
The Roof fans have been through several hail events.

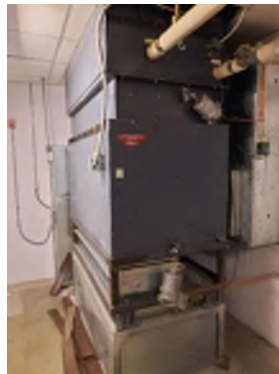
The gymnasium (multi-purpose space) is served with an original to the building Trane air handler located in the equipment mezzanine.

The gymnasium air handler should be replaced with a variable speed unit to reduce energy consumption during periods of low or intermittent load.

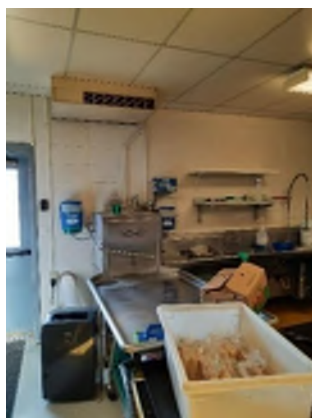
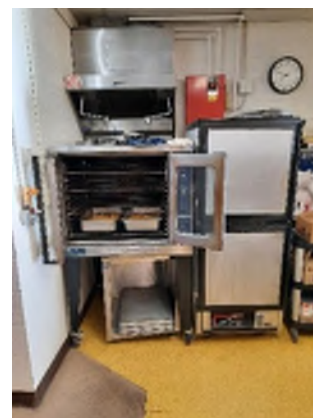
Kitchen equipment (ranges, ovens, and dishwashers) are not equipped with required hoods.

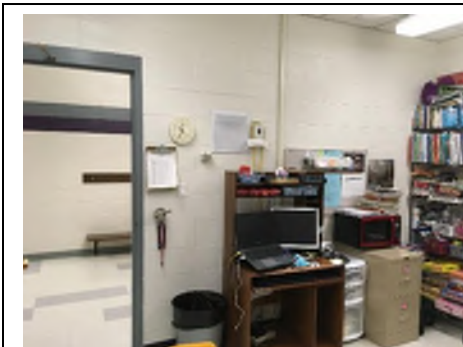
Branch Circuiting: Classrooms are not adequately provided with sufficient quantities of convenience receptacles and circuiting to meet current needs. Most classrooms have four to six receptacles in usable locations often resulting in the need for two or more power strips (Figure 6). In many cases the power strips are overloaded, resulting in additional power strips being added.

Figure 6 – Typical Classroom Appliances and Heavily Loaded Power Strip Below

Branch Circuiting: Additional receptacles and circuits are badly needed in the classrooms and workrooms, particularly near the teacher's desks. Replacing existing receptacles and adding up to eight additional, and increasing branch circuiting to a minimum of two dedicated circuits per classroom and one for workrooms is recommended. The wiring could be installed in a concealed manner if the cost of cutting and patching walls is acceptable. Otherwise, exposed conduit or Wiremold raceway, would be used.

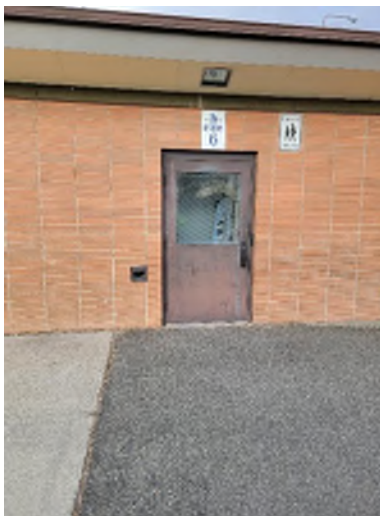
Exterior Doors: There are only a few exterior hollow metal doors and frames doors that need being replaced. The majority are in good working condition.

Exterior Doors: Replace the few exterior doors that are deteriorated. **(Low Cost, Medium Priority)**

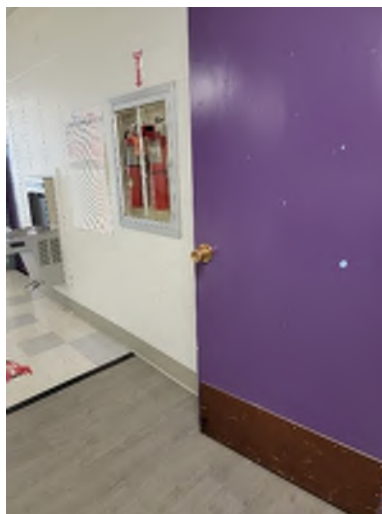
Interior Doors Hardware: Most of the door hardware has been updated to levers, but there are a few locations that are still in need of being upgraded to lever sets.

Interior Doors Hardware: Replace the knobs in the school with new lever sets. **(Low Cost, Medium Priority)**

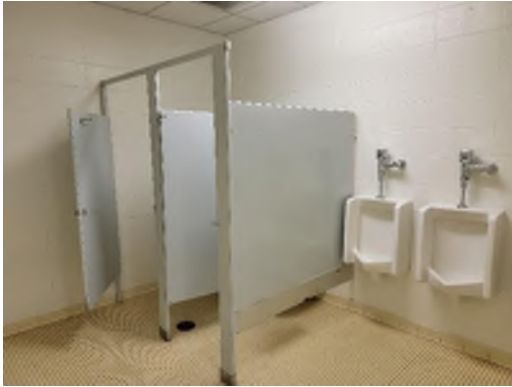
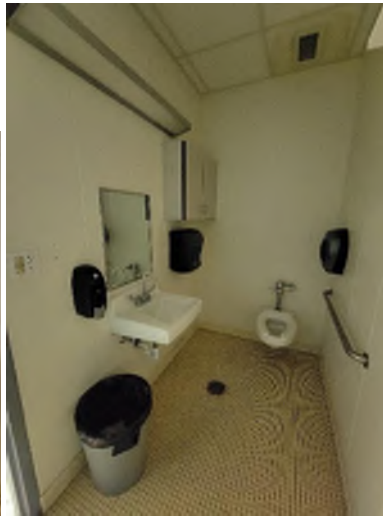
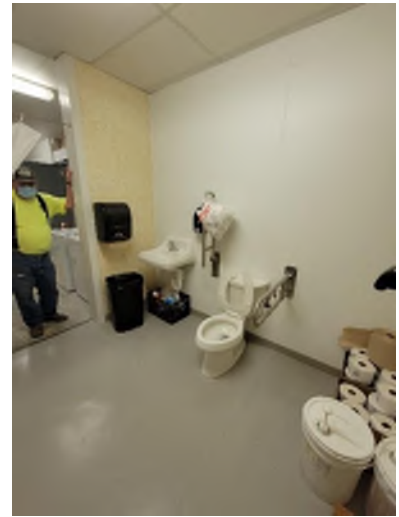
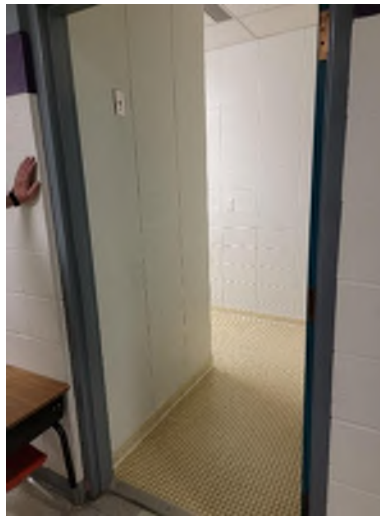
Parking: There are good ADA parking spaces, at this school. Some of the cross slopes do appear to be greater than the 2% allowed. It would be recommended that these be replaced at some point.

Restrooms: There are several restrooms that almost meet ADA requirements. However, none of the facilities restrooms meet the current ADA clearances. It is recommended that at least two of these facilities be renovated.

Parking: Replace the concrete site that has larger cross slope than 2%. **(Low Cost, Low Priority)**

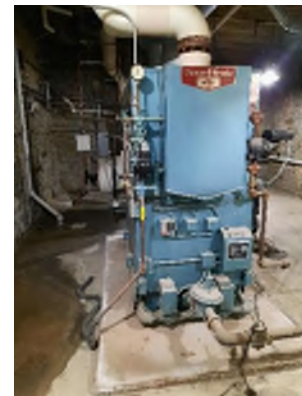
Abandoned steam boiler in basement of Library Building. Unit should be removed. As a portion of the Safety and Security building upgrades radiant slab snow melt was added at the building entrances. This system utilizes ceiling mounted circulation pumps near the building exterior wall to circulate glycol solution through the slab.

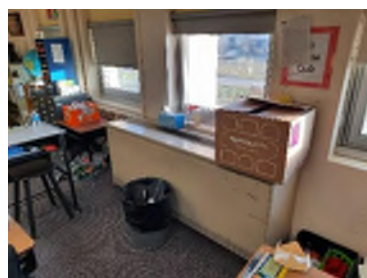
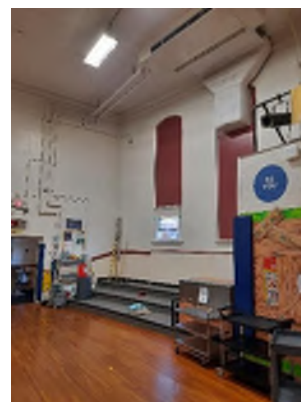
Ventilation: Classroom spaces are primarily served with unit ventilators. The unit ventilators are both floor and ceiling mounted. The floor mounted unit ventilators are older, the ceiling mounted units in the end classrooms are newer. The building cafeteria and library spaces are served with ceiling mounted horizontal unit heaters.

The cafeteria space is served with ceiling mounted unit ventilators

Ventilation: Classroom unit ventilator should be replaced with new equipment to improve space comfort, improve indoor air quality, and reduce equipment noise within the teaching environment.

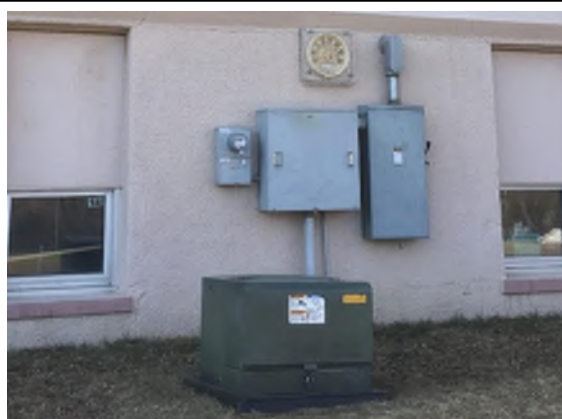
Figure 1 – Pad Mounted Transformer, Metering Cabinet, Meter and Main Disconnect

The highest recorded demand over the last two years from Northwestern Energy was 20.4 KW in March and April 2021. However a peak of 37.6 KW occurred in December, 2018 and there was a 37.2 KW peak recorded in February 2019, which was known to be a historically cold month. Using the higher reading, the calculated

demand is about 250 amps, leaving a spare capacity of about 35% after applying a 0.8 power factor and the demand at 125% per NEC Article 230.87. The service seems adequately sized for the building's current needs.

Electrical Service: The existing service is capable of supporting some additional load, which could include small air conditioning systems for spot cooling portions of the building. However if a larger, central AC system is required a new 3-phase electrical service is recommended.

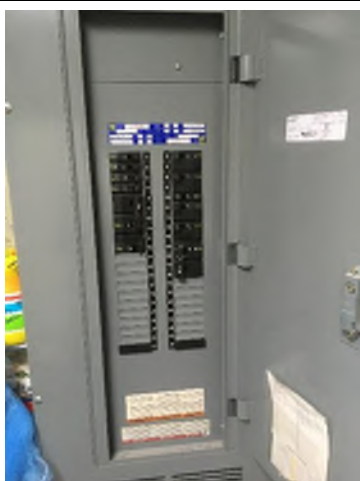
Figure 2 – Main Distribution Panel

Distribution: There is a 600A Main Distribution Panel in the center of the lower level in a closet in the northwest corner of an office (Figure 2). This is a 42 circuit panelboard. The panel directory does not identify the panelboard breakers clearly, but using the sizes as a guide, a fairly reasonable assumption can be made that two 150 amp, three 100 amp and one 50 amp breaker for feeders to branch panelboards and load centers in the building. The Distribution Panel also feeds two handicapped power lift chairs on the ramps, the fire alarm panel and a few miscellaneous loads. It has approximately 40% spare capacity.

Electrical Distribution: If an upgrade to the electrical service is required to support air-conditioning, a new main distribution board, either inside or on the building exterior (See Jefferson Elementary School) will need to be installed. The service voltage configuration will change from 120/240 volts single phase to 120/208 volts 3-phase. This may not be a major concern, but there are some 240 volt motors, i.e. boiler circulation pumps, that may need to be

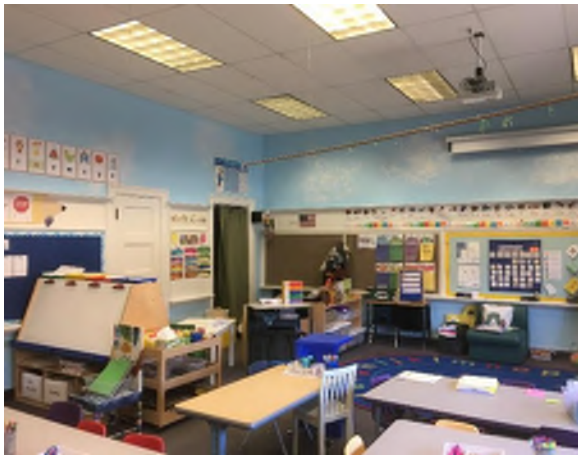
Figure 4 – Typical Classroom Lighting in Main Building

Lighting: Most of the lighting in the classrooms of the main building are 2x4 recessed T8 fluorescent with parabolic louvers and are controlled with occupancy sensors (Figure 4). Corridor fixtures and a few classrooms are 2x4 troffers with acrylic lenses. New recessed 2x4 LED fixtures with dimming and occupancy sensors were installed in the Reception, Nursing and Administrative areas that were remodeled in recent Safety-Security Upgrades. Storage, ramp, utility spaces, Library and Music Classroom (Figure 5) have surface 4-foot fluorescent T8 lamps with acrylic wraparound lenses with occupancy sensors. The Gymnasium lighting consists of surface mounted 4 foot T-5 fluorescent with wire guards.

Lighting: Replacement of fluorescent with LED fixtures and controls is recommended. The energy savings combined with improved occupancy sensors and dimming controls is substantial. There is an added benefit of increased life, which will help reduce maintenance costs. The fixtures in the Reception Area, Nursing Office and Admin Areas have already been replaced in with 2x4 recessed LED troffers. The remaining classrooms and corridors in the main building, Library and the Music Classroom would be replaced with the same. Additional LED exit signs and emergency egress lighting should be added to the corridors, ramps, stairwells, the Library and Music Rooms to ensure compliance with the Life Safety Code. Rebates are available from Northwestern Energy and NCAT to help offset the cost of replacement.

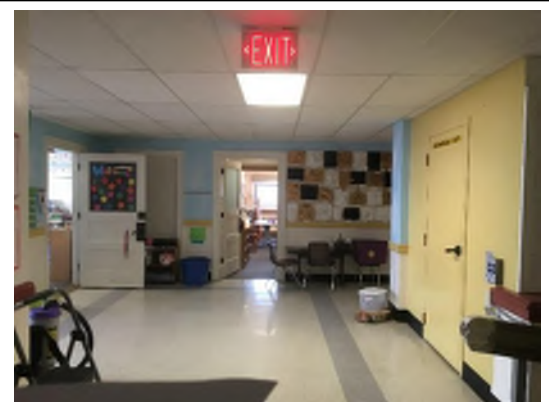
Figure 6 – Exit Signs in Main Building

Most of the exit signs in the main building are newer LED (Figure 6). The Library and Music Classrooms are cardboard; not powered or self-illuminated (Figure 7). Codes do not allow this, unless the face of the sign is illuminated with five foot candles of emergency lighting, for which they do not appear to be. Emergency egress lighting is very sparse in all the buildings. There are a few wall mounted battery units but overall there does not seem to be adequate levels of egress illumination during a power failure, particularly on the ramps and stairs (Figure 8). The new exterior ADA ramp is equipped with emergency egress lighting and battery backup.

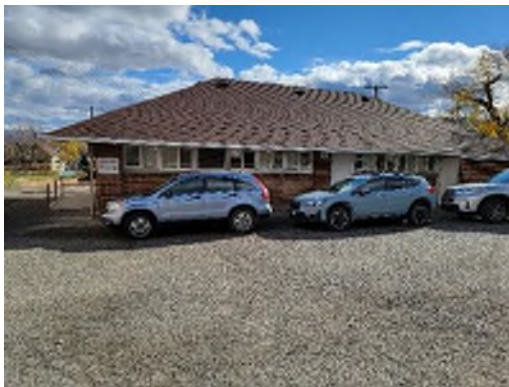
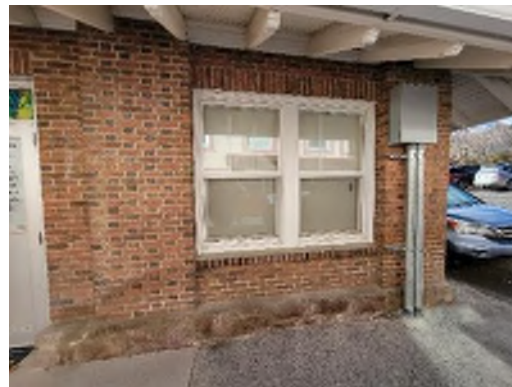
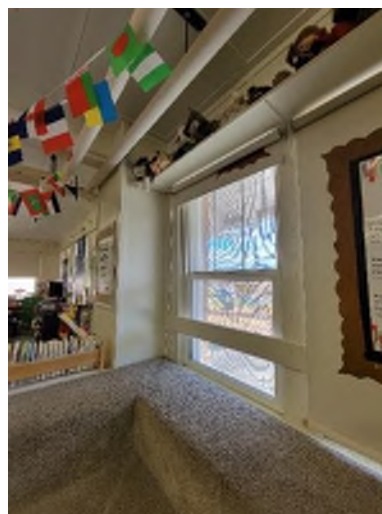
Library Outbuilding: The library windows are much older. Each window is constructed with an interior single hung window and an exterior storm window. The interior window appears to be vinyl and the exterior window appears to be wood. While old they appear to be in good working condition. The exterior windows need paint touch up.

Library Outbuilding: The library windows should eventually be replaced but with the relative conditions this is not a high priority need. The exterior windows should be on the list of touch painting every three to five years. **(Medium Cost – Medium Priority)**

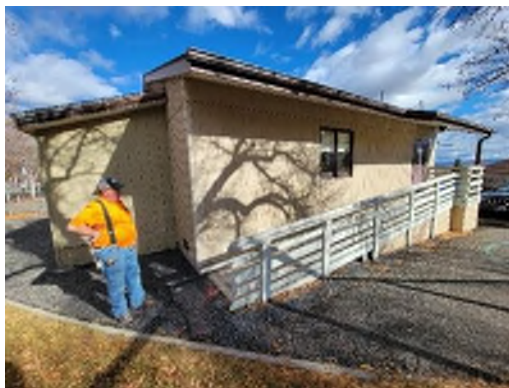
Music Outbuilding: The music building is a modular building that appears to be at the end of its useful life without major renovations including the windows.

Music Outbuilding: While these windows need being replaced the entire building is at the end of its useful life and in need of being replaced. I would recommend replacing the entire structure instead of putting a lot more money into the existing maintenance. **(High Cost – Low Priority)**

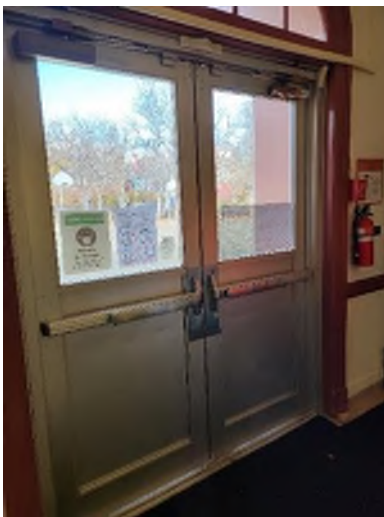
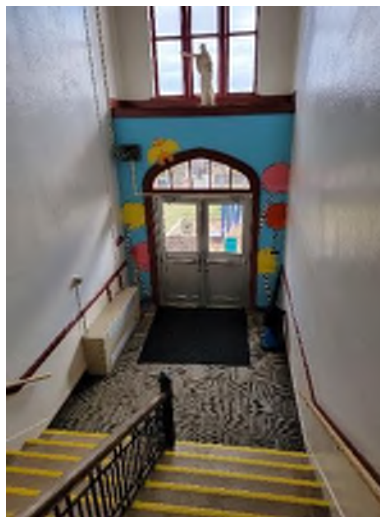
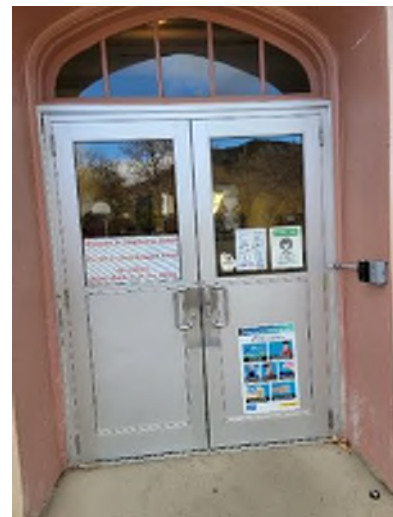
Exterior Doors: The exterior doors are all aluminum systems. Of the (5) locations, (2) were upgraded during the safety and security project and the existing (3) are constantly being repaired or adjusted by the district.

Exterior Doors: The (3) old doors requiring a lot of maintenance should be replaced soon. **(Low Cost – High Priority)**

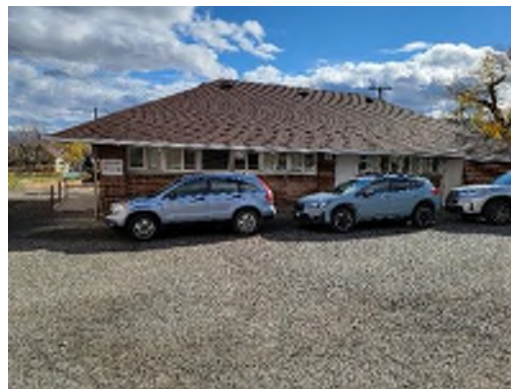
Exterior Doors: Of the (2) main exterior doors on the library one was recently replaced during the safety and security project, and one is an old wood door that should be replaced in the near future.

Exterior Doors: The (1) old door should be replaced when the rest of the exterior doors do. **(Low Cost – High Priority)**

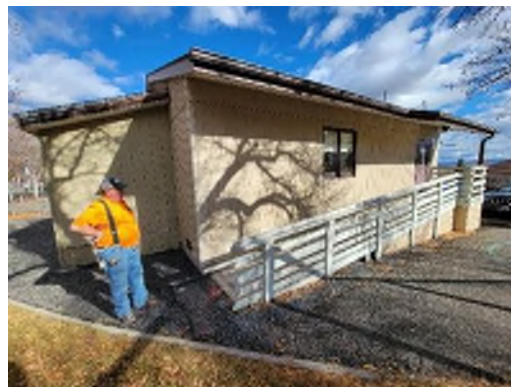
Music Outbuilding: The music building is a modular building that appears to be at the end of its useful life without major renovations including the windows.

Music Outbuilding: I would recommend replacing the entire structure instead of putting a lot more money into the existing maintenance. **(High Cost – Low Priority)**

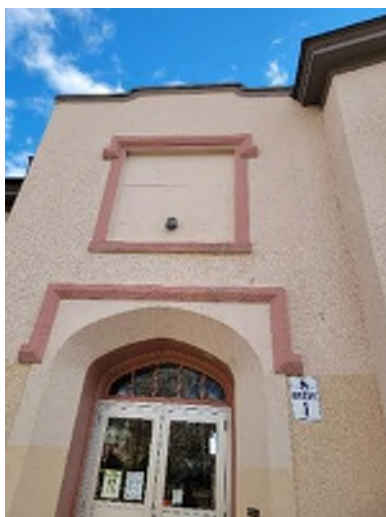
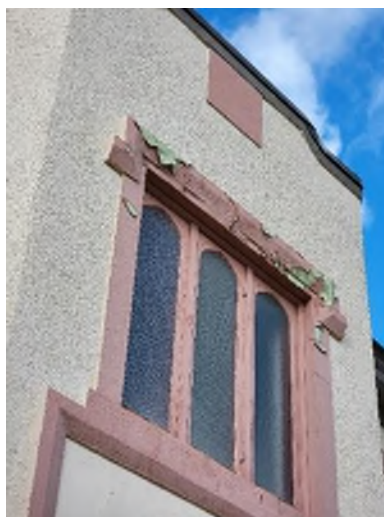
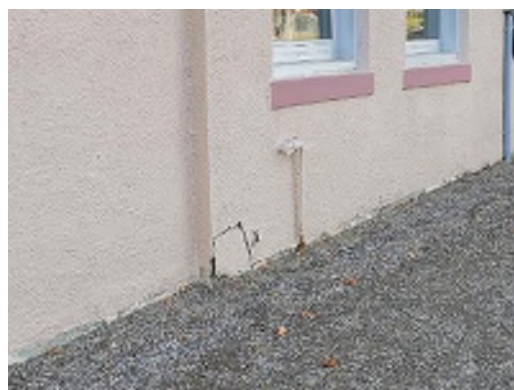
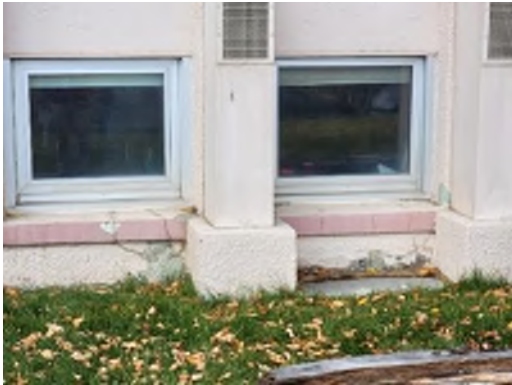
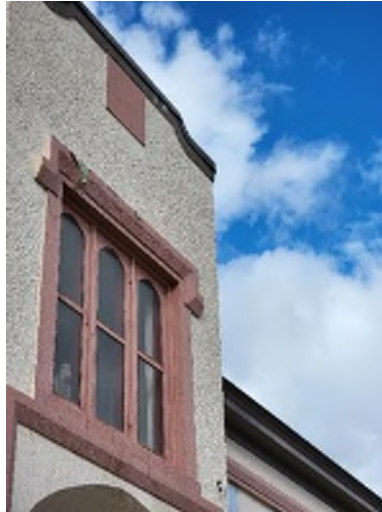
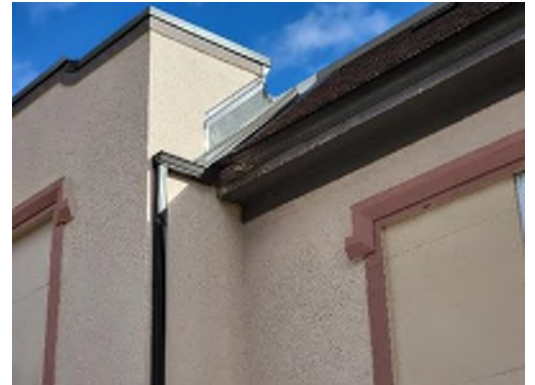
Main Building: The exterior cladding of the main building is a stucco or an Exterior Insulation Finishing System (EIFS) system. At some point this exterior was repainted. However, there a lot of locations that are cracking, the system is falling off (and potentially can injure someone), in addition paint is peeling and allowing moisture into the system. There are also a few locations where electrical boxes are exposed and should be closed in.

The Fascia around the building is a wood system and is cracking and peeling and should be repainted and/or replaced with a metal fascia system.

Main Building: The exterior stucco and fascia needs being repaired. **(Medium Cost – High Priority)**

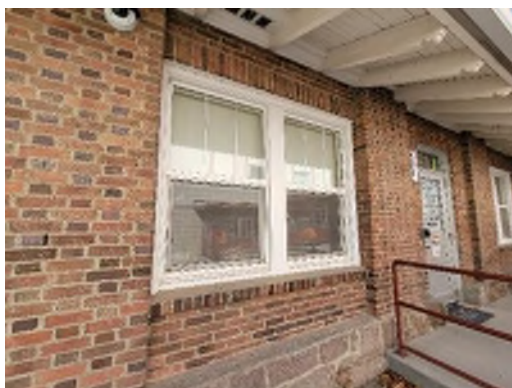
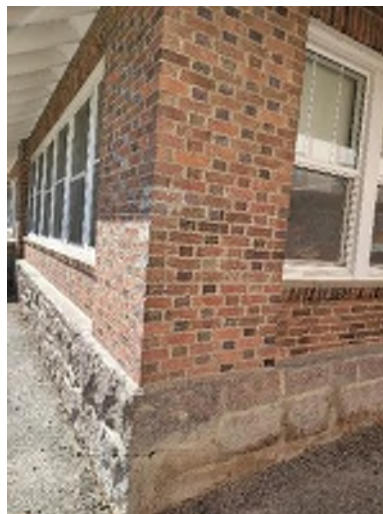
Library Outbuilding: The exterior cladding on the library outbuilding is face brick that is in good shape. However, the mortar joints need being repointed.

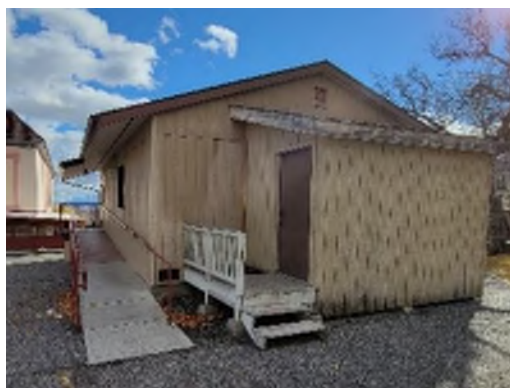
Music Outbuilding: The music building is a modular building that appears to be at the end of its useful life without major renovations including the windows.

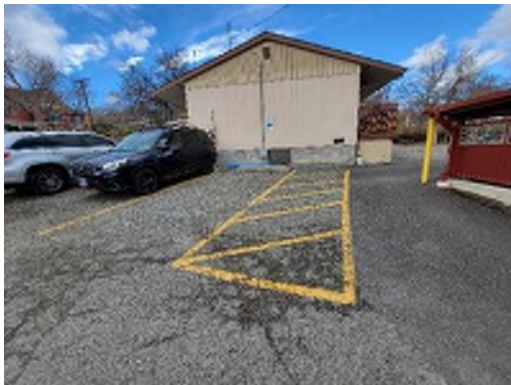
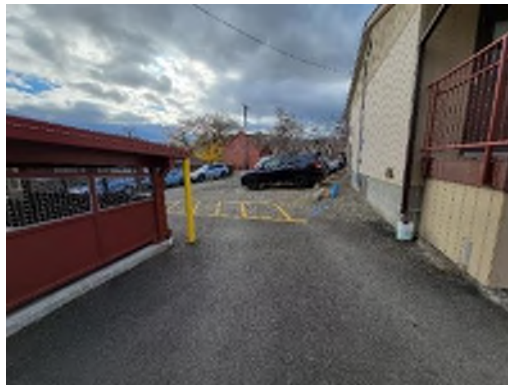
ADA Parking and Exterior Route: The existing ADA parking spot does not meet the required ADA slopes or cross slopes. The asphalt at the ADA parking spot is also cracking and in need of replacement. Once you get past the edge of the building the ADA route appears to be in good shape.

ADA Parking and Exterior Route: This ADA parking spot should be rebuilt to meet ADA. **(Medium Cost – High Priority)**

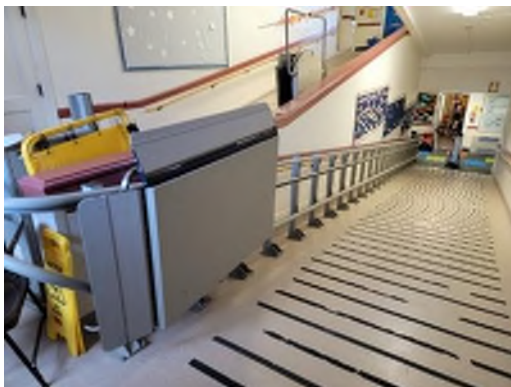
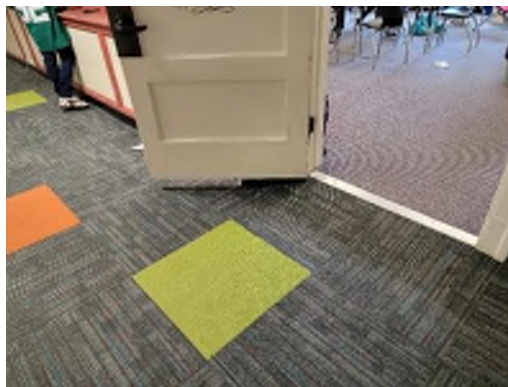
Interior Route: With the use of the Ramp/Stair lift on the main ramps, the school meets the primary ADA need. However, in the basement (4) of the (5) classrooms have a threshold with a 3" tall by 12" long ramp well over the allowable 1":12" ramp slope. Modifying these would be technically difficult and with other classrooms in the school meeting the ADA requirements it is not a huge need.

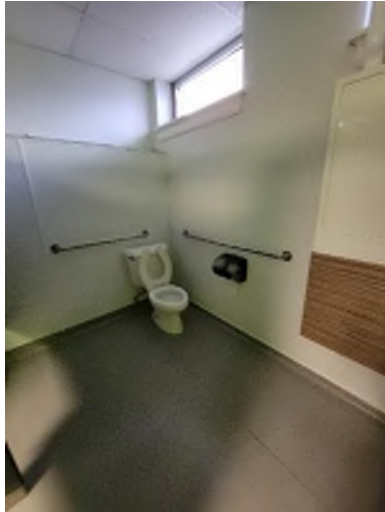
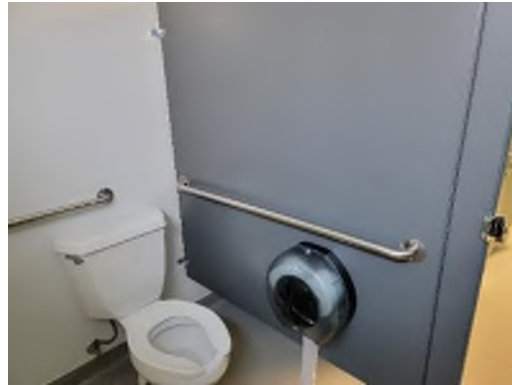
Restrooms: While not all the restrooms are ADA compliant there is at least one facility per floor that is compliant. The ADA stalls are missing Vertical 18" grab bars that should be added.

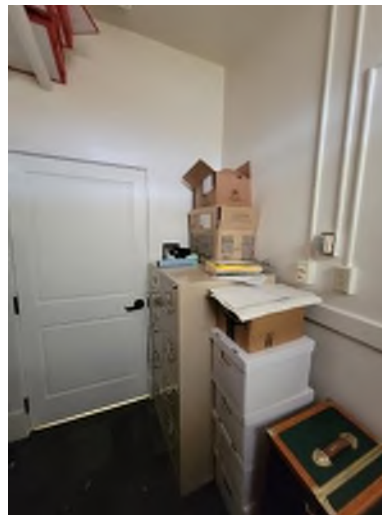
Library Outbuilding: Appears to be in ADA compliance from an architectural standpoint. There are boxes in back that are in the door ADA clearance to the restroom and should be relocated.

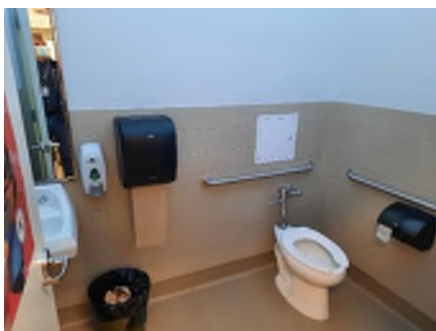
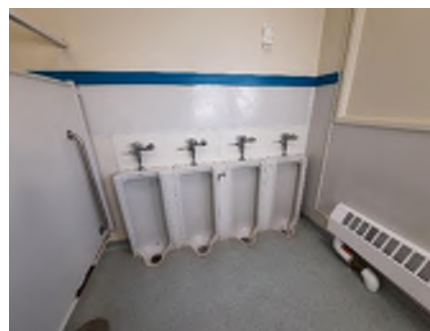
Plumbing: Fixtures are older but functional. The water closets are floor mounted units. Floor mounted wall urinals are still in operation in the building. Fixtures are stained and chipped, but no operational issues reported with either the fixtures or the building piping systems.

The building domestic system is not equipped with a required water tempering valve. Device is required by code. The devices maintain the temperature of domestic water discharge from the water heater to a code designated range.

Kitchen sanitary sewer system is not equipped with a means of removing grease from the waste stream prior to exiting the building. The required grease interceptor protects the building waste piping from kitchen waste and grease. The device is required on all three compartment sinks.

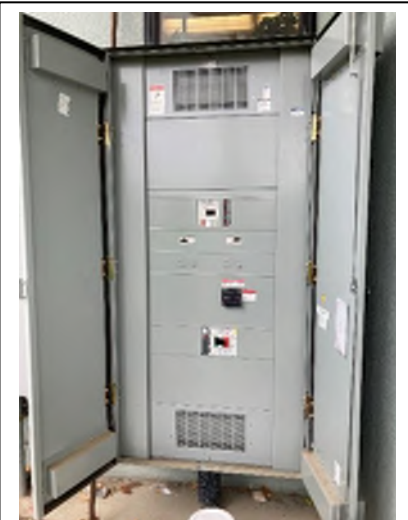
Figure 3 – Interior of Main Distribution Board

Distribution: The 600A-3P main breaker in the MDB (Figure 3) has a maximum rating of 630 amps with an adjustable instantaneous trip setting. There are five distribution breakers; 400A-3P for Panel A, 225A-3P for Panel F, 200A-3P for Condensing Unit 1, 100A-3P for Condensing Unit 2 and 100A-3P for the elevator. There is one provision remaining for up to a 225A breaker.

Electrical Distribution: It is recommended that at least two additional branch circuit panels be added to the building, near the classroom wings in order to provide additional circuits for classrooms and work areas. This

could be accomplished by adding a 200A circuit breaker in the MDB and feeding a new panel in the East portion of the building and one in the West portion. In addition, the obsolete Panel D on the stage of the Auditorium should be replaced with a new panelboard.

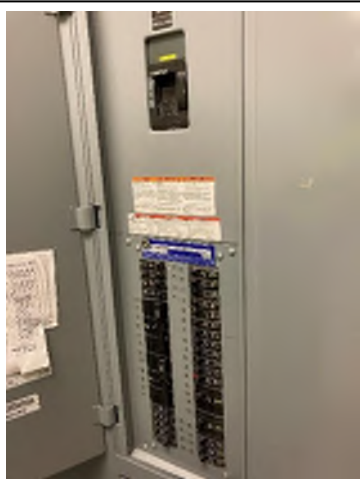
Figure 4 – Panel A

A is located in a storage closet in the lower level near the Art Classroom (Figure 4). It has a 400A main breaker. There are two 150A-3P breakers that feed Panels B and C. There is also a 100A-3P breaker for Panel D. Panel B is located next to Panel A (Figure 5) and serves mostly loads in the east end of the lower level. It has a 100A-3P breaker for Panel E. All of the branch panelboards, except for Panel D, are new and in good to excellent condition. However, the recent HVAC upgrades have used most of the spare capacity, leaving no space for future loads. Panel D is located in the Auditorium on the stage (Figure 6). It is an original panelboard that is obsolete. It serves a stage lighting system and a few other miscellaneous loads in the Auditorium.

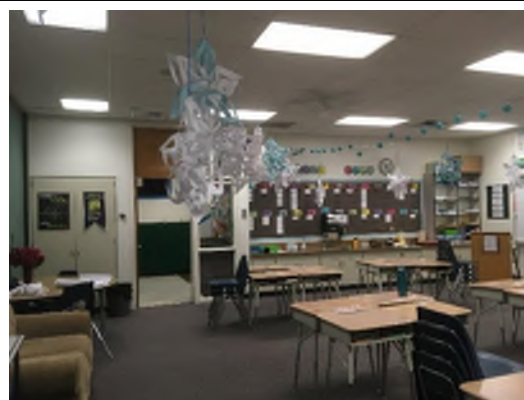
Figure 8 –Classroom Lighting in West Portion of Building

Lighting: The Library, Staff Break, Nursing and Administrative areas that were remodeled in recent Safety-Security Upgrades were provided with LED troffers in lay-in ceiling areas, and surface or suspended 4 foot LED fixtures with acrylic wraparound lenses. In the East portion of the building, the corridors and classrooms are mostly 4 foot T8 surface and suspended fluorescent fixtures with wraparound acrylic lenses (Figure 7). In the West portion of the building, Classroom lighting is predominately 2x4 troffers in lay-in ceilings with acrylic lenses and 4 foot T8 lamps (Figure 8). The building has been equipped with occupancy sensors, but only the areas with the LED lighting have dimming capability.

Lighting: Replacement of fluorescent fixtures with LED fixtures and controls is recommended. The energy savings combined with improved occupancy sensors and dimming controls is substantial. There is an added benefit of increased life, which will help reduce maintenance costs. The fixtures in the Library and surrounding corridor have already been replaced in the West portion of the building with 2x4 recessed flat panels. The remaining classrooms and corridors in the West end should be replaced with the same. The surface and suspended wraparound fixtures in the East portion should be replaced with a similar style fixture with onboard LED's. This will also include the gymnasium lighting. Replacement of remaining older exit signs with new "onboard" LED signs, with combination emergency egress heads, is recommended and will help standardize the building. Additional LED emergency egress lighting should be added to the corridors and stairwells to ensure compliance with the Life Safety Code. Rebates are available from Northwestern Energy and NCAT to help offset the cost of replacement.

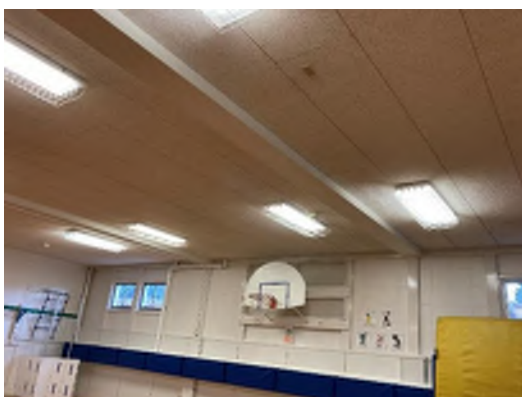
Figure 9 –Gymnasium Lighting

The Gymnasium lighting consists of surface mounted 4 foot T-8 fluorescent with wire guards (Figure 9).

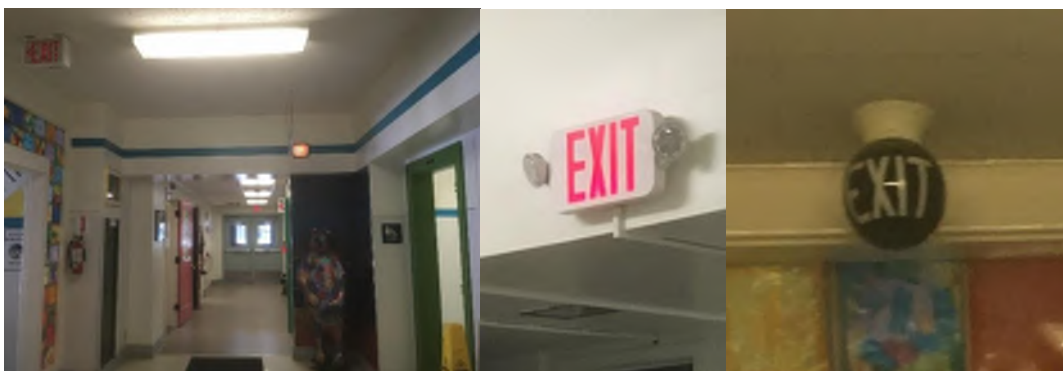
Figure 10 –Exit Signage

There are several different types and styles of exit signs in the building, ranging from some newer LED fixtures to antique glass globes (Figure 10). The older exit signs have been retrofit with LED lamps, but they are not usually equipped with emergency battery packs. and emergency egress lighting throughout the building. Emergency egress lighting is very sparse. There are some wall mounted battery units and combination exit and emergency lighting units, but overall there does not seem to be adequate levels of egress illumination during a power failure.

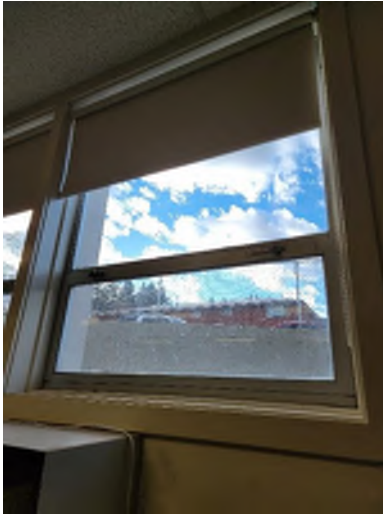
The existing windows are all non-thermally broken frames with insulated glazing. They are in relatively good shape, but will eventually need to be replaced.

The existing windows should eventually be replaced with new thermally broken aluminum frames and low-e double pane glazing. **(High Cost – Low Priority)**

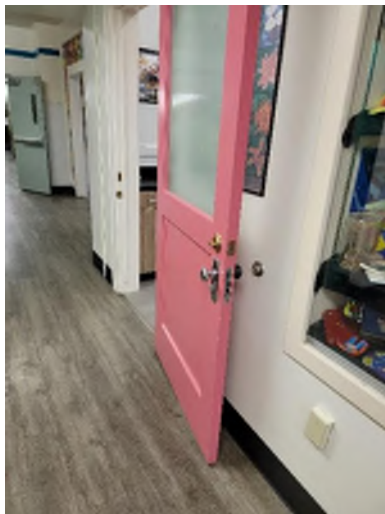
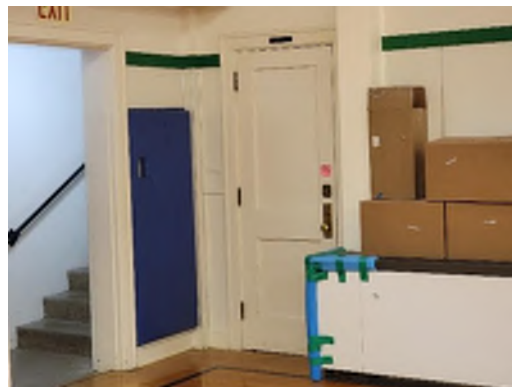
The doors all appear to be in working order. Most of the doors had their knobs replaced with lever sets. However, there are still about a dozen doors with knob that need to be replaced. It should be noted that these doors are not heavily used and are to rooms like storage or janitor so the priority of replacing these is low.

Replace the knob with new lever sets to meet current ADA and life safety codes. **(Low Cost, Low Priority)**

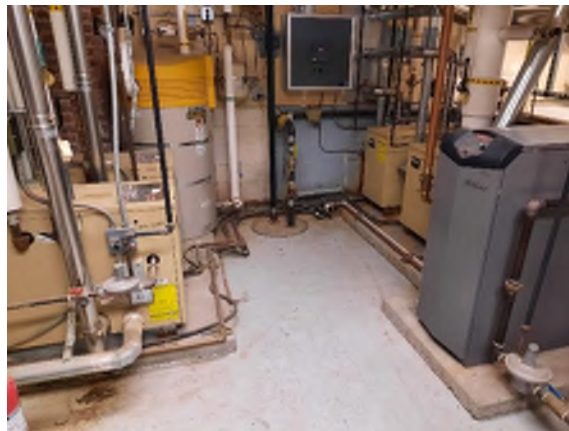
Heating System: A (5) boiler system provides hot water for the building from a central boiler room located in basement area. The Boilers are (4) Weil McLain Model GV Cast Iron Sectional Boilers and a Lochinvar Knight High Efficiency seasonal boiler. The cast iron sectional boilers were installed in the early 1990's, the Lochinvar boiler was added to the plant as a portion of the building (2) story addition in the early 2000's.

Heating: Replace the cast iron sectional boilers with new high efficiency boiler equipment to reduce building energy consumption.

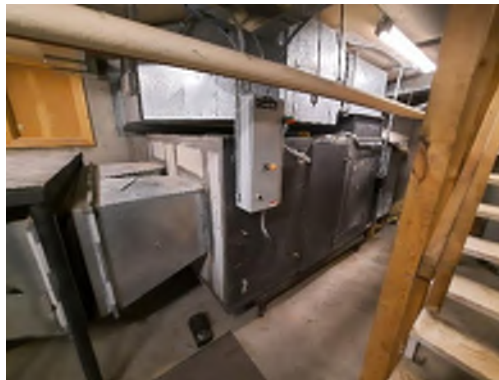
The multi-purpose space air handler is located below the space and is original to the building.

Ventilation: The gymnasium air handler should be replaced with a variable speed air handling unit to reduce energy consumption during periods of low or intermittent load.

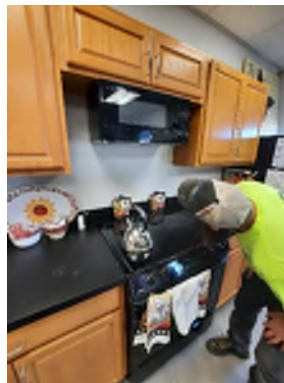
Kitchen equipment (ranges, ovens, and dishwashers) are not equipped with required hoods.

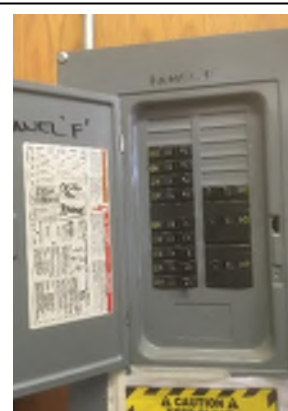
Figure 7 – Load Center Panel F

A load center in the Kitchen is also labeled as Panel F (Figure 7). The branch panelboards installed in the 1987 Addition (A1, B1 and A2) are all in good condition. There are single phase panelboards located in the north classroom areas that were installed for some of the earliest additions to the building in the 1960's, and are now nearing obsolescence.

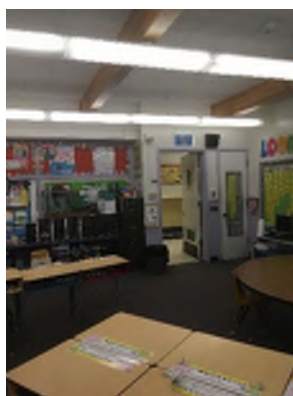
Figure 8 – Typical Classroom Lighting

Lighting: The Staff Break, Entry Lobby and Administrative areas that were remodeled in recent upgrades were provided with LED troffers in lay-in ceiling areas, and surface or suspended 4 foot LED fixtures with acrylic wraparound lenses in gypsum board ceiling areas. In the East portion of the building, the corridors and classrooms are mostly 4-foot T8 surface and suspended fluorescent fixtures with wraparound acrylic lenses (Figures 8 & 9). Most of the building has been equipped with occupancy sensors, but only the areas with the LED lighting have dimming capability.

Lighting: Replacement of fluorescent fixtures with LED fixtures and controls is recommended. The energy savings combined with improved occupancy sensors and dimming controls is substantial. There is an added benefit of increased life, which will help reduce maintenance costs. The surface and suspended wraparound fixtures in the classrooms should be replaced with a similar style fixture with onboard LED's. This will also include the gymnasium lighting. Replacement of older exit signs with new "onboard" LED signs, with combination emergency egress heads, is recommended and will help standardize the building. Additional LED emergency egress lighting should be added to the corridors and stairwells to ensure compliance with the Life Safety Code. Rebates are available from Northwestern Energy and NCAT to help offset the cost of replacement.
