Helena School District Deferred Maintenance Report

January 31, 2022

RE: Deferred Maintenance Review
Helena Public Schools
Final Report

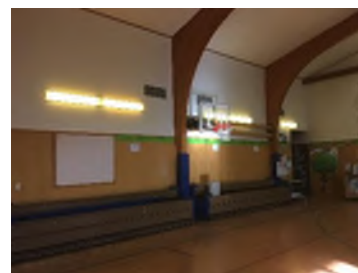
Figure 10 – Gymnasium Wall Mounted Lighting

The Gymnasium lighting consists of surface mounted 4 foot T-5 fluorescent fixtures with wire guards on the ceiling and 4 foot T-8 wall mount units with polycarbonate lenses (Figure 10).

The exit signs are mostly red LED with battery backup (Figure 11). Dual-head emergency lighting units are located in corridors for egress lighting. Four of the wall mounted fluorescent fixtures (Figure 10) in the Gymnasium are equipped with emergency battery packs, although it is not known if they are functional.

Lighting: Replacement of fluorescent fixtures with LED fixtures and controls is recommended. The energy savings combined with improved occupancy sensors and dimming controls is substantial. There is an added benefit of increased life, which will help reduce maintenance costs. The surface and suspended wraparound fixtures in the classrooms should be replaced with a similar style fixture with onboard LED's. This will also include the gymnasium lighting. Replacement of older exit signs with new "onboard" LED signs, with combination emergency egress heads, is recommended and will help standardize the building. Additional LED emergency egress lighting should be added to the corridors and stairwells to ensure compliance with the Life Safety Code. Rebates are available from Northwestern Energy and NCAT to help offset the cost of replacement.

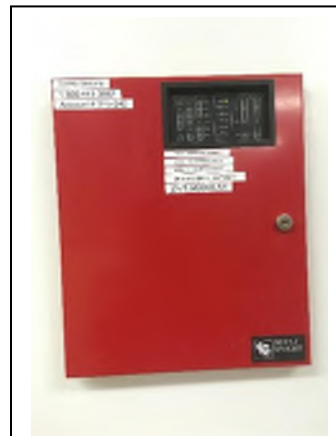
Figure 13 – Fire Alarm Control Unit

The Fire Alarm System, as classified in the International Fire Code, is a manual detection system. The Control Unit(s) is located on the north wall of the Entry Lobby (Figure 13). It is a Silent Knight Model SK-6324, conventional fire alarm panel with six Class B initiating circuits. It is an obsolete Control Unit and parts are only available from re-sellers of used equipment.

Replacement of the fire alarm system is overdue. Much of the original wiring may still be in place. Replacement of the complete fire alarm system with a new, addressable voice evacuation system is recommended.

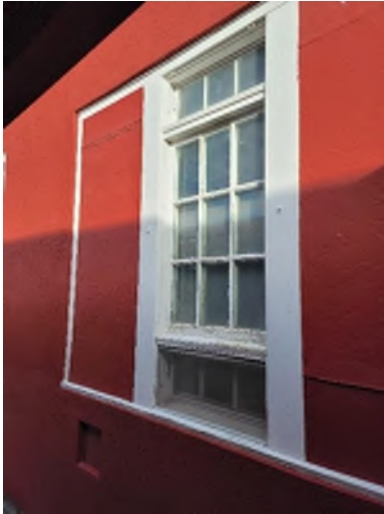
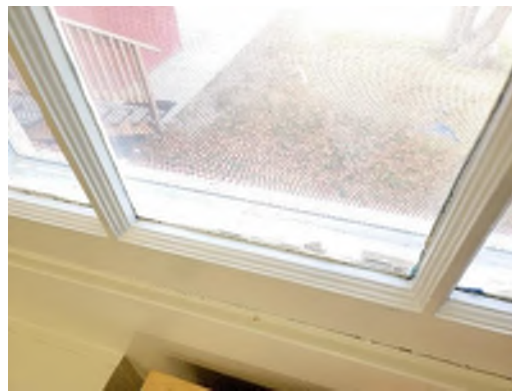
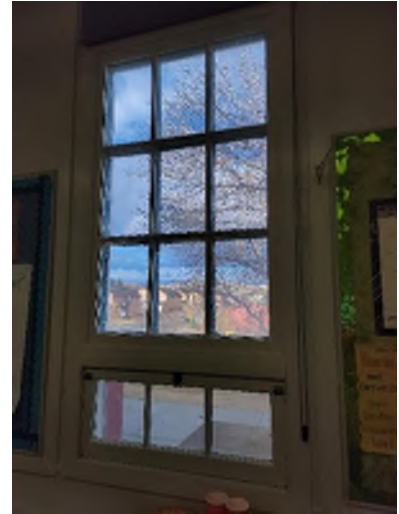
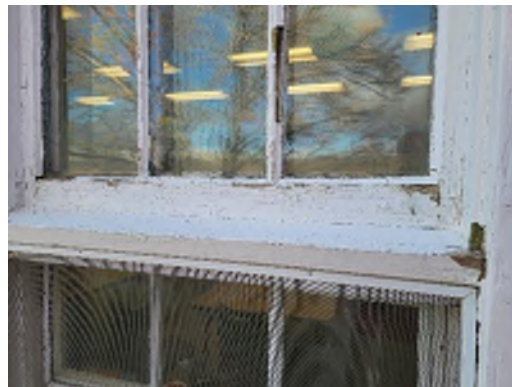
Wood Framed Single Paned: Most of the school still has the old wood Framed Single Pane Windows that are at the end of their usable life and need to be replaced.

Wood Framed Single Paned: Replace all these windows with new thermally broken aluminum double paned windows. **(High Cost, High Priority)**

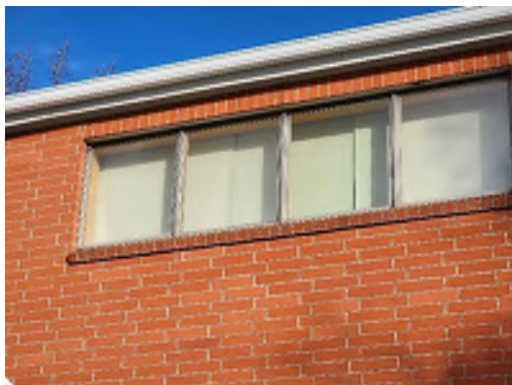
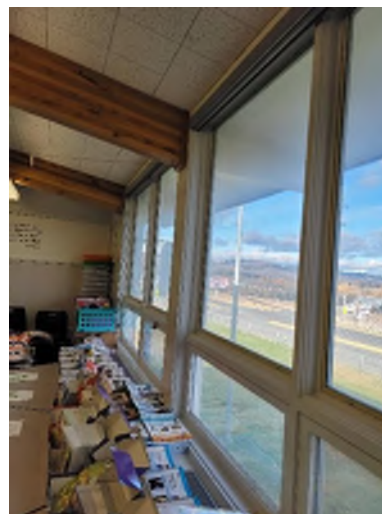
Old Aluminum Windows: There are some older aluminum framed double paned windows on the gym and the classroom wing that appear to be in good shape. However, on the classroom wing the south facing windows need to be replaced. All these windows will eventually need to be updated.

Old Aluminum South Windows: The South facing windows should be replaced sooner than later, with new thermally broken aluminum double paned windows. **(Medium Cost, Medium Priority)**

Old Aluminum Windows: The rest of the older aluminum windows have a little bit more life in them but should eventually be replaced with new thermally broken aluminum double paned windows. We would recommend replacing the gym windows with a Kalwall system. **(High Cost, Low Priority)**

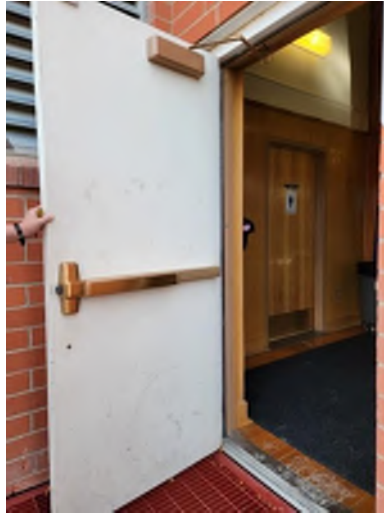
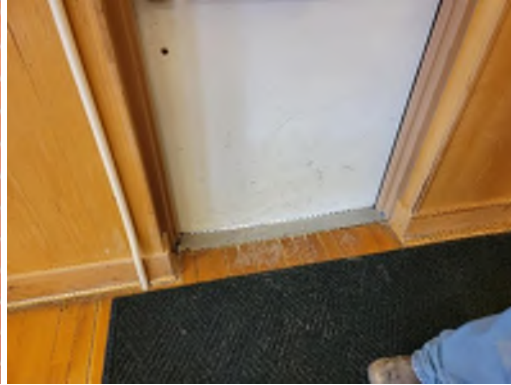
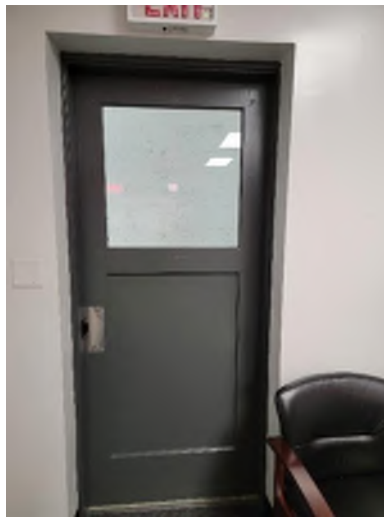
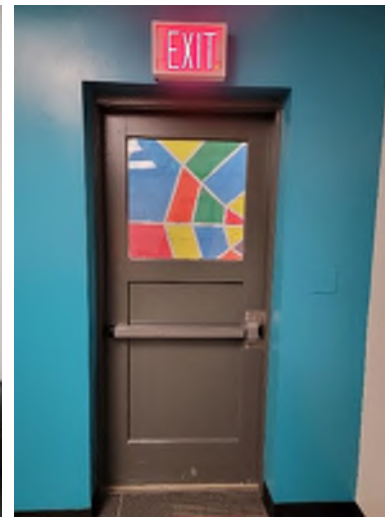
Exterior: There are (3) exterior doors that need replaced as they are constantly being maintained by the district.

Main Building Exterior: There are (3) exterior doors that need being replaced. **(Low Cost, High Priority)**

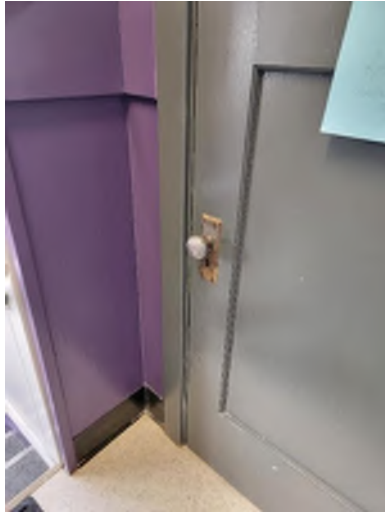
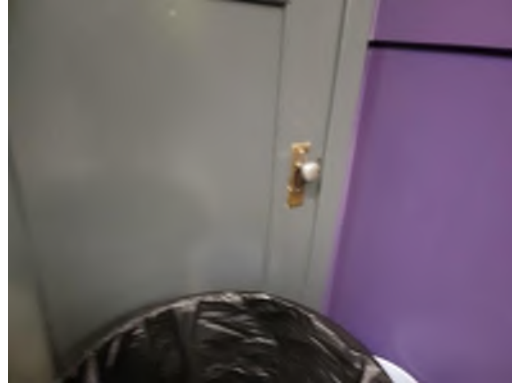
Interior: There are (2) interior doors that still have knobs in place of lever handles that should be upgraded.

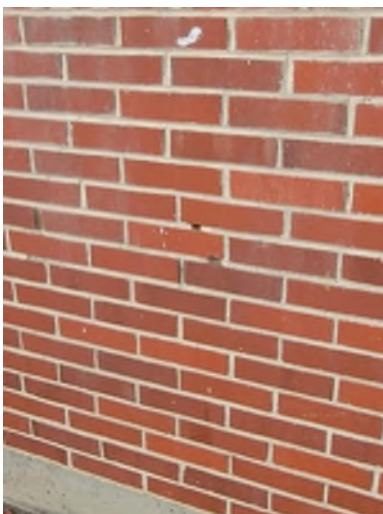
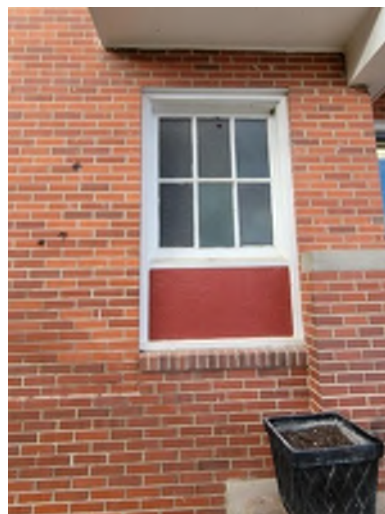
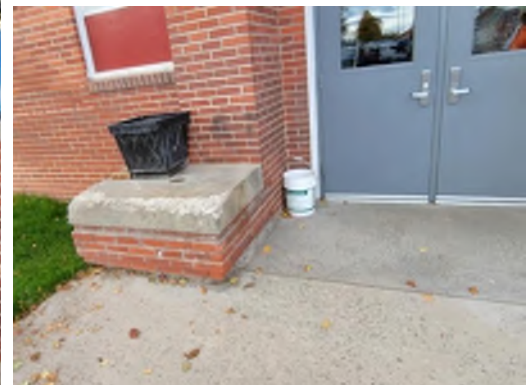
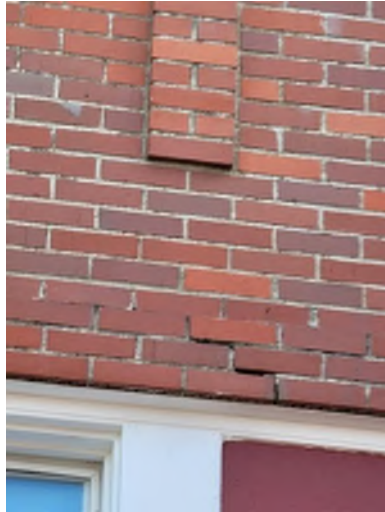
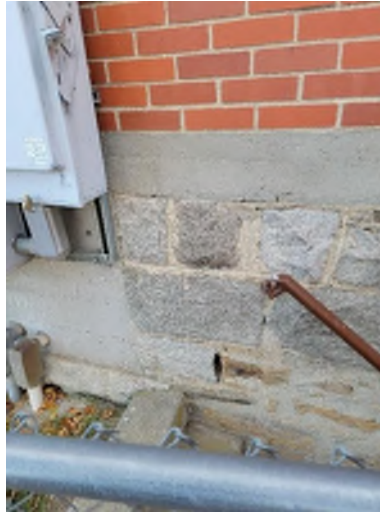
Main Building Brick: The exterior brick mortar joints need to be repointed.

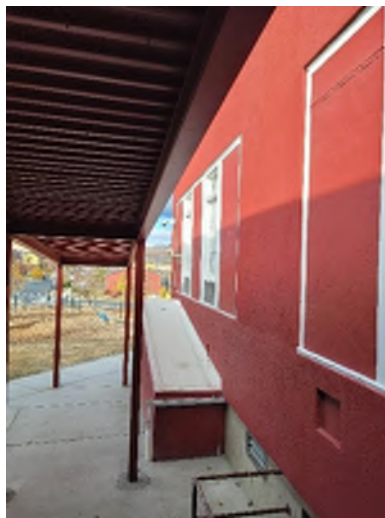
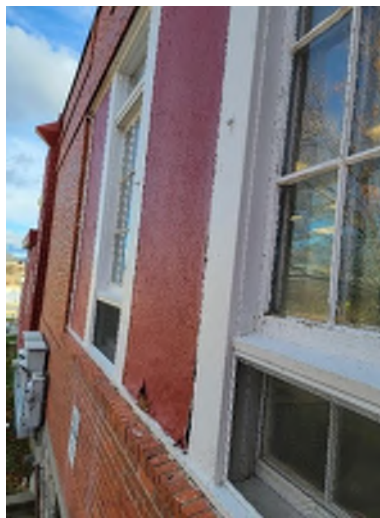
Main Building Window Infill: Some of the original windows were infill with a prefinished paneling wall system. These panel are in disrepair and in need of being replaced. It would be our recommendation to replace these panels with windows in place of a new exterior finish.

Main Building Window Infill: Replace infilled wall panels with new windows. **(High Cost, High Priority)**

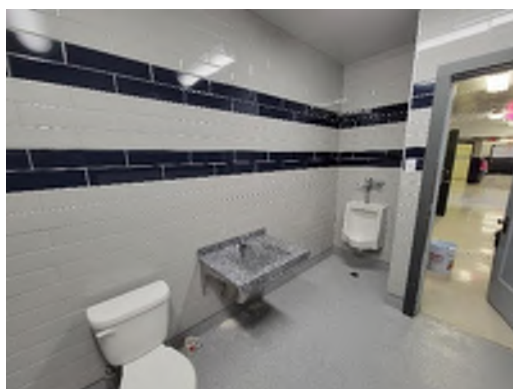
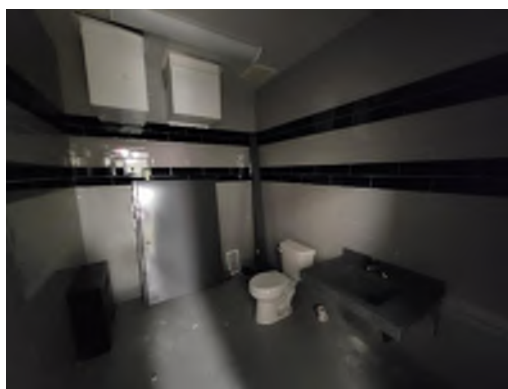
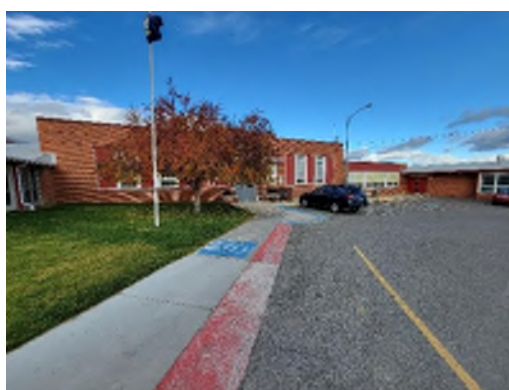
Main Building: The main restrooms are in the process of being completed to meet ADA requirements. The only assessable issue observed was, the access from the ADA parking spot appeared to have more than a 2% cross slope.

Main Building: The cross slope at the parking spot should be rebuilt to meet the code minimum of 2%. **(Medium Cost, Low Priority)**

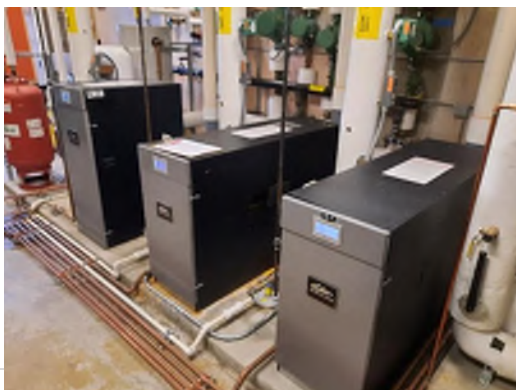
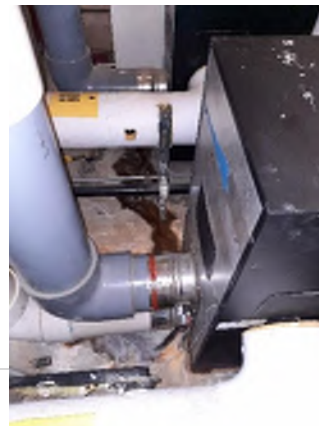
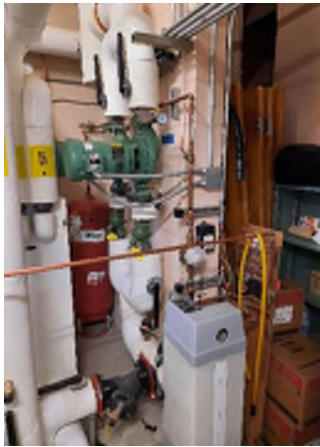
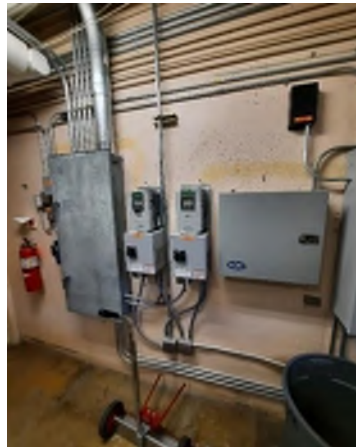
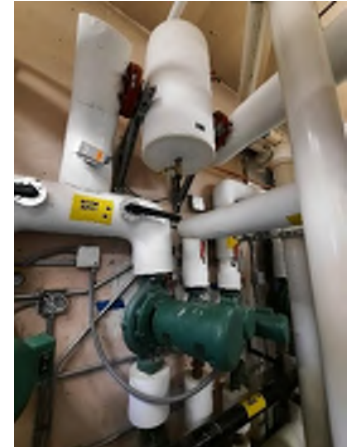
Heating System: A (2) boiler system provides hot water for the building from a central boiler room located in basement area. The Boilers are (2) Apex High Efficiency condensing units. The boilers were installed in 2014. The boilers are separated from the building heating season via a flat plate heat exchanger. The system contains a complicated system of in-line pumps and control valves that makes the system temperamental and maintenance intensive.

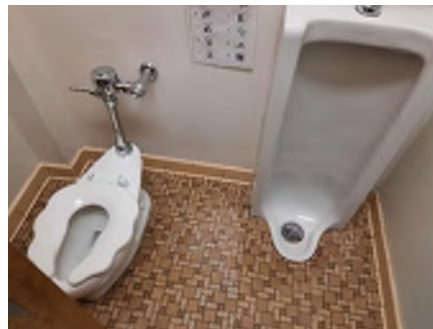
Building plumbing fixtures are older, chipped and stained but no operational issues reported.

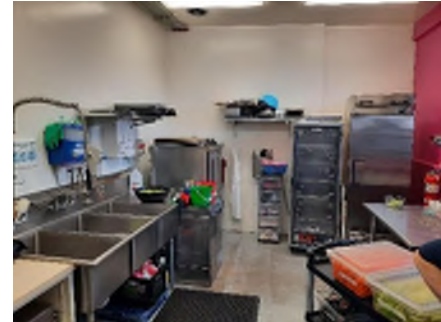
Kitchen sanitary sewer system is not equipped with a means of removing grease from the waste stream prior to exiting the building. The required grease interceptor protects the building waste piping from kitchen waste and grease. The device is required on all three compartment sinks.

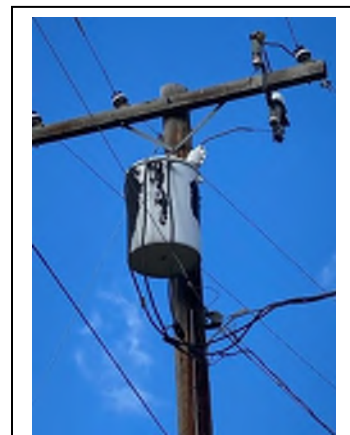
Figure 1 – 50 KVA Pole Mounted Transformer

Electrical Service: The building service is derived from a 7.2 kV single phase primary distribution line on a utility pole located across a delivery and parking area west of the building. There is a 50 kVA utility company oil filled transformer on the pole (Figure 1). The secondary service characteristics are 120/240 volts, single phase, three wire with a nominal 320 amp rating. The secondary aerial conductors cross the parking area and connect to a lighting pole, where they are spliced to a set of parallel conductors before continuing to two service masts and weather heads located on the roof above the boiler room (Figure 2). The secondary conductors have a nominal rating of 400 amps, and drop down inside of the service masts to a metering cabinet that is located in the southwest corner of the

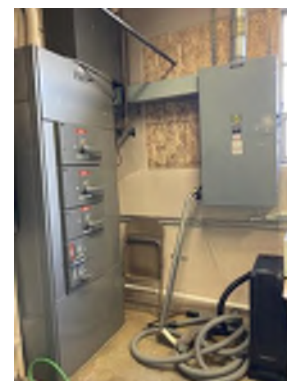
Figure 3 –Main Distribution Board MDB and Main Breaker #6

Distribution: The MDB (Figure 3) contains five fusible main switches and there is a sixth main disconnect, an enclosed circuit breaker, on the adjacent wall that is a tapped from the MDB bus. Main Switch #1 is 250A and feeds South Wing Panels A, B and C. Switch #2 is 200 amps and feeds North Wing Panels D, E and F. Switch #3 is 200 amps and feeds Gymnasium Panel G. Switch #4 is 20 amp and is labeled “fire alarm”. Switch #5 is a spare. Switch #6, the enclosed breaker, feeds Panel H in the Boiler Room. It has a 400-amp rating. Panels A, B and C are 70 amp, 14-circuit Square D NQO panelboards with main breakers. One panelboard serves two classrooms. There are four or five spare breakers in each. They are located in vestibule areas between classrooms. Panels D, E and F in the North Wing are similar, except that F does not have a main breaker. Panel G is located in the Gymnasium near the Kitchen. It is a new Square D, 72-circuit, NQ panelboard. It serves the Kitchen, the Reception/Administrative offices, the Gymnasium and the Stage. There are only 5 spare breakers available. Panel H is a relatively new panel that was installed for a boiler upgrade project. H serves boilers, pumps and equipment loads. There may be one spare 20 amp breaker available. Panel I is located adjacent to MDB. It is a Square D NQO panelboard was the original Boiler Room electrical panel. It serves miscellaneous

loads, the Fire Alarm Control Unit and receptacles in the Boiler Room and basement classrooms. No spares are available.

Electrical Distribution: It is recommended that building be converted from 120/240 volts, single phase, to 120/208 volts, 3-phase. The existing fusible distribution board and separate main breaker will be replaced with a new 3-phase main distribution board with circuit breakers. The existing single phase panelboards G (Gymnasium) and H (Boiler Room) are new, and do not necessarily need to be replaced, but they will have to be reconnected for balanced phase loading to the new MDB. The remaining panelboards in the building, A through F in the Classroom Wings, and I in the Boiler Room should be replaced with new 3-phase panelboards. New feeders will need to be run to the Classroom Wing Panelboards. The panelboards in each wing will have feed-through lugs and individual main breakers so that only one feeder is needed per wing. They will be mounted directly over the existing locations. Unfortunately, there are no attic or crawl spaces in the classroom wings, so the feeders may need to be run exposed at the ceilings or enclosed in a new furred chase.

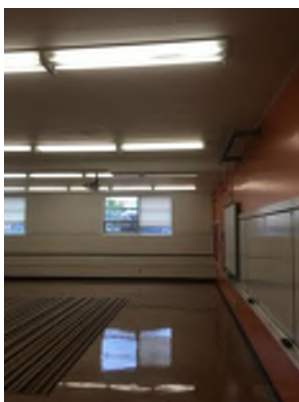
Figure 7 – Lower-Level Classroom Lighting

Lighting: The Entry Lobby, Staff Break, Workroom, Nursing and Administrative areas that were remodeled in recent Safety-Security Upgrades were provided with surface mounted 4 foot LED fixtures with acrylic wraparound lenses. The remaining portions of the building; the corridors, classrooms and vestibules, are mostly 4 foot T8 surface and suspended fluorescent fixtures with wraparound acrylic lenses (Figure 7). They are aligned in continuous rows in the north and south classroom wings. Most of the wraparound fixtures in the lower level classroom are missing the acrylic lenses and the fluorescent lamps are exposed.

Lighting: Replacement of fluorescent fixtures with LED fixtures and controls is recommended. The energy savings combined with improved occupancy sensors and dimming controls is substantial. There is an added benefit of increased life, which will help reduce maintenance costs. The fixtures in the administrative areas in the southwest end of the building and adjacent lobby have already been replaced. The classrooms and corridors in the North, South and Lower-Levels should be replaced with the same. The gymnasium lighting should be replaced with LED fixtures with wire guards and multi-level lighting controls.

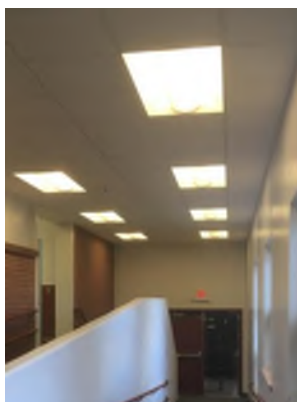
Figure 8 – Lighting over the Ramp

There are a few areas, i.e. the hallway and ramp adjacent to the Gymnasium, with 2x4 troffers in lay-in ceilings with direct/indirect diffusers and T8 lamps. The building has been equipped with occupancy sensors, but only the areas with the LED lighting have dimming capability. The Gymnasium lighting consists of surface mounted 4 foot T-5 fluorescent with wire guards

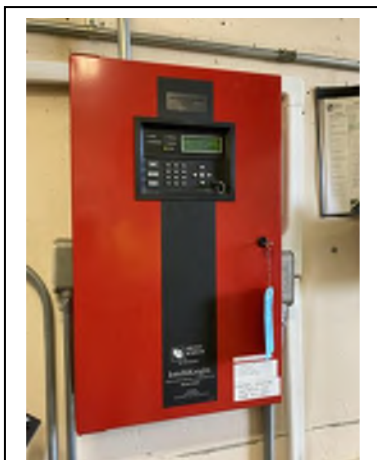
Figure 11 – Fire Alarm Control Unit

The Fire Alarm System, as classified in the International Fire Code, is a manual detection system. The Control Unit(s) is located on the south wall of Boiler Room in the lower level (Figure 11). It is a Silent Knight Intel-Knight Model 5808 addressable panel. There is a remote annunciator located in the main entry lobby. There are manual pull stations at exit pathways. Horn/strobes

are located in the lower-level classrooms, corridors, common areas and the Gym. The north and south wing classrooms are not equipped with horn/strobes, but they are in the vestibules between classrooms. There are a few smoke detectors in the building for release of magnetic door holders.

The fire alarm system issues and wiring are of concern. It is an addressable system, but some of the wiring from the original fire alarm system appears to have been reused. This will most likely continue to cause trouble alarms and temporary shutdowns of the system. Replacement of the fire alarm system with a new, addressable voice evacuation system is recommended.

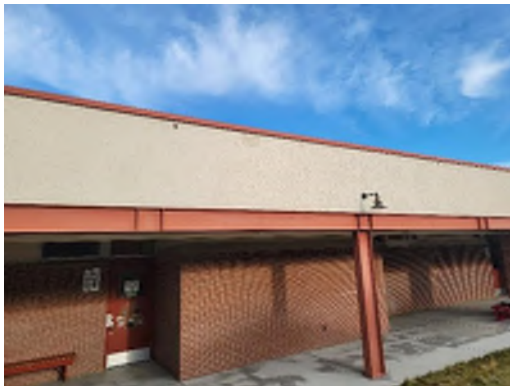
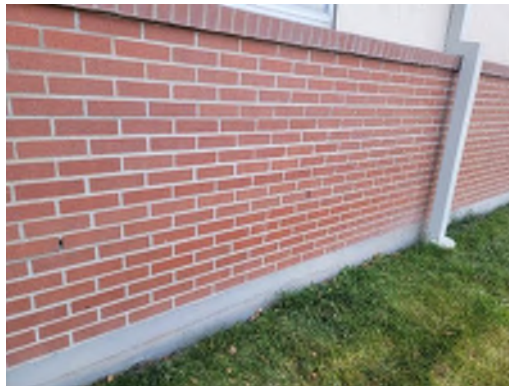
Brick: The face brick on the exterior is in relatively good shape. However, the north facing brick that is getting sprayed by the sprinkler system needs having the mortar repointed.

Brick: Repoint the mortar on the brick that is being sprayed by the sprinkler system. We would also recommend adding a 18" to 24" landscaping rock edge next to the building to reduce the deterioration in the future. **(Low Cost, Low Priority)**

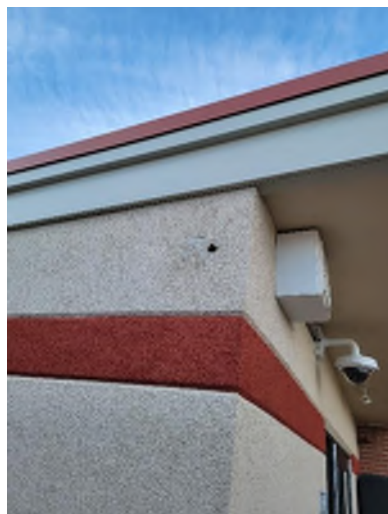
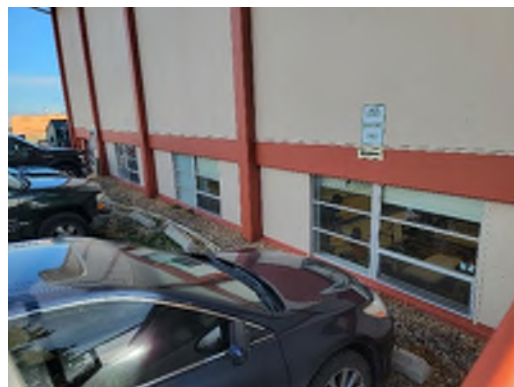
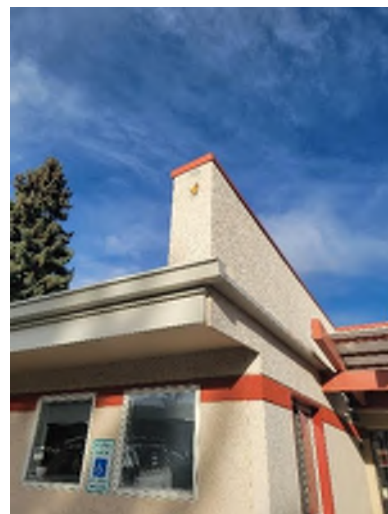
EIFS: The External Insulation and Finish System that was used has a lot of birds making their nests in the walls. These need to be patch as maintenance, but the best way to fix the issue is to replace the exterior system with either a metal lath-based stucco system or some other cladding system.

EIFS: Replace the EIFS system with a fiber cement or metal panel system. **(Medium Cost, Low Priority)**

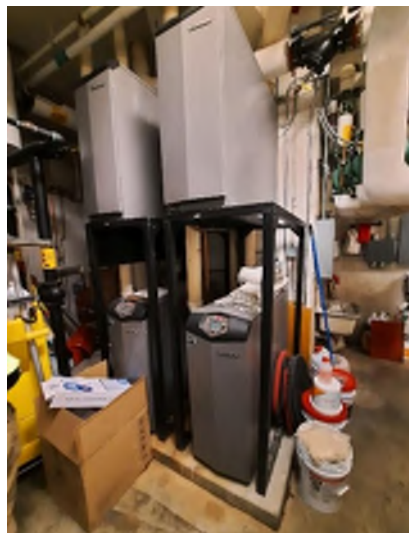
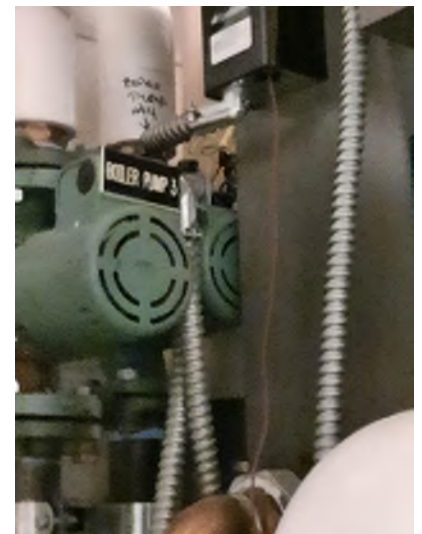
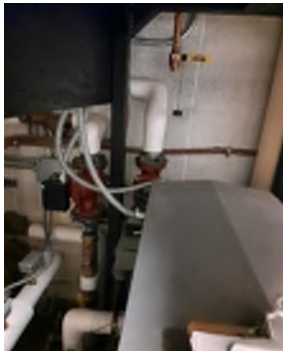
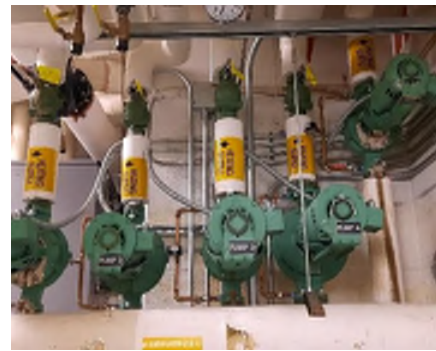
Heating System: A (4) boiler system provides hot water for the building from a central boiler room located adjacent to the gymnasium space. The Boilers are Lochinvar Knights Model KBN 800. The boilers are installed in a stacked 2 x 2 arrangement. The upper two units are installed on field constructed frames. The stacked arrangement makes service difficult. Each boiler is equipped with a dedicated circulation pump. With the stacked arrangement access to

the lower-level circulation pumps is not possible without removing the stacked equipment.

The individual zone distribution pumps should be replaced with two central distribution pumps. The parallel pumping system will create redundancy and better system reliability.

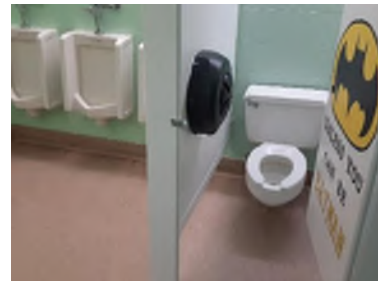
Building plumbing fixtures are older, chipped and stained but operational with no reported operational issues.

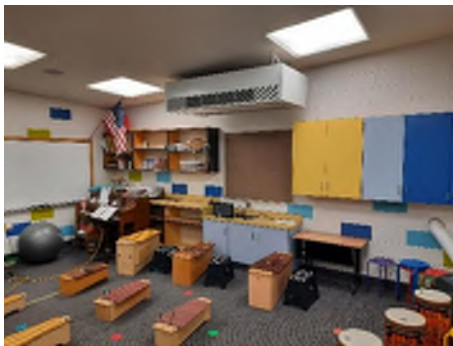
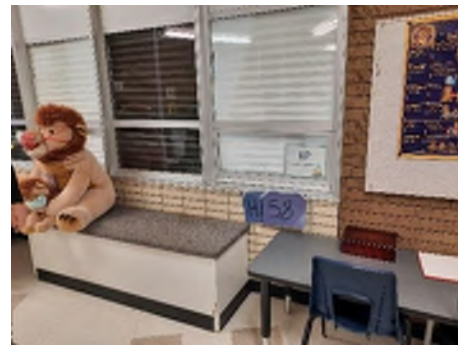
The (2) classroom spaces on the second floor are equipped with ceiling mounted unit ventilators. This equipment is not connected to the building exterior therefore the spaces are not provided ventilation air.

Ventilation: Replace the floor mounted unit ventilators with new equipment. Replace integrated fan coil units with floor mounted unit ventilators.

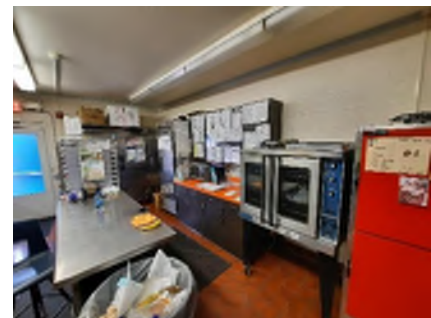
Kitchen equipment (ranges, ovens, and dishwashers) are not equipped with required hoods.

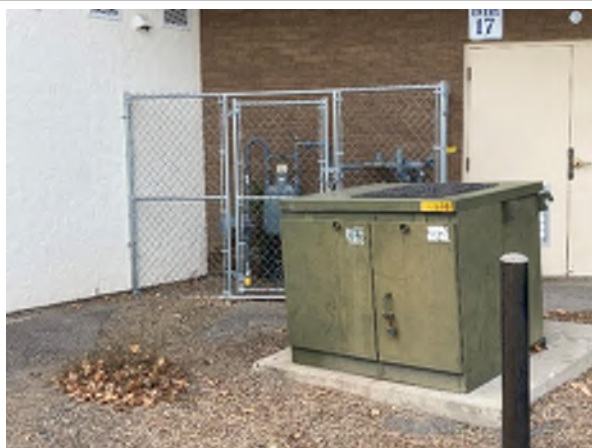
Figure 1 – Pad Mounted Transformer

Electrical Service: The building service is derived from an underground 12.47 kV primary distribution line. The primary line originates from a riser pole located across Sierra Road, north of the property. The primary line terminates at a primary junction can and then continues to a 150 kVA (estimated) pad mounted transformer on the southeast side of the school near the Boiler Room (Figure 1). The secondary service characteristics are 120/208 volts, three phase, four wire. The conductors are parallel sets of 4#500 XHHW run in parallel in 3-inch conduits with a nominal 800 amp rating. The secondary exits the transformer underground and then rises into the bottom of the Main Distribution Board inside of the Building.

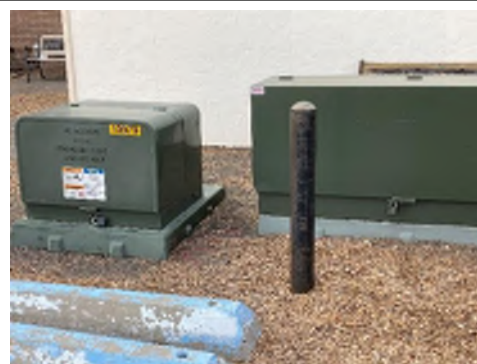
Figure 2 – Single Phase Pad Mounted Transformer for Out-Buildings

Outbuilding Services: There are other services on the site; a modular classroom building, a sewage lift station building and a well pump house. The services to the well pump house and the sewage lift station buildings are 3-phase, underground, and appear to originate from fusible switches in the Main Distribution Board in the school. There are two switches labeled for the sewer system, one of which is most likely for an older system that was replaced. The labeling for the switches should be updated.

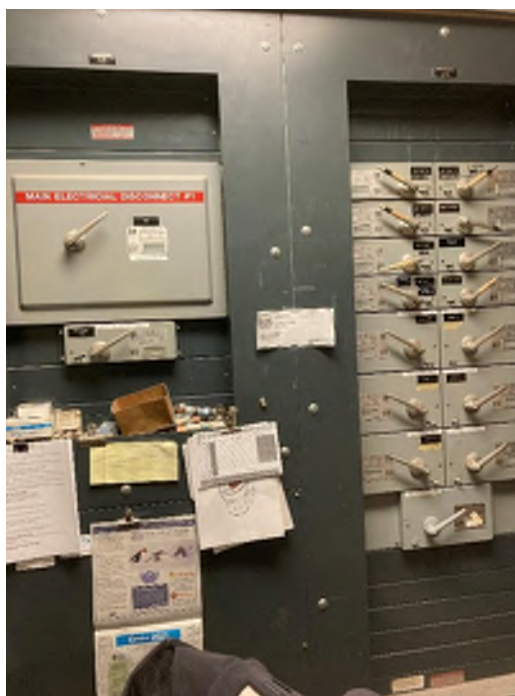
Figure 4 – Fusible Main Distribution Board with Main Disconnect No. 1

Electrical Distribution: The Main Distribution Board is located in a separate Electrical Room adjacent to the Boiler Room. It is a General Electric QMR fusible distribution panel with a 600 amp main switch, fused at 450 amps and labeled “Main Disconnect No. 1” (Figure 4). The Main Switch is located in Section 1 of the distribution panel along with a 30 amp switch for Emergency Panel X. The bottom of section 1 contains the incoming lugs and the service entrance conductors. The utility company metering equipment is also located in this section and the meter is installed adjacent to the distribution board. Section 2 contains eight, 30 amp and seven, 100 amp fusible switches. The 100 amp switches feed branch panelboards A, B, C, D, K, the well pump and the septic system. The 30 amp switches feed the boiler, pumps, an air compressor and the sewer lift station. There may be space for adding another switch if a twin module was installed in the bottom to replace the single switch module.

Electrical Distribution: A new outdoor metering cabinet, meter and an exterior main distribution board is recommended. Panel H would remain and would be reconnected to the new outdoor distribution board. The indoor Main (fusible) Distribution Board should be replaced with a new circuit breaker distribution board with the capacity to support additional panelboards to the Classroom pods for more convenience receptacles. The existing branch panelboards do not necessarily need to be replaced, as parts may still be available, but the lifespan is limited. With the recent announcement by General Electric that the company will be split into three parts, the Power division being one of those, it calls into question how long breakers will be available for panelboards that are already obsolete.

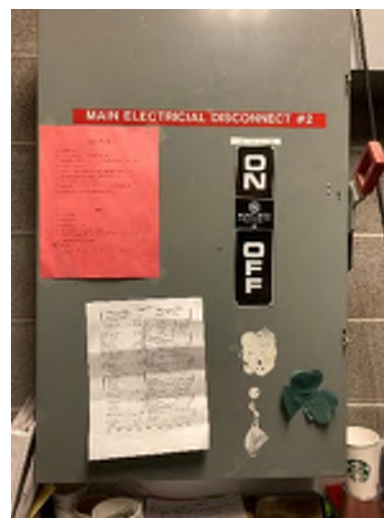
Figure 5 –Main Disconnect No. 2

Main Disconnect Switch No. 2 was installed to serve the 1972 addition to the school. It feeds another distribution panel, Panel H, that is located directly across from the Electrical Room in the Boiler Room.

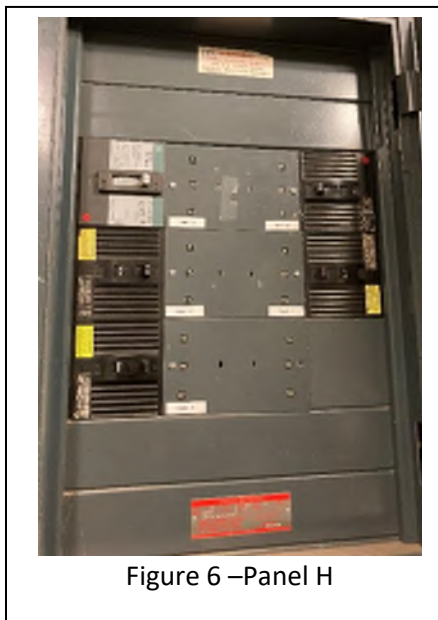
Figure 6 –Panel H

Panel H is a General Electric CDP 600 amp distribution style panelboard with two, 20 amp circuit breakers for heating water pumps, a 225 amp for Panel G, a 175 amp for Panel F and a 150 amp for Panel E. There is space for one more 225 amp circuit breaker (Figure 6).

The service conductors have sufficient spare capacity for additional loads, but there are not enough spaces in the distribution board to install new switches or circuit breakers if a major air conditioning upgrade was needed. The spare 225 amp space in Panel H could be used to serve one large AC unit, but is not enough for the entire school.

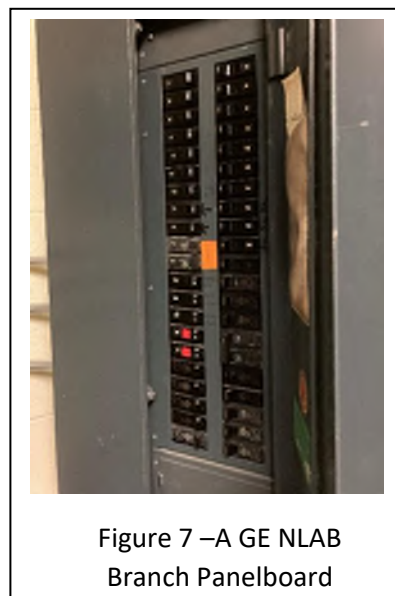
Figure 7 –A GE NLAB Branch Panelboard

There are seven original General Electric NLAB style (Figure 7) panelboards in the school, a new 18 circuit Square D NQ panel in the Kitchen and a new UPS panel that was recently installed. The original panelboards are mostly lacking any spare breakers or spaces. GE no longer manufactures the NLAB panelboard or replacement parts. There are circuit breakers available, i.e. the newer THQB style that will adapt with hardware. However, any major upgrades would probably be easier to accomplish if the panelboards are replaced with new.

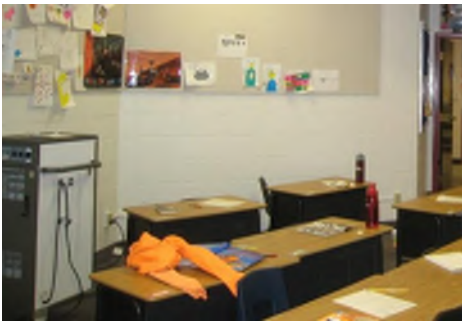
Figure 8 – Typical Classroom with Receptacle Added Using Wiremold

The lack of receptacles often results in the need for two or more power strips. Some of the classroom have receptacles above work counters that are all on the same circuit in the pod. There is generally one circuit per classroom. This was not unusual in the 1970s, when the school was built. However, technological advances have necessitated more computer equipment to be located in classrooms.

Branch Circuiting: Additional receptacles and circuits are badly needed in the classrooms and workrooms, particularly over work counters and near the teacher's desks. Replacing existing receptacles and adding up to eight additional receptacles and increasing branch circuiting to a minimum of two dedicated circuits per classroom is recommended. The wiring will most likely need to be run in exposed raceways, i.e. Wiremold, since many of the walls are CMU block construction.

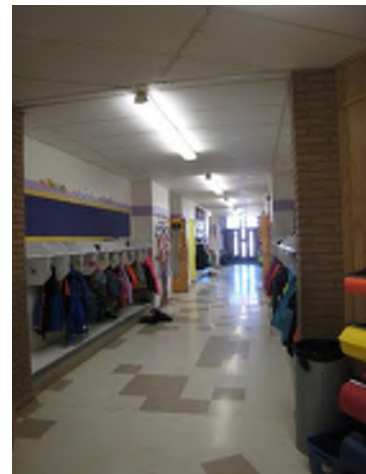
Figure 9 –Corridor Lighting

Lighting: Staff Break, Nursing, Reception and Administrative areas that were remodeled in recent Safety-Security Upgrades are mostly recessed LED troffers with some smaller surface styles used in the Vestibule. Most of the existing fixtures in Corridors are 4-foot T8 fluorescent fixtures with wraparound acrylic lenses (Figure 9).

Lighting: Replacement of fluorescent fixtures with LED fixtures and controls is recommended. The energy savings combined with improved occupancy sensors and dimming controls is substantial. New fixtures would be very similar in appearance to the existing and could utilize the same circuiting, pendants and suspension mounting hardware. Rebates are available from Northwestern Energy and NCAT to help offset the cost of replacement.

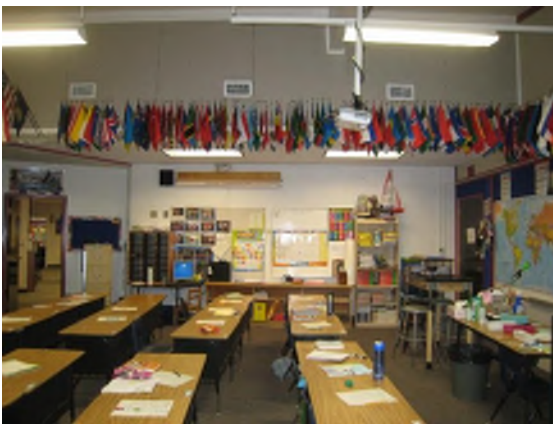
Figure 10 –North Pod Classroom Lighting

Classroom lighting in the North Pod is a combination of suspended 4-foot long T8 fluorescent acrylic wraparound lenses and 2x4 parabolic troffers (Figure 10). Classroom lighting in the South Pad is suspended 4-foot long T8 fluorescent fixture (Figure 11). The Gymnasium lighting is 4-foot T-5 fluorescent fixture with wire guards. The building is equipped with occupancy sensors, but only the areas with the newer LED lighting have dimming capability.

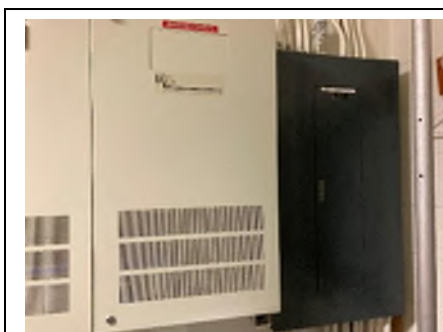
Figure 12 – South Pod Emergency Lighting Inverter

Exit and Egress Lighting: Due to the nature of the “pod” style design of the school, there are many corridors and exits. Overall, the building seems to be lacking in both exit signs and emergency egress lighting. The South pod has an emergency lighting inverter located adjacent to Panel G near the Kitchen (Figure 12) that provides emergency power to selected luminaires for egress lighting and for exit lighting in the gym and corridors. There was originally an emergency lighting inverter in a storage room in the Library of the North pod, but it has been removed. This resulted in the installation of battery powered emergency lighting units in the corridors and classrooms (Figure 13). It is not known if the exit signs in the North pod were equipped with batteries after the inverter was removed. Six of the eight classrooms in the North pod with exterior doors are designated as Entries 2 through 9 with exterior placards. The six are marked only with non-illuminated cardboard signs (Figure

Exit and Egress Lighting: Replacement of the exit signs with new "onboard" LED signs is recommended. New exit signs combined with LED emergency egress lighting heads should be installed at all exit doors that do not have an illuminated sign and possibly in other locations where an adjacent emergency lighting unit can be deleted and combined. Wall and ceiling mounted emergency egress lighting with battery packs and LED heads should be added to every corridor to ensure the lighting level meets the minimum requirements of the Life Safety Code and IBC. The emergency battery inverter system near the Gym should be investigated further to determine its best use; it may be that it can continue to serve the emergency lighting for the Gym.

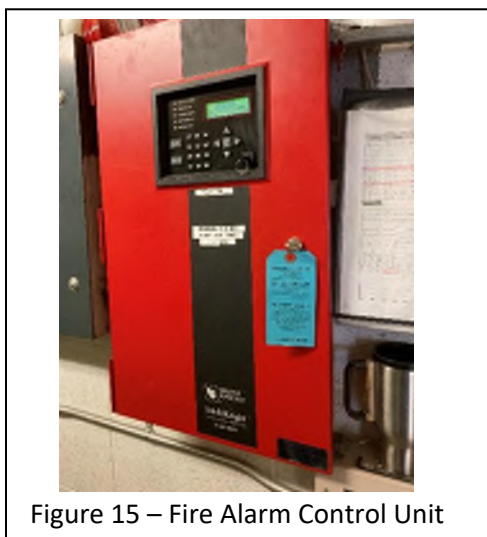
Figure 15 – Fire Alarm Control Unit

The Fire Alarm System, as classified in the International Fire Code, is a manual detection system. The Control Unit is located in the Boiler Room, near Panel H (Figure 15). There are manual pull stations at most exit pathways, but not at the six of the exit doors in the North classroom pod, which is required.

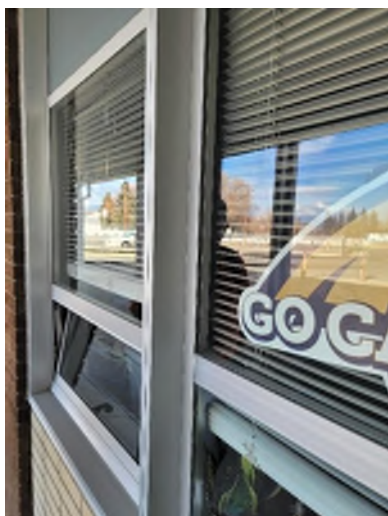
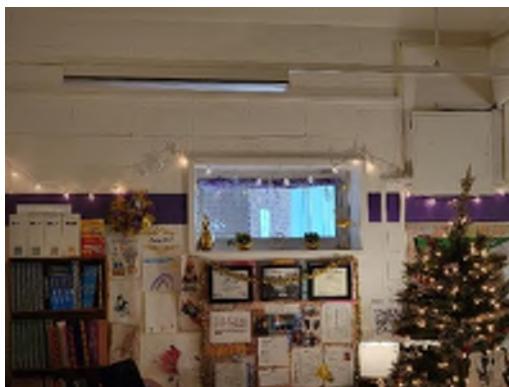
Windows: All the windows are older aluminum non-thermally broken frames with single pane glazing. These windows are well beyond their useful life.

Windows: Replace all the existing exterior windows with new aluminum thermally broken double pane low-e glazing. **(High Cost, Low Priority)**

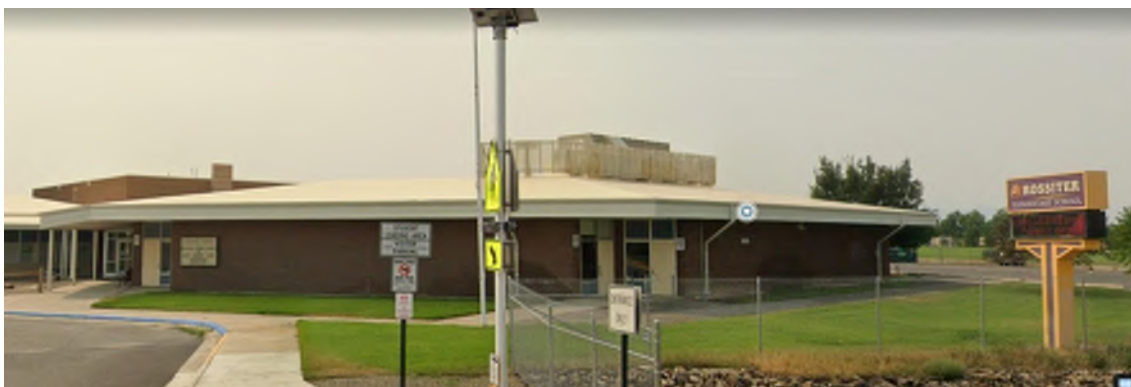
Classrooms without Windows: None of the classrooms in the library addition have real windows, they have a sidelight next to the door. While this is not a violation of the code, it has been proven that natural lighting in classrooms helps facilitate learning and retention.

Classrooms without Windows: It would be highly recommended to cut in windows into all the classrooms. **(Medium Cost, Low Priority)**

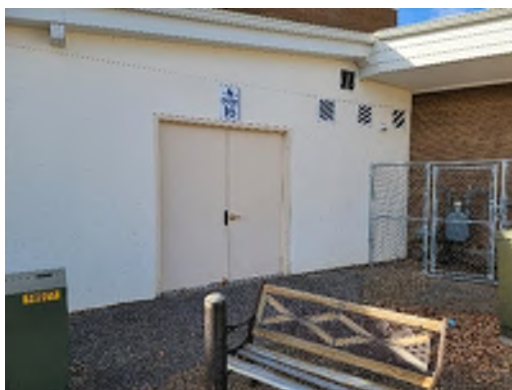
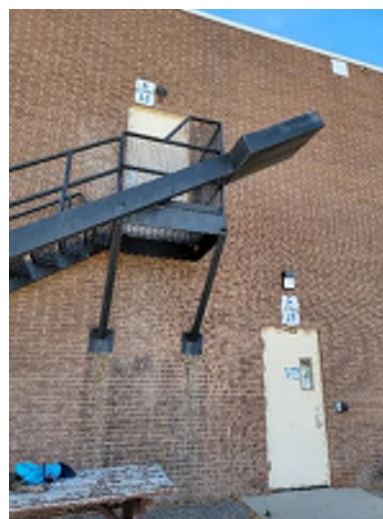
Exterior Doors: All but two of the exterior doors are old and require constant maintenance. They are all beyond their useful life and should be considered being replaced.

Exterior Doors: Replace all older exterior doors with new galvanized insulated hollow metal doors or thermally broken aluminum doors. **(Medium Cost, Medium Priority)**

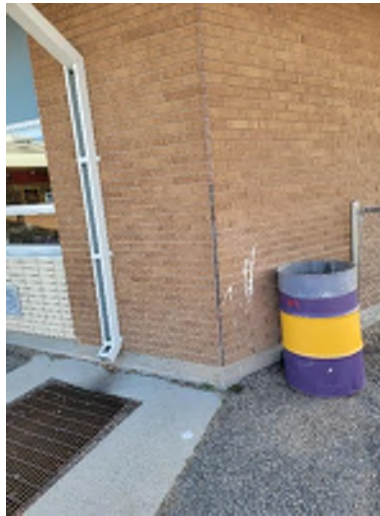
Masonry: The face brick masonry is in good shape. However, the control joints are cracked or missing and should be resealed with caulking.

Masonry: Reseal all masonry control joints. **(Low Cost, High Priority)**

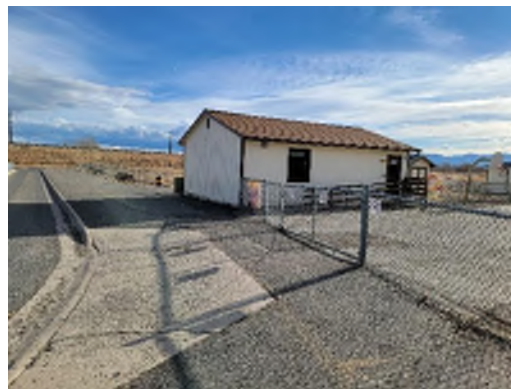
Outbuilding: The older music outbuilding is well past its useful life and should be scheduled to be replaced or have a lot of money put into it to renovate it.

Outbuilding: Replace or remodel the Music Outbuilding. **(High Cost, Low Priority)**

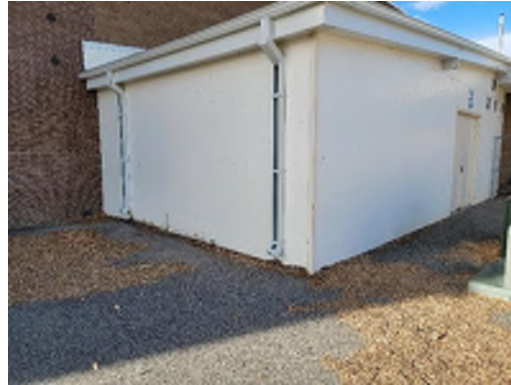
Storage Addition: There is a wood framed storage addition that was added to the southwest of the gym. This structure's prefinished paneling is degrading and should be replaced.

Storage Addition: Replace all exterior siding on the storage addition with new metal wall panels. **(Medium Cost, Medium Priority)**

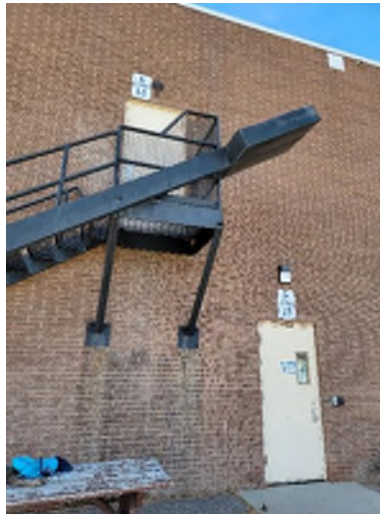
Exterior Stair Railing: The railing on the exterior stair does not meet current requirements and should be renovated. There is also a large counterweight that was installed and should be removed.

Exterior Stair Railing: Modify the railing on the exterior stair to meet guard railing requirements and give better fall protection from the young students. We would also recommend removing the counterweight as it is not needed any longer. **(Medium Cost, High Priority)**

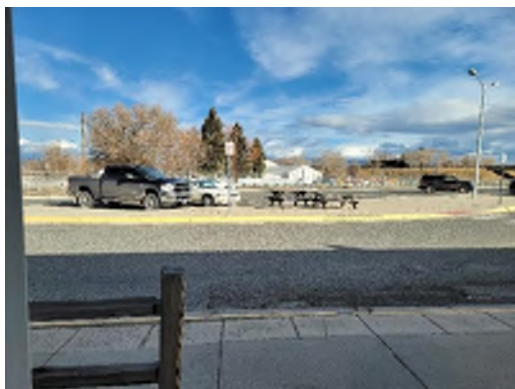
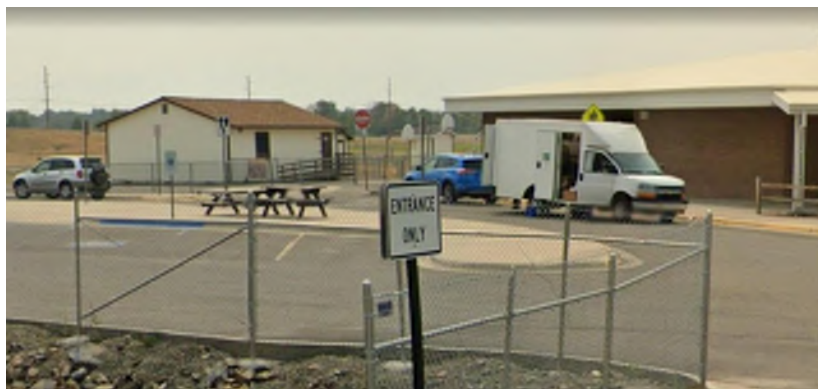
Parking: The exterior parking is in good shape from the parking lot to the sidewalk next to the building. However, sidewalk under the overhang into the building is pitted out and should be replaced.

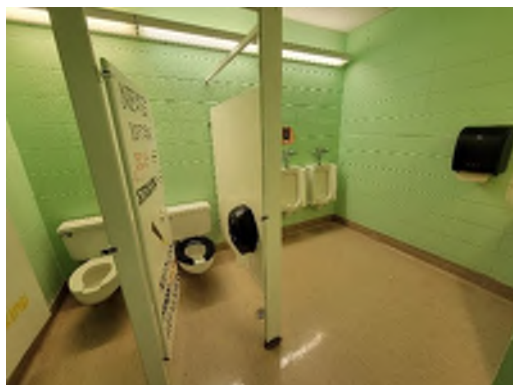
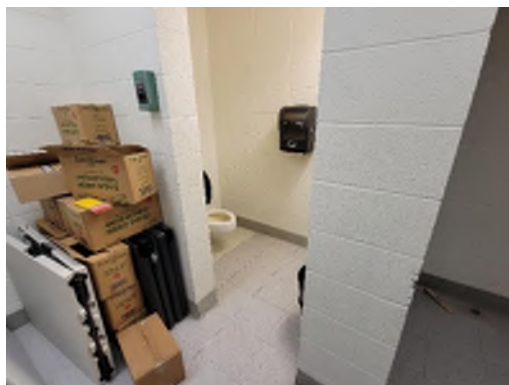
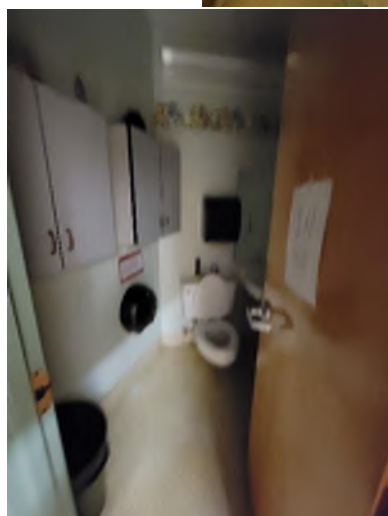
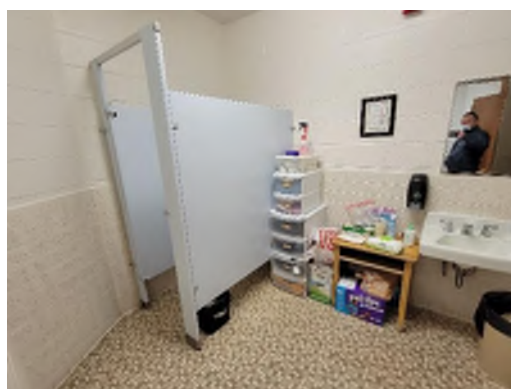
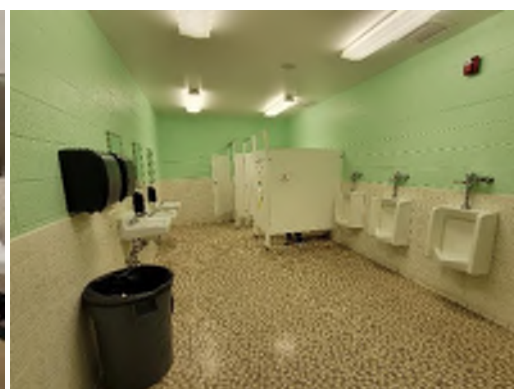
Bathrooms: Rossiter has more restroom fixtures and facilities than any other elementary school with a total of (15) rooms and (45) water closets or urinals). Of these restrooms only one currently meets ADA standards. While additional rooms could be brought up to current standards it would require masonry to be removed as none of the entries meet the required clearances. I would not recommend putting these updates on the current priority list, but if the restrooms are updated in later years the ADA status should be reevaluated.

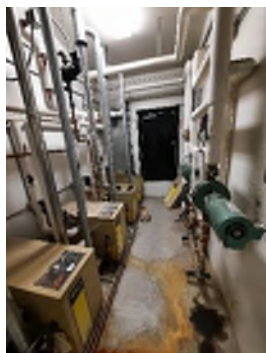
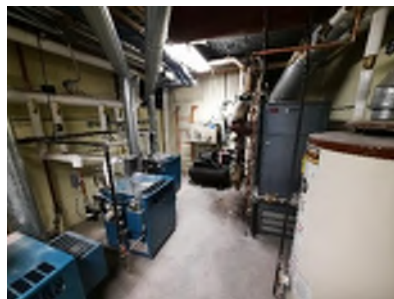
Heating System: The building heating consists of five separated boiler systems distributed throughout the building in four different boiler rooms. The building boilers are all cast iron sectional designs. The boilers are of three different manufacturers and four different sizes. There are a total of 14 different boilers within the building. In one instance, there are 2 separate boiler plants in a single boiler room. One of the systems is a single unit while the other boiler system is a four-unit modular system. There are a total of three modular systems within the building and two single boiler plants.

Heating: Replace the cast iron section boiler plants. The design effort should be to consolidate equipment and provide system redundancy. Consideration should be given to piping between the different equipment rooms and establishing a single boiler plant with the building.

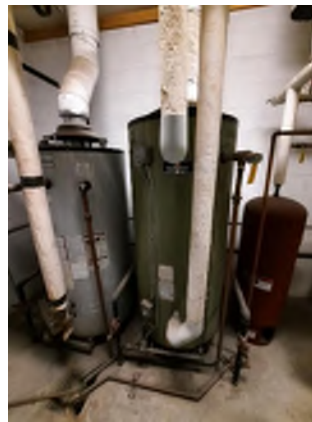
Domestic hot water for the building is generated with three separate gas fired water heaters. These systems are distributed in various equipment rooms throughout the building. The domestic hot water systems are not equipped with a tempering valve as required by code.
