Helena School District Deferred Maintenance Report

January 31, 2022

RE: Deferred Maintenance Review
Helena Public Schools
Final Report

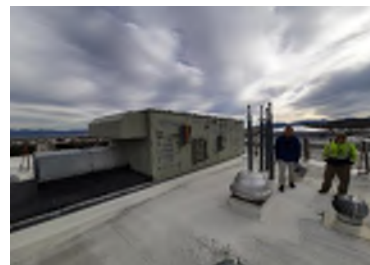
Ventilation: The building ventilation is provided via five different roof mounted air handling units and a lower area crawlspace unit. The units are equipped with hot water coils to temper the ventilation air, but the individual space temperature control is via duct mounted reheat coils. These coils are located within the building in closet spaces.

down the corridor to a central return located in the common space. The use of the corridor as an air passageway is a code violation.

Ventilation: Replace the roof mounted equipment with new unit equipped with air cooled mechanical cooling.

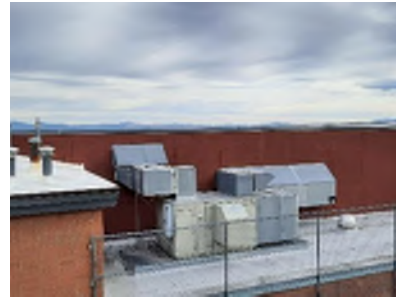
The gymnasium space is equipped with a roof mounted air handling unit. This unit is exposed on the roof and has become a haven for a flock of pigeons. This flock of pigeons creates a non-sanitary area around the unit.

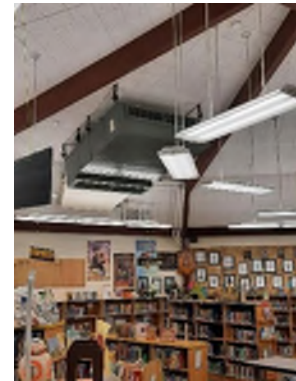
Air Conditioning: The air handling equipment is not equipped with any means of mechanical equipment. All units are sized for economizer cooling.

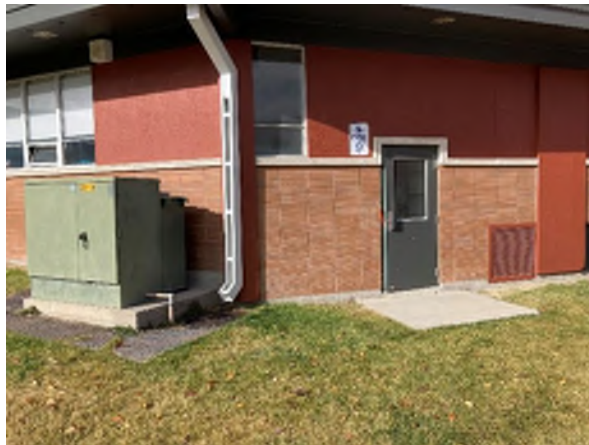
Figure 1 – Pad Mounted Transformer

Electrical Service: The building service is derived from an underground 12.47 kV primary. The original drawings show the primary originating from a riser pole located southwest of the property in the alley adjacent to California Street. However, at some point this may have changed because a riser pole does not appear to be at that location. There is a riser pole located east of the property at Colonial Drive and Reber Broadwater Cupola Park, that may be the origination point of the primary now. The primary terminates at a 150 kVA pad mounted transformer on the southeast side of the center pod of the school (Figure 1). The secondary service characteristics are 120/208 volts, three phase, four wire with a nominal 600 amp rating. The secondary exits the transformer underground and then passes through the foundation wall where it terminates at the Main Distribution Board (Figure 2). The utility meter is adjacent. The utility metering current transformers appear to be located in the bottom of the MDB in a separate compartment. One area of concern with this installation is that the transformer is just a few inches from the exterior building wall and positioned directly under an overhang and just a few feet from windows. The clearances are not adequate to meet current utility company standards or safety codes.

Electrical Service: The close proximity of the pad mounted transformer to the building is a concern because the transformer is so close to the building and the overhang extends over it. Transformer faults are rare but do happen on occasion. A fault could start a fire or worse. Relocation of the transformer to a location at least 5 feet from the building and 10 feet from any windows is recommended and would meet current utility company safety requirements. If this were to be done, then it would be an opportune time to increase the electrical service ampacity from 600 to 800 amps or more, depending on future air conditioning loads. The service upgrade would also provide an outdoor metering cabinet, meter and an exterior main disconnect.

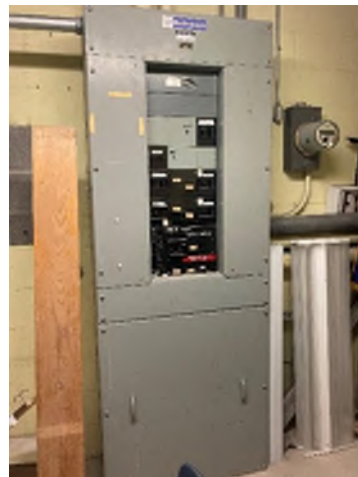
Figure 2 – Main Distribution Board

The Main Distribution Board is a Westinghouse Model CDP (Figure 2). The incoming electrical service enters the side of the cabinet, then turns downward and terminates in the metering compartment. The service conductors are parallel sets of 4#350 THW run in parallel in 3-1/2 inch conduits. The distribution board is obsolete but apparently Cutler-Hammer can provide compatible circuit breakers. There are five 3-pole distribution breakers in MDB feeding six branch panelboards in the school as follows; 350A - Panels F & G, 225A - Panel D, 200A - Panel B, 175A - Panel E, 100A - Panel C. There is also a 150A spare breaker and two 20A-1P breakers for exit and egress lighting.

Electrical Distribution: It is recommended that the Main Distribution Board be replaced with a new board with the capacity to support the power requirements for a new central AC system and add additional panelboards to the Classroom pods for more convenience receptacles. The existing branch panelboards do not necessarily need to be replaced, as parts are still available.

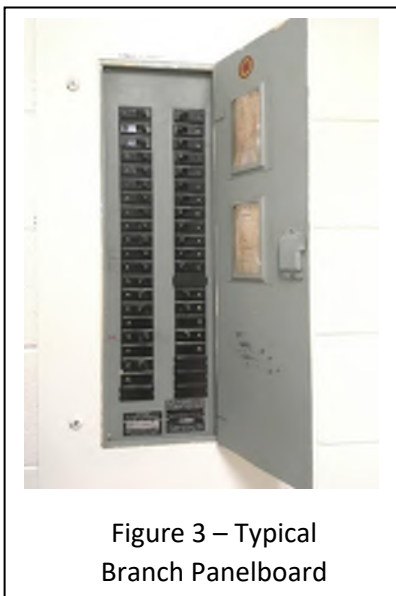
Figure 3 – Typical Branch Panelboard

Electrical Distribution: There are 5 original branch panelboards in the school. All are Westinghouse panelboards. Circuit breakers are available through Cutler-Hammer. One of the original panelboards (Panel B in the Boiler Room) was recently replaced with a Square D NQ branch panelboard to provide additional circuits for new equipment installed for the Safety-Security Upgrades. A 4 kVA UPS and UPS panelboard was also added recently for battery backup of the data switches. The original panelboards are for the most part lacking any spare breakers or spaces.

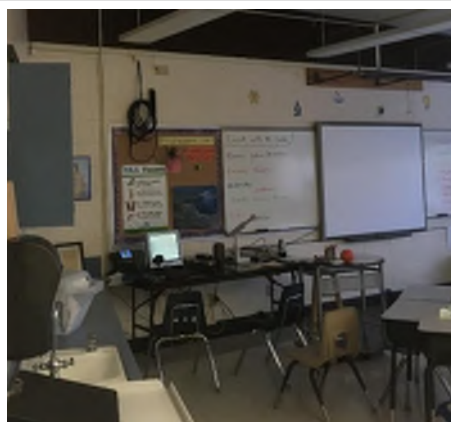
Figure 4 – Typical Classroom Clustering of Appliances and Power Strip

Branch Circuiting: Classrooms are not adequately provided with sufficient quantities of convenience receptacles and circuiting to meet current needs. Most classrooms have five to six receptacles in usable locations often resulting in the need for two or more power strips (Figure 4). In addition, there are only three circuits are shared between four classrooms, so essentially there is less than one circuit per classroom. This

Branch Circuiting: Additional receptacles and circuits are badly needed in the classrooms and workrooms, particularly over work counters and near the teacher's desks. Replacing existing receptacles and adding up to 8 additional and increasing branch circuiting to a minimum of two dedicated circuits per classroom and one for workrooms is recommended. The wiring could be installed in a concealed manner if the cost of cutting and patching walls is acceptable. Otherwise exposed Wiremold raceway or possibly even conduit would be used.

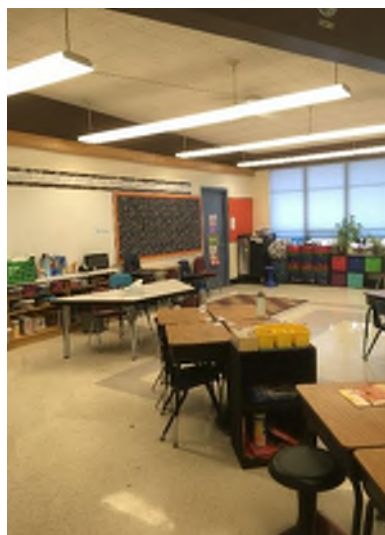
Figure 5 – Typical Classroom Lighting

Lighting: Staff Break, Nursing, Reception and Administrative areas that were remodeled in recent Safety-Security Upgrades are mostly recessed LED troffers with some surface wraparound styles used in the Lobby. The remaining existing fixtures in Corridors are mostly 4 and 8-foot T8 fluorescent fixtures with wraparound acrylic lenses (Figure 6). Classrooms and Library are suspended 4-foot long T8 acrylic wraparound lenses mounted in continuous rows (Figure 5). Storage and utility areas are mostly 2-lamp surface fixtures with wraparound lenses. The Gymnasium lighting is 4-foot T-5 fluorescent with wire guards. The building is equipped with occupancy sensors, but only the areas with the newer LED lighting have dimming capability.

Lighting: Replacement of fluorescent with LED fixtures and controls is recommended. The energy savings combined with improved occupancy sensors and dimming controls is substantial. New fixtures would be very similar in appearance to the existing and could utilize the same pendants and suspension mounting hardware. Rebates are available from Northwestern Energy and NCAT to help offset the cost of replacement.

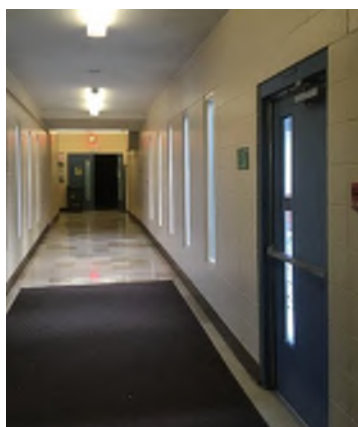
Figure 6 – Typical Corridor Lighting and Non-illuminated Exit Sign

Exit and Egress Lighting: Due to the nature of the "pod" style design of the school, there are many corridors and exits. Not surprisingly, overall, the building seems to be lacking in both exit signs and emergency egress lighting. There are exterior exit doors shared by each pair of classrooms. A few of these are identified as exits with a non-illuminated cardboard sign (Figure 7), but the majority have no signs at all, even though they are identified as "Entries" with a placard on the building exterior. This may be in conflict with the IBC and Life Safety Codes because if these are *required* exits then they should have an illuminated exit sign (Figure 8) and emergency egress lighting. In general, there is very little emergency egress lighting in the building, other than in the center pod around the recently remodeled Reception and Administrative areas. Commons areas, i.e. the Gym and Library have some emergency lighting, but even these areas seem to be underlit for egress.

Exit and Egress Lighting: Replacement of the original exit signs with new “onboard” LED signs is recommended. New exit signs should be installed at all exit doors that do not have an illuminated sign. The new exit signs could be a combination unit that is equipped with a battery pack and two LED emergency lighting heads. Wall and ceiling mounted emergency egress lighting with battery packs and LED heads should be added to every corridor to insure the lighting level meets the minimum requirements of the Life Safety Code and IBC.

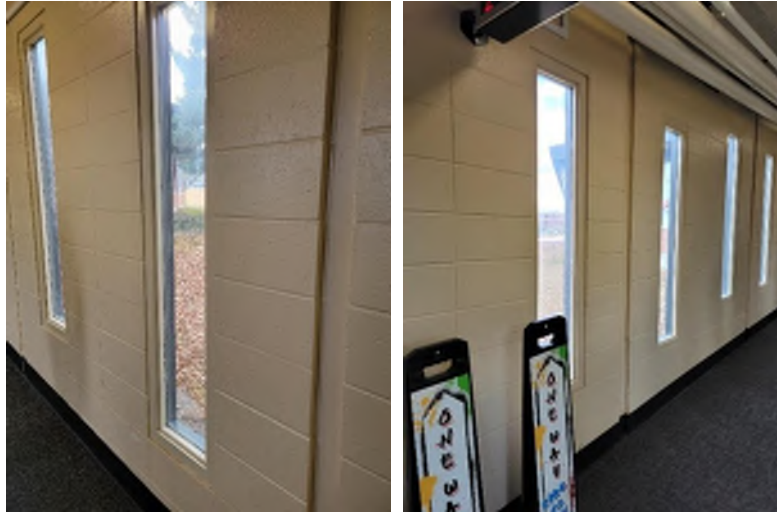
Hollow Metal Windows: There were new windows installed on the connection Corridors that have hollow metal window frames with single pane wire glass. These should be replaced.

Hollow Metal Windows: Replace the hollow metal windows with thermally broken frames and double pane low-e glazing. **(High Cost, Medium Priority)**

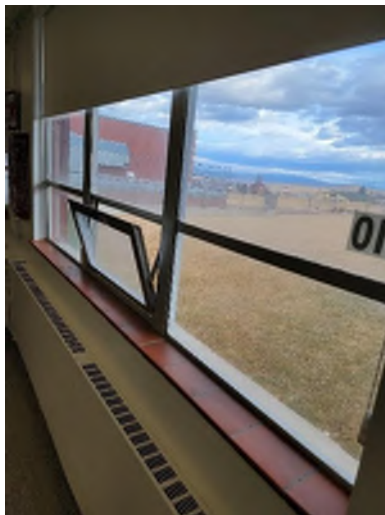
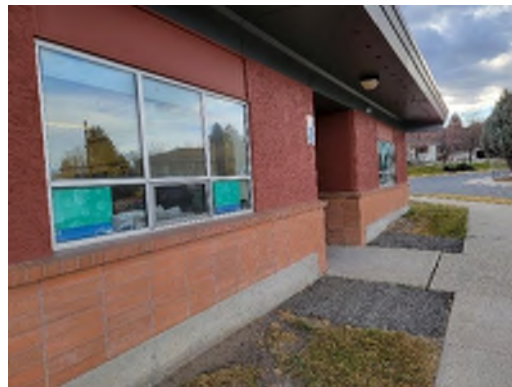
Aluminum Windows: The rest of the school has non-thermally broken aluminum framed windows with single pane glazing. These should be replaced.

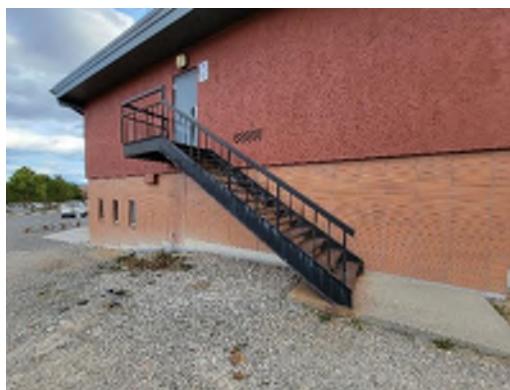
Exterior Stairs: There is a set of exterior egress stairs where hand/guard railing have much larger openings that the current code allows. This should be considered a fall hazard and should be updated.

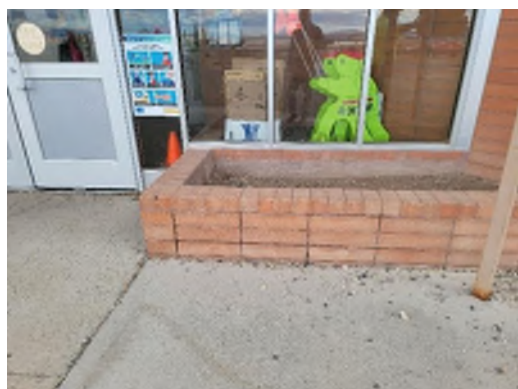
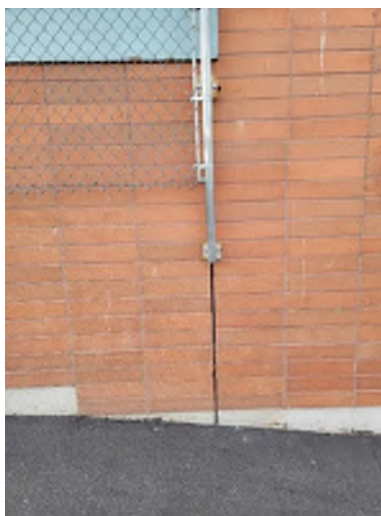
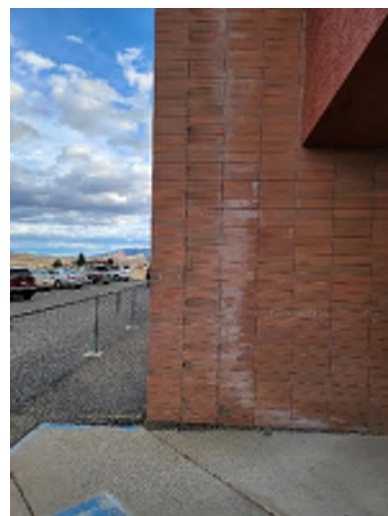
Masonry: There are a few locations that the exterior masonry is in need of being repointed and all of the control joints need to be filled in with new sealant.

Masonry: Repoint the few locations of masonry that the mortar joints are cracking. Replace all sealant at the masonry control joints. **(Low Cost, High Priority)**

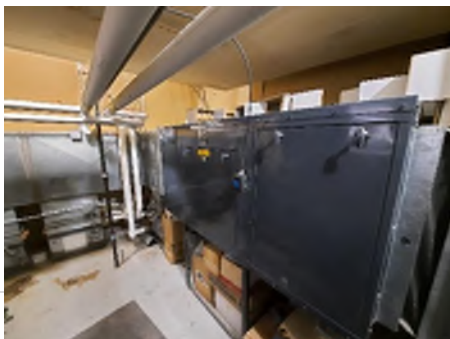
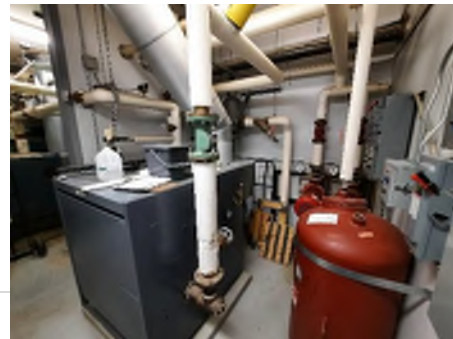
Heating System: The building heating consist of three separated boiler systems. All are in a central boiler plant with a limited amount of interconnecting piping. As the building was expanded, an additional boiler system was added to the building. All three systems utilize cast iron sectional boilers. Each system has their own air separator, expansion system and distribution pumps. Two of the systems have dedicated combustion air systems while the third system is not equipped with a combustion air system. The plant is significantly oversized for the installed building load connected to the individual systems.

Heating: Replace all cast iron section boilers into a single integrated boiler system utilizing high efficiency condensing boilers. The boiler room pump scheme should be combined to allow system redundancy and simplification of maintenance.

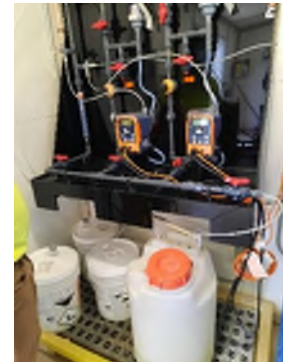
Plumbing: The building domestic water is provided via a water well on property. This well system is equipped with a chlorination system. The piping on the chlorination system is beginning to fail and should be re-piped to ensure proper water quality.

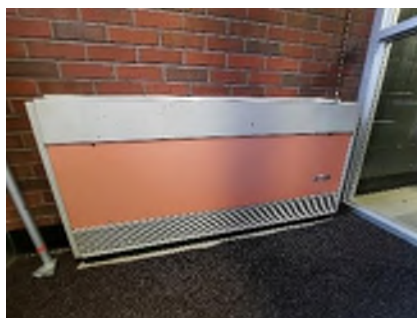
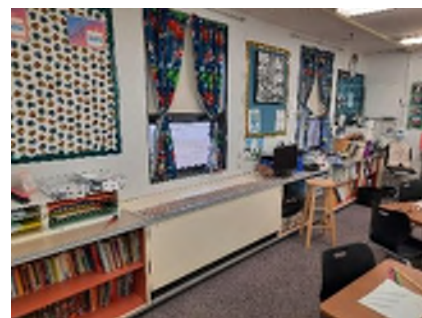
1. The original building is equipped with floor mounted unit ventilators. The unit ventilators are original to the building.

Ventilation: Replace floor mounted unit ventilators new equipped. The mezzanine blower coils should be replaced with small air handling equipment capable of variable flow operation.

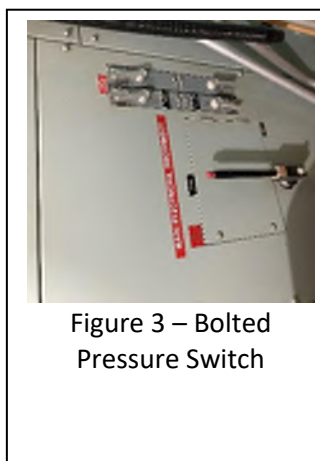
Figure 3 – Bolted Pressure Switch

Distribution: The MDB consists of two sections. There is a 600A-3P main disconnect, a bolted pressure switch in the incoming section (Figure 3). The utility metering and meter are above the switch. Bolted pressure switches are susceptible to failure unless they are maintained and exercised regularly. Capital High School a similar switch in the main building that failed in the summer of 2021 and had to be replaced.

Electrical Distribution: A new electrical service will allow the existing bolted pressure switch to be removed. A main lug kit can be installed in its place in order to maintain Section 2. It is also recommended that at least one additional branch circuit panel be added to the building, near the original classrooms and replacing original panels A and C with new.

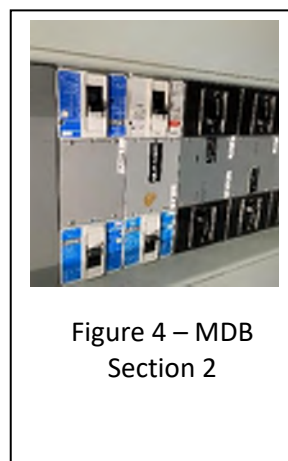
Figure 4 – MDB Section 2

Section two of the MDB contains ten distribution breakers; four 125A-3P for Panels A, B, C & D; one 70A-3P for a Range; one 150A-3P for Panel E, four 200A-3P for Panels F, G, ME (Figure 4) and a Modular Classroom/Library. The labeling and identification needs improvement because two breakers are not identified properly. There appear to be spaces for additional circuit breakers. Panel A is an old panelboard, located in the original school area. It does have some spare breakers, but they may be obsolete (Figure 5). Panel B is located in the administrative area, was recently installed during the Safety-Security Upgrades and has spare capacity. Panel ME (Figure 6) is in the Boiler Room and Panel D is adjacent. Panel ME has at least 50% spare capacity but Panel D does not have any spares. Panel C is located in the Kitchen, is also an original panel and has just a small amount of spare capacity. Panels E and F are located in the south classroom wing additions. Both have spare capacity.

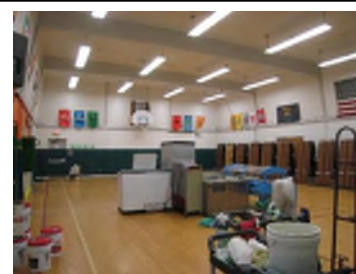
Figure 11 –Gymnasium Lighting

The Gymnasium lighting consists of suspended 4 foot tandem T-8 fluorescent fixtures with wire guards (Figure 11).

Lighting: Replacement of fluorescent fixtures with LED fixtures and controls in classrooms, corridors, gymnasium and other areas is recommended. The energy savings combined with improved occupancy sensors and dimming controls is substantial. There is an added benefit of increased life, which will help reduce maintenance costs. The fixtures in the Modular Classroom Library and Music Classrooms will be included. The 1992 addition will have recessed 2x4 LED flat panels. The surface and suspended wraparound fixtures in the original school classrooms and the 1977 Addition should be replaced with similar style fixtures with onboard LED's. The existing exit signs may be reusable, but it may be more advantageous to replace them with combination exit signs with emergency egress heads. Cardboard and paper signs will be replaced with new illuminated exit signs with emergency heads. Rebates are available from Northwestern Energy and NCAT to help offset the cost of replacement.

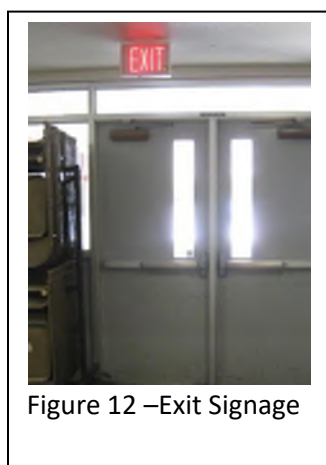
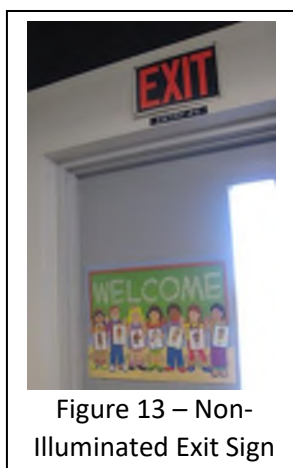
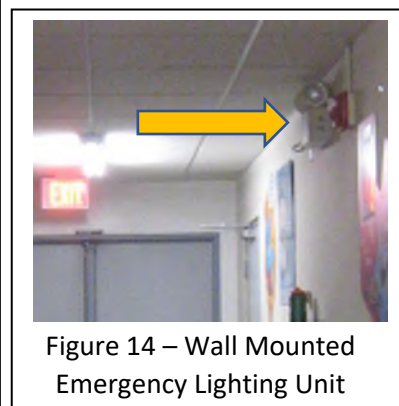
Most of the exit signs in the building are steel housings with stencil faces that have been converted to LED (Figure 12). There are a few exit doors that are not provided with illuminated exit signs that are not Code compliant (Figure 13). Both interior and exterior LED emergency egress lighting was provided in the recent Safety-Security Upgrade. There are some 2x4 troffers in the 1992 Addition that were equipped with emergency battery backup. Emergency egress lighting in the original portion of the school and in the 1977 Addition appears to be very sparse. A few wall mounted units have been placed in some corridors (Figure 14), but they are lacking in most.

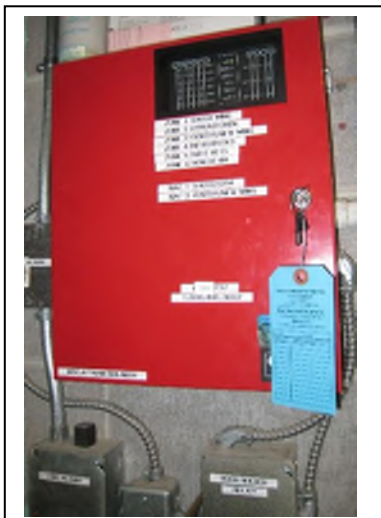
Figure 15 – Fire Alarm Control Unit

The Fire Alarm System, as classified in the International Fire Code, is a manual detection system. The Control Unit(s) is located on the east wall of Mechanical Equipment Room 126. It is a Silent Knight Model SK-6324 (Figure 15). There is a remote annunciator located in the Reception

The fire alarm system appears to be functioning correctly at the present. However, it should be upgraded in the next few years to a new addressable voice evacuation system with speakers and strobes added to every room to comply with current Fire Codes. Usually any failure of the existing equipment will require the system to be upgraded to meet current codes anyway, although sometimes the AHJ will allow temporary exceptions.

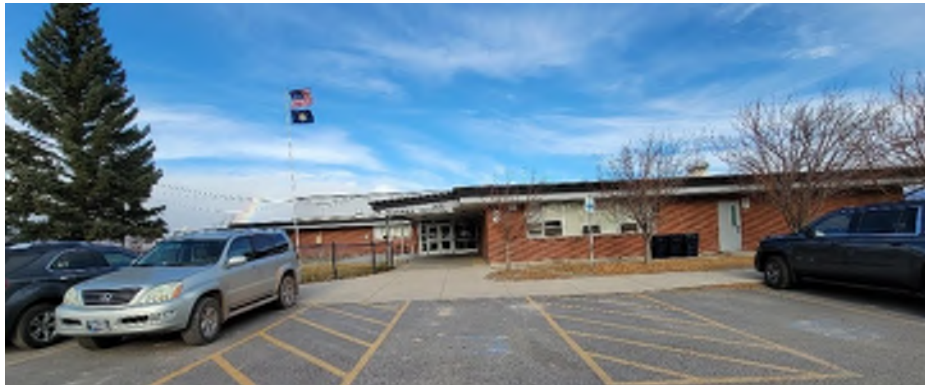
Aluminum Single Pane: The original gym, library and classroom area of the building had non-thermally broken aluminum framed windows with single paned glazing. These windows should be replaced as they are beyond the useful life.

Aluminum Single Pane: Replace the original aluminum framed single pane windows with new thermally broken double pane low-e windows. **(Medium cost, Medium Priority)**

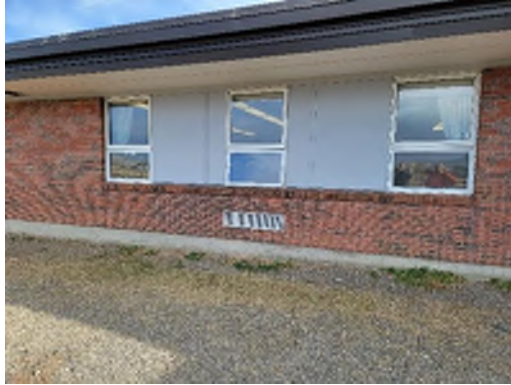
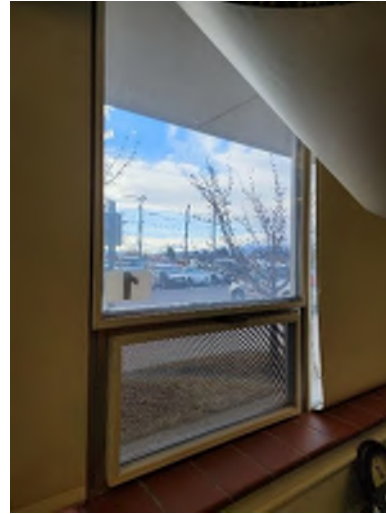
Wood Windows: The first addition to the school (about 1/3 of the school) has wood frames and single pane windows. These windows are beyond their useable life and should be replaced.

Wood Windows: Replace the wood frames and single pane windows with new thermally broken double pane low-e windows. **(Medium Cost, High Priority)**

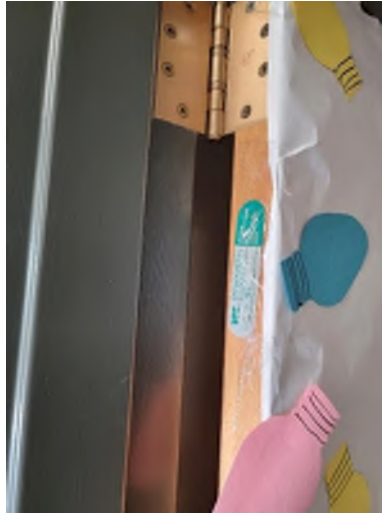
Interior Rated Doors: The newest addition had fire rated doors installed at the corridors. These doors were blocked open, or their closers were removed. This is a breach in fire code and can be fixed with the installation of magnetic hold opens.

Interior Rated Doors: Install mag holds on all interior fire rated doors to allow them held open without infringing on the fire code. **(Medium Cost, High Priority)**

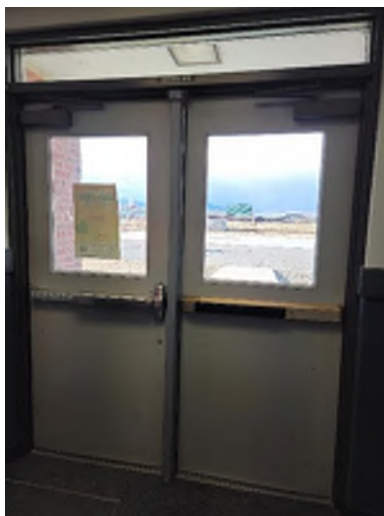
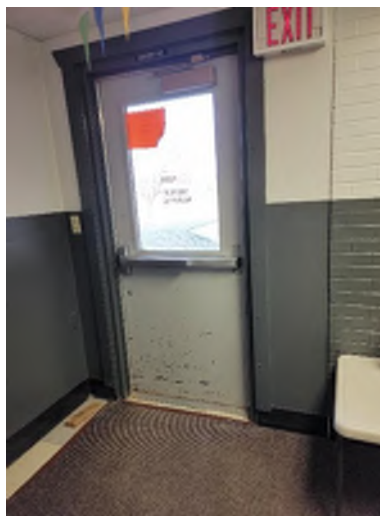
Exterior Doors: Three of the exterior doors are constantly being adjusted by the maintenance staff and need being replaced.

Exterior Doors: Replace the three exterior door creating heavy maintenance issues. **(Medium Cost, Medium Priority)**

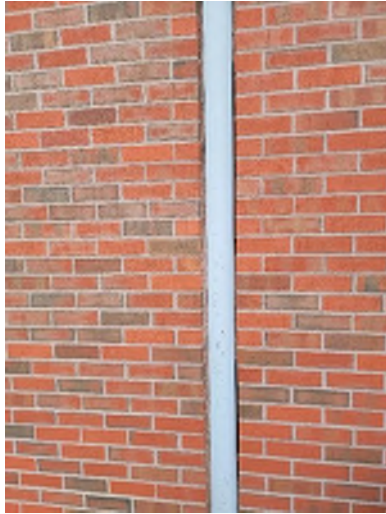
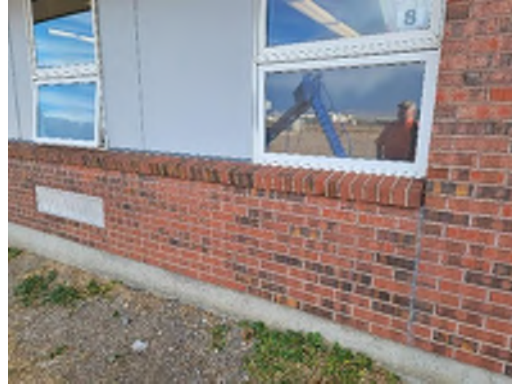
Masonry: Most of the exterior cladding on the Warren School is a face brick masonry. The finish is in good shape however the control joint need to be re-sealed.

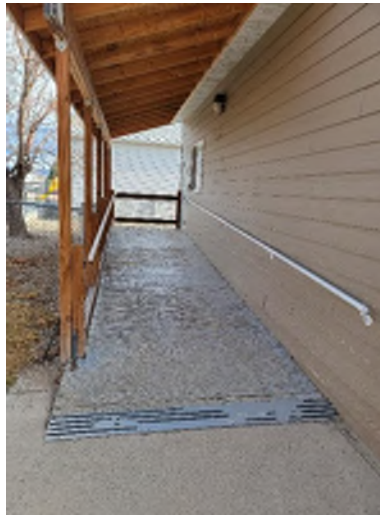
Outbuilding ADA Ramp: One of the outbuilding buildings has an ADA ramp was built out of plywood and needs to be replaced.

Outbuilding ADA Ramp: Rebuild the plywood ramp to be more durable. We are including a price for concrete to be used. **(Medium Cost, Medium Priority)**

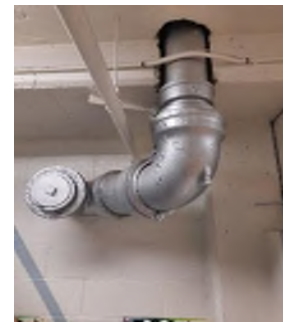
The domestic water system is insulated copper piping. Isolation valves in the system are indicating their age with leaking valve packing and sections of insulation missing due to previous repairs. Isolation valve operational status was indicated as a problem (valves don't work). When repair work is required on the domestic water system the entire building service needs to be shut-off to allow service.

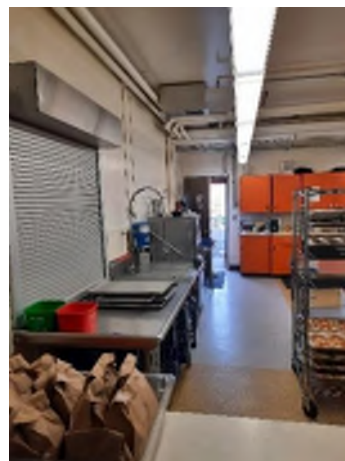
Kitchen equipment (ranges, ovens, and dishwashers) are not equipped with required hoods.

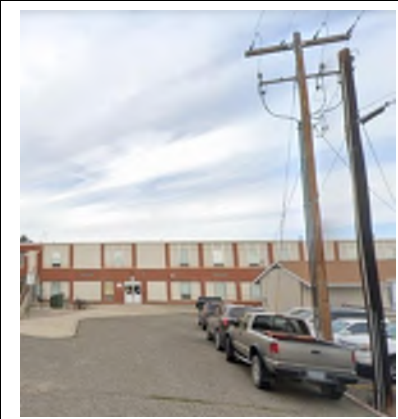
Figure 1 – Primary Electrical Service

Electrical Service: The building service is derived from a 12.47 kV primary distribution line on a riser pole located on the south east side of the school, adjacent to Cleveland Street (Figure 1). The primary line crosses under the parking lot and terminates in a 300 kVA pad mounted transformer near Entry 5 on the east side of the building (Figure 2). The secondary service characteristics are 120/208 volts, three phase, four wire with a nominal 800 amp rating. The secondary conductors exit the transformer underground then rise up on the exterior of an old transformer vault and into the meter enclosure (Figure 3). The meter and the main disconnect are adjacent. There is a separate overhead service drop to two Modular Classrooms located north of the main electrical service. They have their own meter/main at 120/240 volt, single phase.

Electrical Service: The existing 800 amp electrical service and main disconnect have little spare capacity. The service conductors and the main disconnect should be increased to at least 1200 amps, or possibly larger if air conditioning is added. A disconnect this large will probably require a 2-section outdoor enclosure, either free-standing or against the exterior building wall.

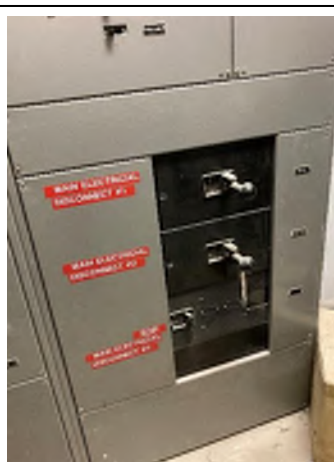
Figure 4 – MSBD Section 1

Distribution: The Main Switchboard (MSBD) is located in a basement Electrical Room and consists of two sections (Figures 4 & 5). The nameplate rating of the switchboard is 2000 amps. Section 1 contains two 600A-3P and one 400A-3P “sub” main circuit breakers. Although neither are labeled as such, one of the 600 amp breakers appear to serve Section 2 of MSBD and the other 600 amp breaker may feed Panel SDP2. The 400 amp breaker is labeled “Panel SDP”. Section 2 of MSBD contains six 200 amp distribution breakers for Branch Panels A, A2, B, C, D and F, and six 100 amp breakers for Panels E, G, H, J, K and P.

Electrical Distribution: A new electrical service will also require an upgrade to the MSBD. Careful consideration must be given to where the new MSBD is located so that the installation is compliant with the access and working clearance requirement of current Codes, which requires a minimum of two exits from the room. It is also recommended that at least one additional branch circuit panel be added to each floor on the west side of the building, near the classrooms to allow for additional receptacle circuits.

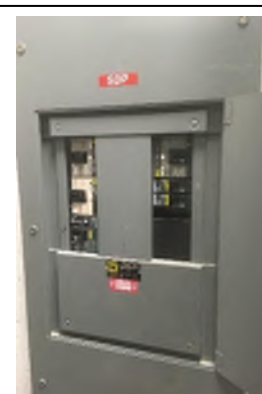
Figure 6 – Panel SDP

Panel SDP is located adjacent to MSBD in the Electrical Room. SDP contains one 225A-3P, three 100A-3P and two 20A-1P breakers (Figure 6). The two 20 amp breakers are identified as “Sign Message Board” and one of the 100 amp breakers is labeled “Panel P2”. The other breakers are not labeled but they may be for the feeders to Branch Panels L, M and P. Panel SDP2 is located in the wood shop. It contains two 150 amp breakers for Panels B1 and D1; one 175 amp breaker for Panel A1; and three 200 amp breakers for Panels C1, R and T (Figure 7). It is obvious that identification and labeling of the distribution breakers is of concern, not just for maintenance but for safety as well.

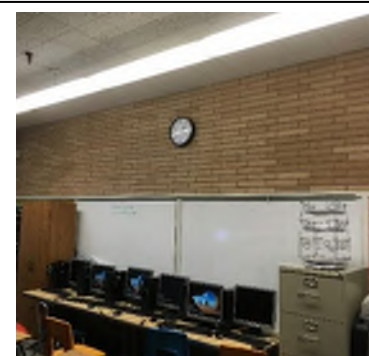
Figure 11 – Classroom Workstations

Branch Circuiting: Classrooms are not adequately provided with sufficient quantities of convenience receptacles and circuiting to meet current needs. Most classrooms have four to eight receptacles but there are not enough in locations where they are needed, i.e. near the teacher's desk, PC workstations or over work counters (Figure 11).

Branch Circuiting: Additional receptacles and circuits are needed in the classrooms. There may be adequate spare capacity in some of the existing panelboards to accommodate the new circuits, and if not, the existing panelboards could be replaced. Circuiting will be increased to a minimum of two dedicated circuits per classroom. Wiring can be run above lay-in ceilings in the corridors, then into the classrooms, where it will be surface mounted in Wiremold or exposed conduit.

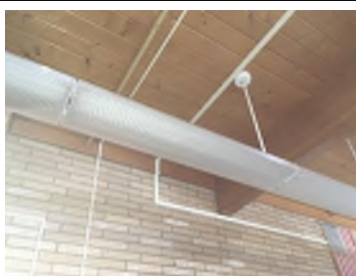
Figure 12 – Typical Classroom Lighting

Lighting: A few new LED downlight fixtures were installed in the Reception areas in the recent Safety-Security Upgrades, but the bulk of the lighting in the school consist of four foot long surface or suspended mounted fluorescent fixtures (Figure 12). The fixtures in the corridors and in the north addition to the school are 2x4 fluorescent troffers with acrylic lenses (Figure 13). The building has been equipped with occupancy sensors.

Lighting: Replacement of fluorescent fixtures with LED fixtures and controls in classrooms, corridors, gymnasium and other areas is recommended. The energy savings combined with improved occupancy sensors and dimming controls is substantial. There is an added benefit of increased life, which will help reduce maintenance costs. The fixtures in the Modular Classrooms will be included. The North Addition and the corridors will have recessed 2x4 LED flat panels. The surface and suspended wraparound fixtures in the cafeteria and classrooms will be replaced with similar style fixtures with onboard LED's. The existing exit signs may be reusable, but it may be more advantageous to replace them with combination exit signs with emergency egress heads. Rebates are available from Northwestern Energy and NCAT to help offset the cost of replacement.

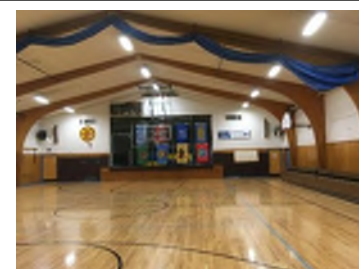
Figure 14 – Old Gymnasium Lighting

The Old Gymnasium lighting consists of suspended 4 foot tandem T-8 fluorescent fixtures with wire guards (Figure 14). The lighting in the New Gymnasium in the North Addition Metal Halide.

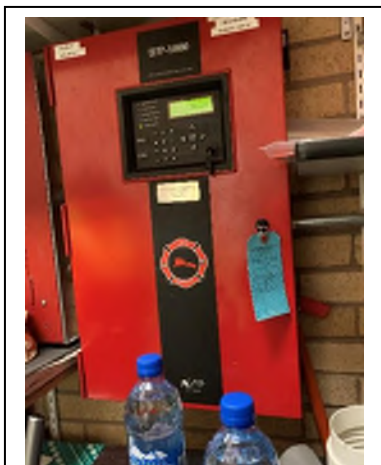
Figure 16 – Fire Alarm Control Unit

The Fire Alarm System, as classified in the International Fire Code, is a manual detection system, although there are some smoke and heat detectors in storage rooms and the elevator shaft. The building does have a fire sprinkler system and it is supervised by the Fire Alarm Control Unit.

The Control Unit(s) is located on the north wall of a storage room in the Reception Office. It is a Silent Knight Model IFP-1000 (Figure 16). There is a remote annunciator station at Entry 19 on the north end of the west classroom wing. There are manual pull stations at exit pathways, horn/strobes in the corridors (Figure 15), common areas, the Gyms, Cafeteria and Classrooms. Only a few of the classrooms in the school have horn/strobes, which is not in compliance with the current Fire Codes which require notification in every habitable room. There are a few smoke detectors in the corridors for release of magnetic door holders and the coiling doors at the Reception windows, plus the elevator lobby, certain air handlers and storage rooms.

The fire alarm system appears to be functioning correctly at the present. However, it should be upgraded in the next few years to a new addressable voice evacuation system with speakers and strobes added to every habitable room to comply with current Fire Codes. Usually any failure of the existing equipment will require the system to be upgraded to meet current codes anyway, although sometimes the AHJ will allow temporary exceptions.

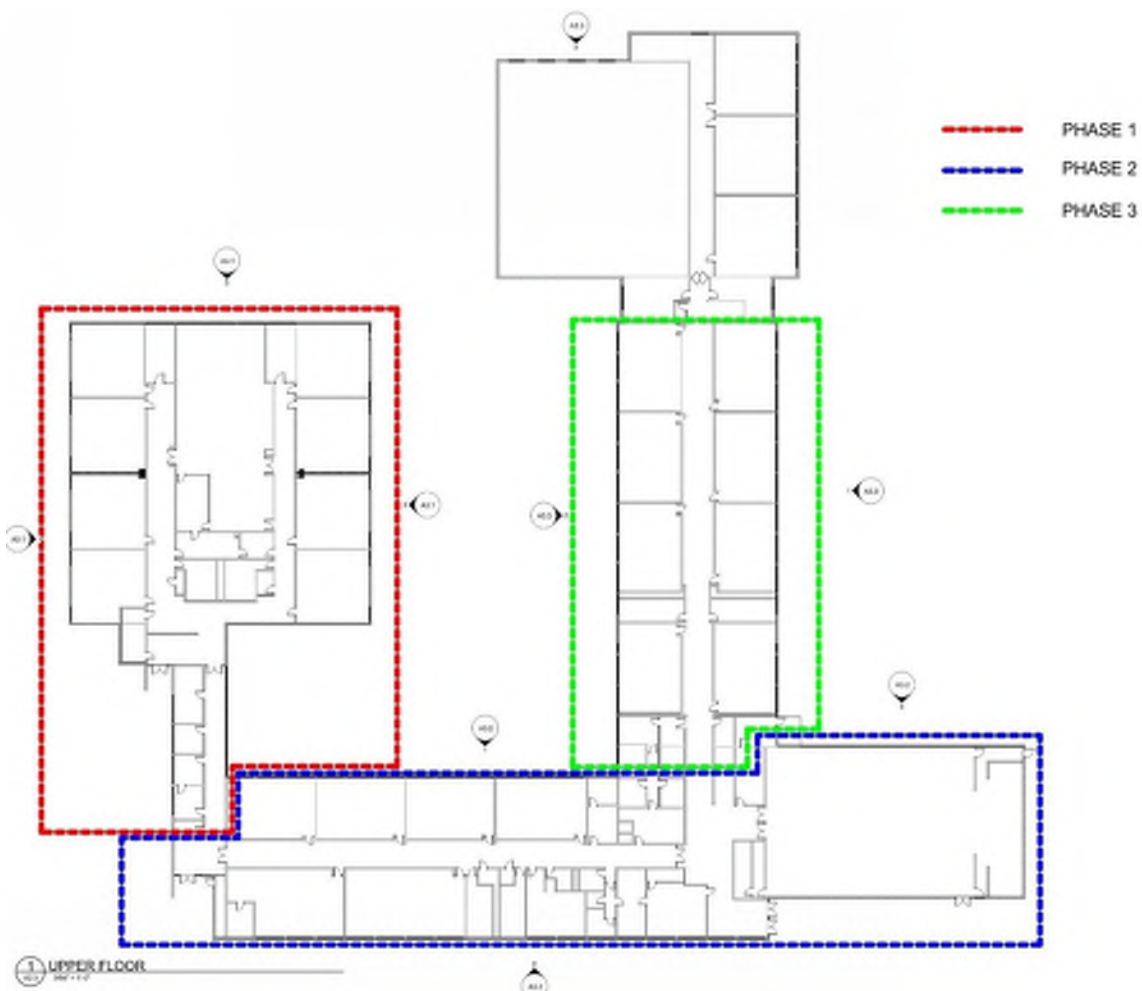
Aluminum Single Pane: There are a lot of Single Pane non-thermally broken Aluminum windows at CR Anderson. Many of these windows are a curtain wall system and are not just punched openings. As such there is addition work that will be required to replace these windows. All of these windows should eventually be replaced. In fact, we had been working with the School District on a previous project to develop plans and cost estimate for the use of attaining Grants to help the district with money to replace these windows. We split them up into three. I believe this grant was submitted in early 2021.

Aluminum Single Pane: Replace all the single pane windows with new thermally broken frames and double pane low-e glazing (Each phase as shown is approximately 1/3 of this total). **(High Cost, Medium Priority)**

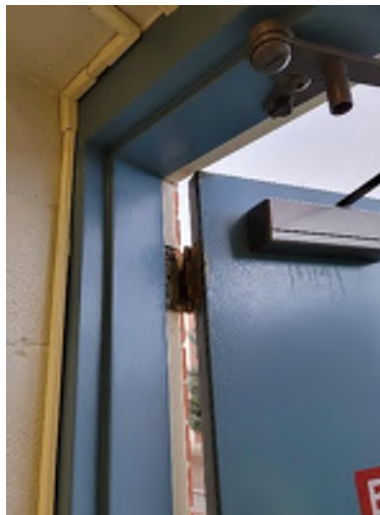
Exterior Doors: There are seven exterior man doors that are rusting out at the door bases, The hardware is also well passed the useful life and constantly needing maintenance.

Exterior Doors: Replace the seven (7) man doors with new hollow metal insulated doors. Make sure the frames are fully grouted as they are heavily used by students and staff. **(Medium Cost, High Priority)**

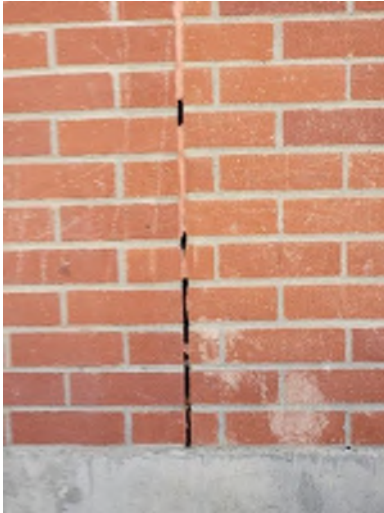
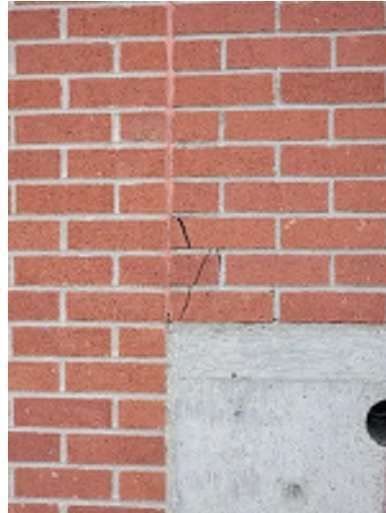
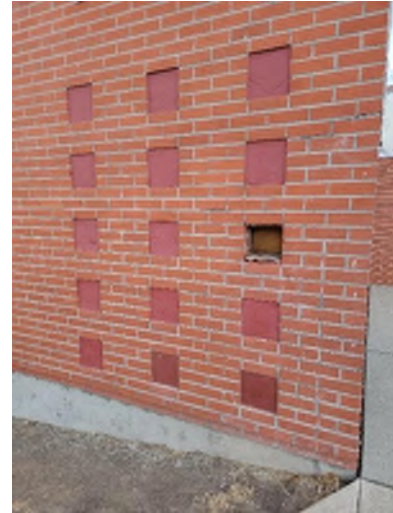
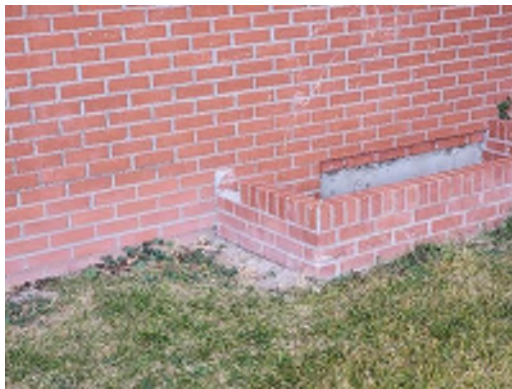
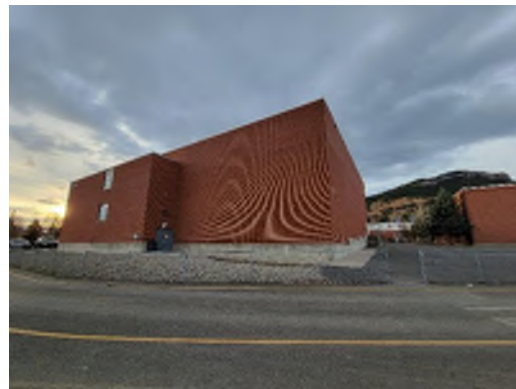
Masonry: Most of the exterior cladding on the CR Anderson School is a face brick masonry. While most of the brick is in good shape there are a few locations that need some maintenance. In addition, all the control joints need to be re-sealed.

Masonry: Fix all of the damage masonry and repoint all the control joints. **(Low Cost, High Priority)**

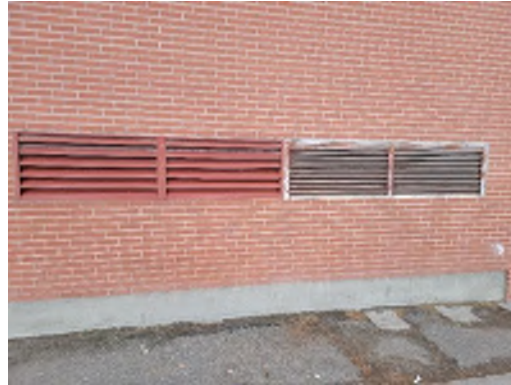
Louvers: There are a few louvers north of the library that could use being replaced. This might be an aesthetic item and does not need to be a high priority.

Louvers: Replace the damage louvers. **(Low Cost, Low Priority)**

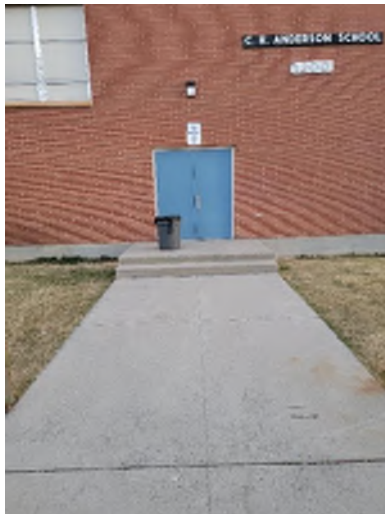
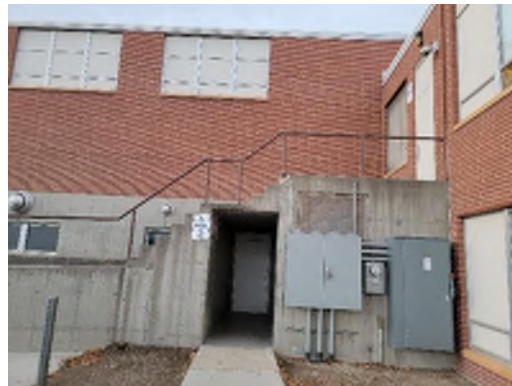
Stair Railing: There are three locations around the exterior that need hand/guard railings added or renovated. There are two stairs that have over the 6" change in elevation, but do not currently have handrails. And one stair north of the multi-purpose room that easily has an 8 foot fall hazard and does not have acceptable guard railing. This location will also require some concrete patching to bring it up to code.

Stair Railing: Add handrailing to the two steps. Add a guard railing and repair the concrete in the back at entry No. 6. **(Medium Cost, High Priority)**

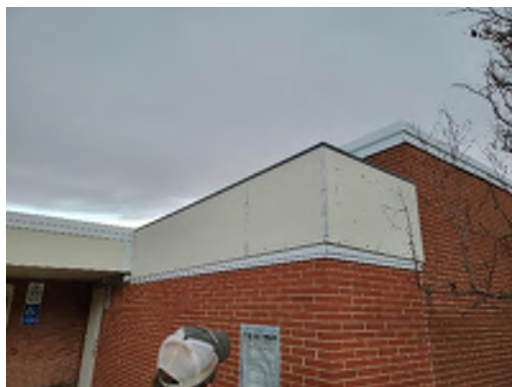
Entrance Roof/Fascia: On the southwest entrance there was a roof rebuilt over an exit stair that was not built using quality construction methods and has painted plywood as the exterior siding. This should be replaced with a better exterior cladding.

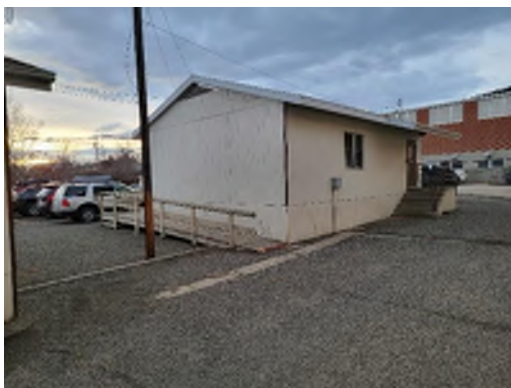
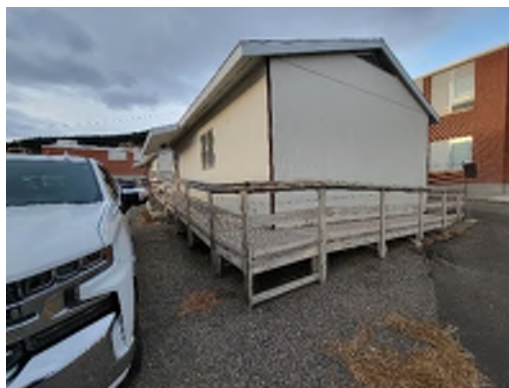
Outbuildings: There are two small modular outbuildings that set on the east side of the school. These appear to be past their useful life without some upgrades or replacement. This list includes installing new insulation, siding, windows, doors, skirting, exterior ADA ramps, and most likely mechanical would the recommended items needing to be updated.

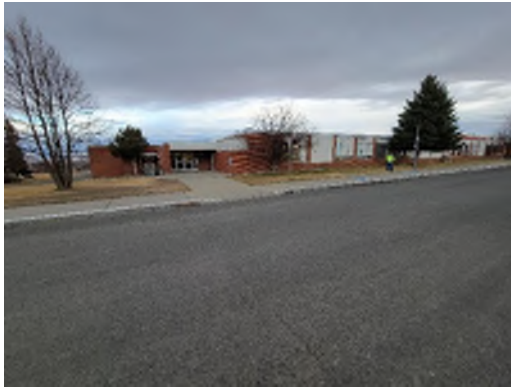
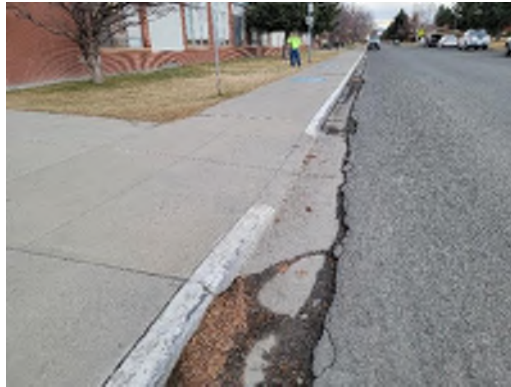
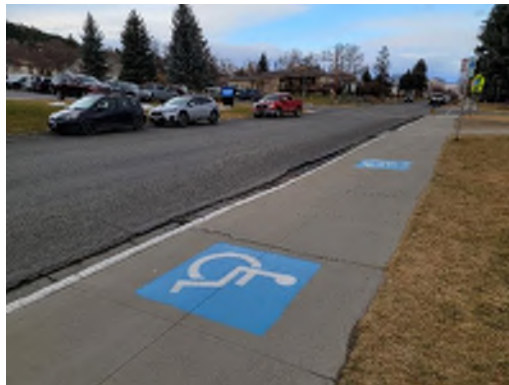
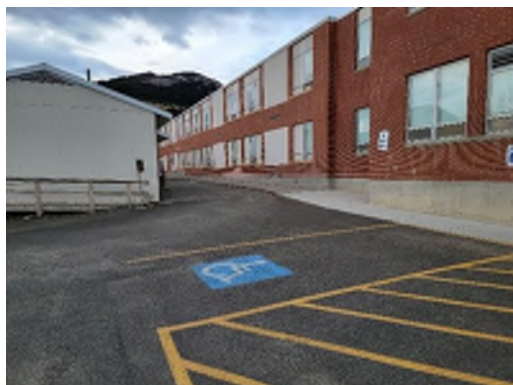
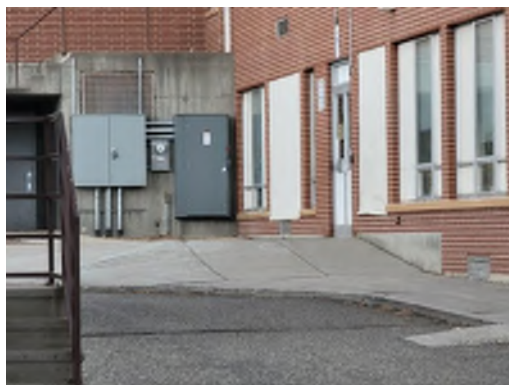
Parking and Accessible Route: The ADA parking at CR Anderson is in bad shape. There is some ADA parking on Knight Street that do not meet any code requirements. In addition, when the parking lot on Cleveland was replaced recently two ADA parking spots were installed and do me ADA. However, there is no accessible route into the building from these parking spots. There should be some modifications made to allow for better accessible parking and access.

Parking and Accessible Route: Rebuild ADA Access to the building, both on the front and from the new parking lot on the north. **(High Cost, High Priority)**

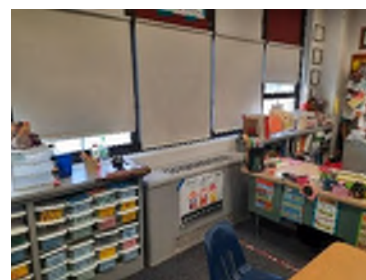
Ventilation: The building classroom spaces are served with individual classroom unit ventilators. These unit ventilators are steam. There are issues with the operation of the unit fans, steam valves and associated traps. With the different unit issues, space occupants seem to operate the units manually to maintain the individual space temperature to the occupant satisfaction.

Ventilation: Replace classroom unit ventilators with new equipment to insure proper space ventilation. The new units should be hot water. Consideration should be given to upsizing the units and piping to allow distribution of chilled water during cooling season to condition the spaces in warmer weather to improve the teaching environment.

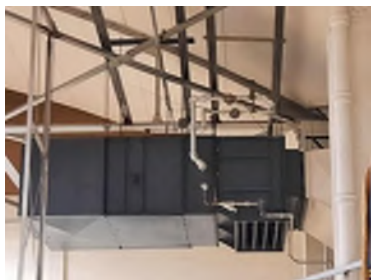
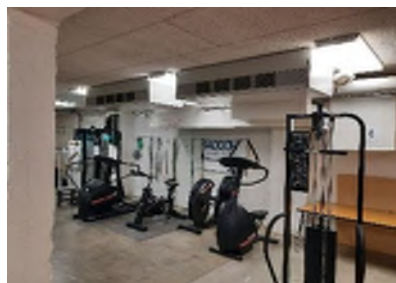
The gymnasium space is equipped with (2) air handling units suspended within the space. The units are original to the building and due to noise are operated sporadically to provide space heat.

Replace the gymnasium air handling units with new equipment.

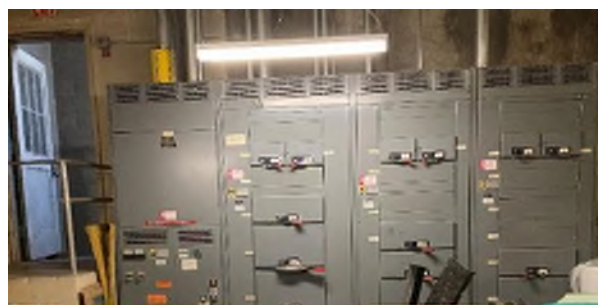
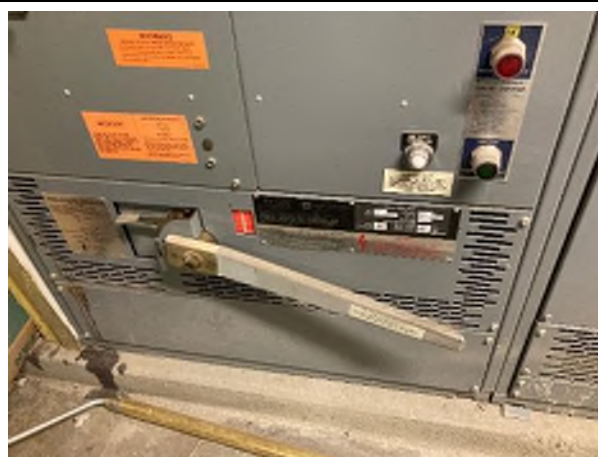
Figure 5 – MSWB Section 1 Service Disconnect (Bolted Pressure Switch)

MSWB appears to be in good condition, although the bolted pressure switch (service disconnect) is a concern. A similar style switch failed in June, 2021 at Capital High School. Without regular *certified* maintenance, these switches can be prone to failure to close after being opened resulting in an extended power outage until a work around is found. Sometimes the contacts leave a gap which can cause an arc, a short circuit and possibly fire.

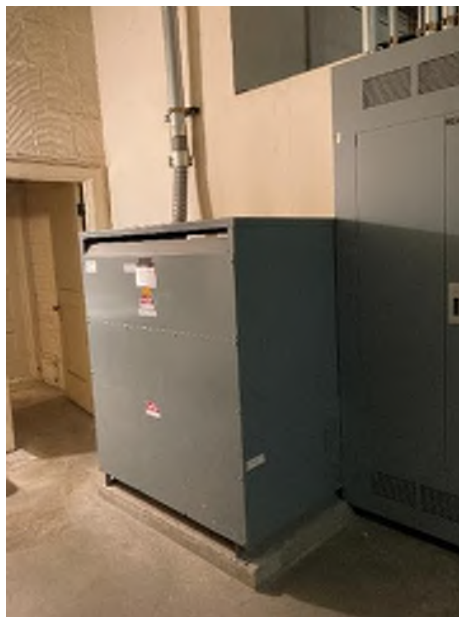
Figure 7 – Transformer A

Transformer A is located near MSWB. It is a 480-120/208 volt, 3-phase, 300 KVA dry type transformer (Figure 6). It serves adjacent Distribution Board MDBL (Figure 7). Current Codes require a transformer of this size to be installed in a one-hour fire rated room. It is not clear if the entire Mechanical Room meets the requirements.

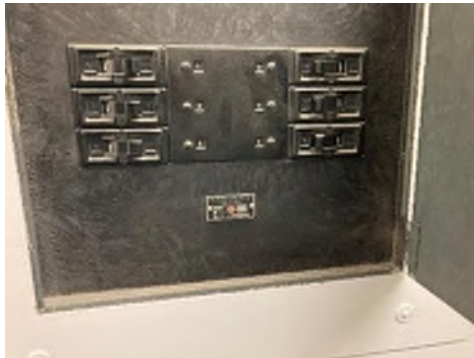
Most of the branch panelboards in the building are in good condition. But there are a few that are original vintage with obsolete breakers (Figure 22).

Figure 22 – Obsolete Panel

Electrical Distribution: The existing 120/240 volt, 3-phase open delta switchboard should be removed and replaced with a new 120/208 volt, 3-phase switchboard. This will require replacing the existing single-phase panelboards in the school with 3-phase. Most of the existing 240 volt equipment in the building should be able to operate at 208 volts, and if not, it may need to be replaced anyway, due to age, or buck-boost transformers can be provided if it cannot be replaced.
