Helena School District Deferred Maintenance Report

January 31, 2022

RE: Deferred Maintenance Review
Helena Public Schools
Final Report

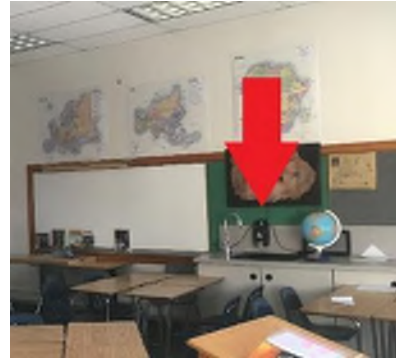
Figure 23 – Power Cord Run Over Work Counter Sink

Branch Circuiting: Classrooms are not adequately provided with sufficient quantities of convenience receptacles and circuiting to meet current needs. Many of the classrooms have four to eight receptacles but there are not enough in locations where they are needed, i.e., near the teacher's desk, PC workstations or over work counters (Figure 23).

Branch Circuiting: Any of the original wiring must be replaced with new. Additional receptacles and circuits are needed in the classrooms. There may be adequate spare capacity in some of the existing panelboards to accommodate the new circuits but replacing the existing single-phase panelboards with new three-phase will certainly provide the necessary capacity. Circuiting will be increased to a minimum of two dedicated circuits per classroom. Wiring can be run above lay-in ceilings in most rooms, then concealed inside the wall cavities or surface mounted in Wiremold or conduit.

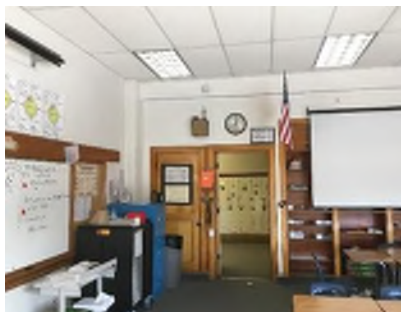
Figure 24 – Classroom Lighting

Lighting: A few new LED downlight fixtures were installed in the Entries in the recent Safety-Security Upgrades, but the rest of the lighting in the school consist mainly of four foot long fluorescent lamped, surface wraparound acrylic lens or recessed 2x4 parabolic troffers (Figures 24 & 25). The building has been equipped with occupancy sensors.

Lighting: Replacement of fluorescent fixtures with LED fixtures and controls in classrooms, corridors, gymnasium, cafeteria and other areas is recommended. The energy savings combined with improved occupancy sensors and dimming controls is substantial. There is an added benefit of increased life, which will help reduce maintenance costs. The surface wraparound fixtures will be replaced with similar style fixtures with onboard LED's. The 2x4 parabolic troffers will be replaced with new LED flat panel fixtures. The existing exit signs may be reusable, but it may be more advantageous to replace them with combination exit signs with emergency egress heads. Rebates are available from Northwestern Energy and NCAT to help offset the cost of replacement.

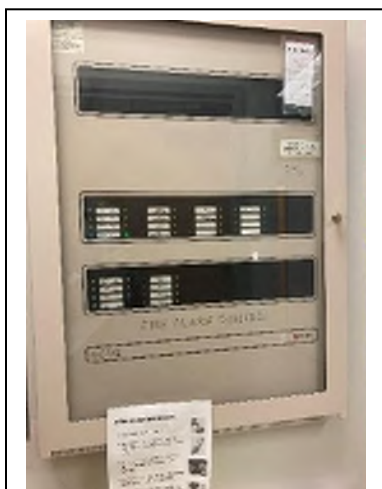
Figure 26 – Fire Alarm Control Unit

Simplex Model 4002 (Figure 26). There is a remote annunciator in the Entry area. There are manual pull stations at exit pathways, horns in the corridors, common areas, the Gyms, Cafeteria and Classrooms. There are a few smoke detectors in the corridors for release of magnetic door holders, certain air handlers and storage rooms.

The fire alarm system appears to be barely functional. The staff reports that fire alarms cannot be heard at the far ends of the building. Replacement with a new addressable voice evacuation system with speakers and strobes throughout should be given high priority.

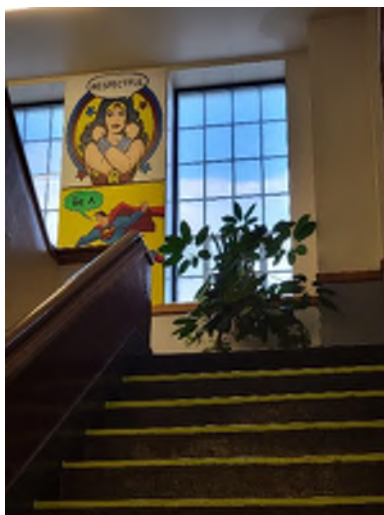
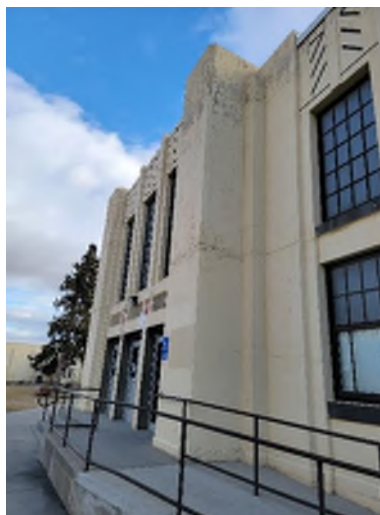
Old Single Pane Windows: There are only a handful of older single pane windows at Helena Middle School (HMS). These windows are all in circulation areas or in the gymnasium. It would be recommended to update these windows.

Old Single Pane Windows: Replace the single pane windows with thermally broken aluminum framed double pane low-e glazed windows. **(High Cost, Medium Priority)**

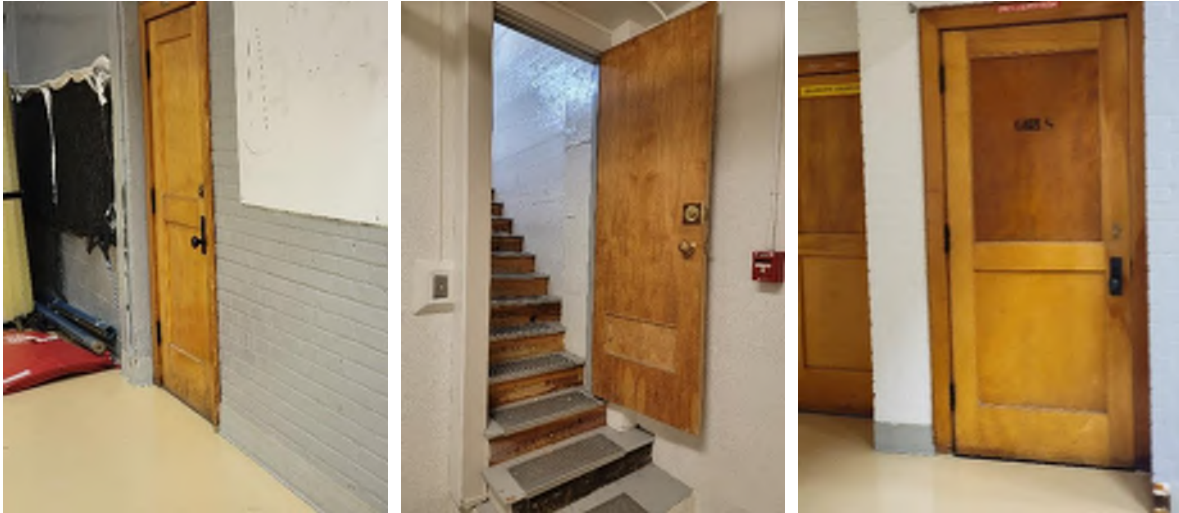
Old Interior Doors: While most of the doors are original to the school and really great, they also all have knobs instead of lever handles. This is a life safety and even accessible item that should be addressed. It would be recommended to have updated lever handle installed.

Old Interior Doors: Add new interior door lever set to the older interior doors. **(High Cost, Medium Priority)**

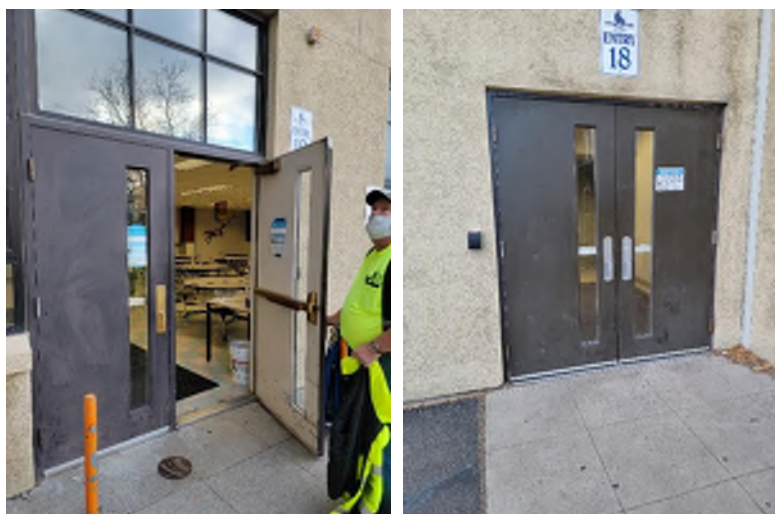
Exterior doors: While some of the exterior doors have been upgraded overtime there are still 24 exterior doors that are in constant need of maintenance and should be replaced. This includes two overhead sectional doors in the basement.

Exterior doors: Replace the 24 older exterior doors with either aluminum insulated doors or hollow metal insulated doors. **(High Cost, Medium Priority)**

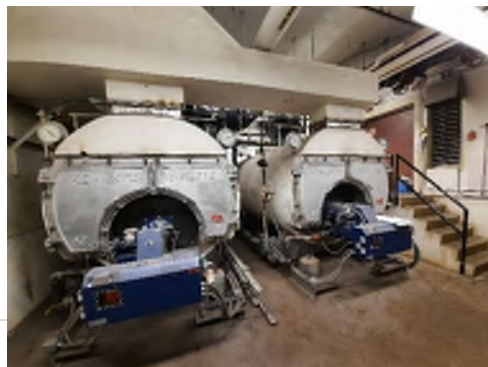
Heating System: The building heating system is hot water, utilizing (2) Kewanee Model KGP 85 FG w/Power Flame Burners Model C5-G-30. Boilers rated for 8,370 MBH. These boilers are original to the building. These units are estimated to have an operational efficiency of 50-55%. The boiler plant has had sufficient capacity to expand with the building. The boilers originally generated domestic hot water for the building via a ceiling mounted storage tank with integral hot water coil. This tank and coil have been abandoned in place.

Heating: Replace the boiler equipment with a modular high efficiency boiler system. The boiler room upgrade should include updated distribution pumps, air management devices (air vents and system air separator) and remove the abandoned equipment to create maintenance or additional building storage space.

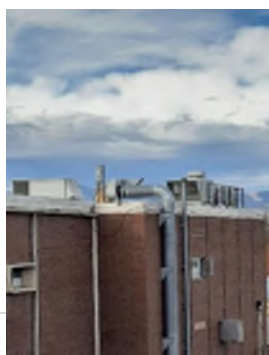
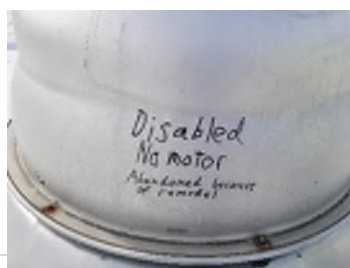
The building exhaust system is a combination of in-line utility set fans in building equipment rooms, roof mounted mushroom fans, and roof mounted utility set units. The fans were reported to have severe operational issues. Several units have been abandoned in place.

Replace all roof mounted fans.

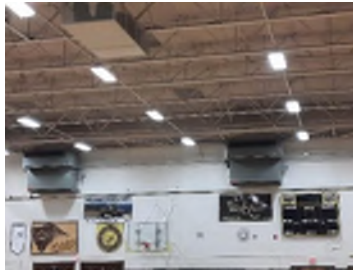
The gymnasium space is equipped with (4) air handling units suspended within the space. The units are original to the building and due to noise are operated sporadically to provide space heat.

Replace the gymnasium air handling units with new equipment.

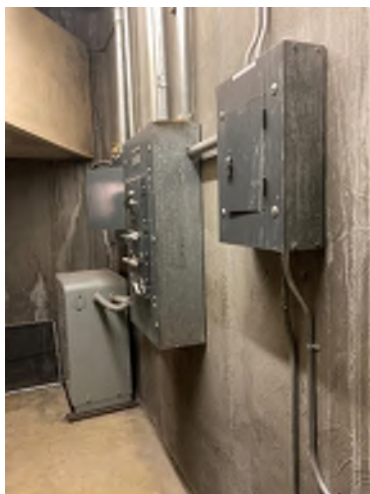
Figure 6 – Panels BHA, Sub-Distribution, BLA and Dry Type Transformer

There are several small distribution panels and dry type transformers that are still in service from the original 1964 construction (Figures 6, 7 and 8). Most are obsolete but are still serviceable with parts obtained from re-sellers.

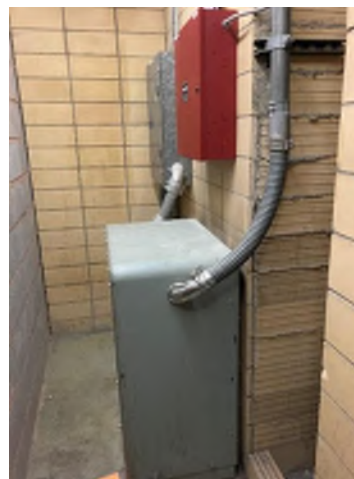
Unfortunately, much of the original equipment is located in small rooms, i.e. Janitor Closets, that have very restricted clearances that are not safe or in compliance with the NEC. The transformer installation in Figure 7 is a typical situation.

Figure 7 – Panel CHA and Type Transformer in Closet. Working Clearances are Non-Compliant

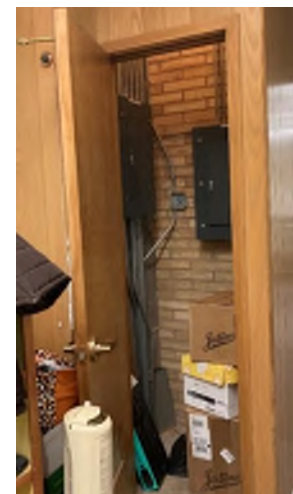
Figure 8 – Panels BHB and BLB in Closet. Working Clearances are Non-Compliant

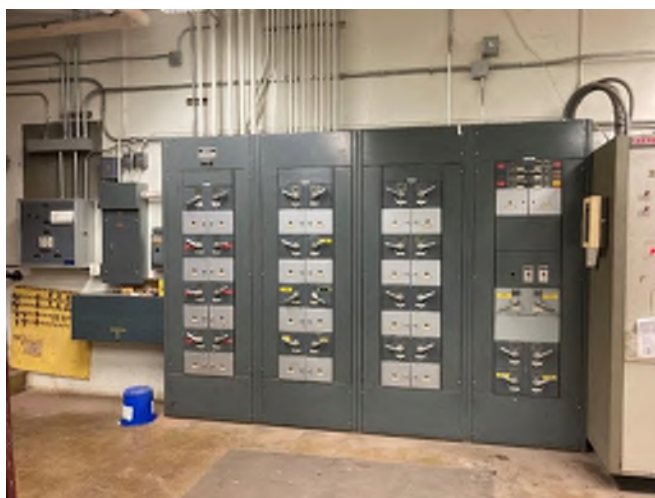
Figure 9 – Boiler Room Motor Control Center

There is a 4-section motor control center located in the Boiler Room (Figure 9). It contains 24 combination switch and motor starters for building exhaust fans. It is part of the original building electrical equipment. The control center is obsolete, but again is serviceable with parts obtained from re-sellers.

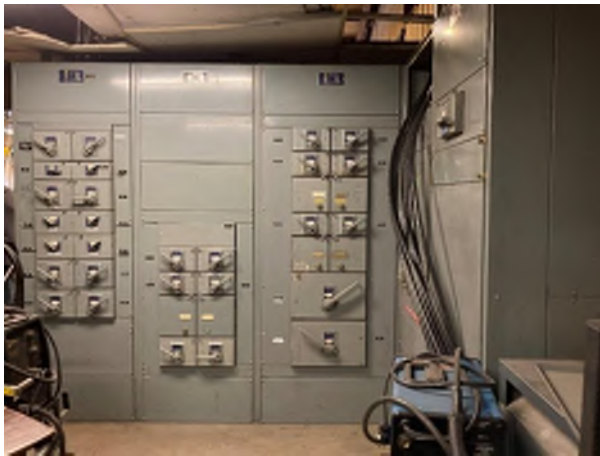
Figure 12 – Vo-Tech Main Switchboard. New Service Conductors Awaiting Final Connection

Distribution - Vo-Tech: The Main Switchboard in the Vo-Tech Building is 5-sections (Figure 12). Sections 1 through 4 are 277/480 volt, 3-phase, Section 5 is 120/208 volt, 3-phase. As previously mentioned, the bolted pressure, main disconnect switch failed and had to be bypassed. The fusible switches in the board are obsolete, but there are OEM switches that can be adapted for use if needed.

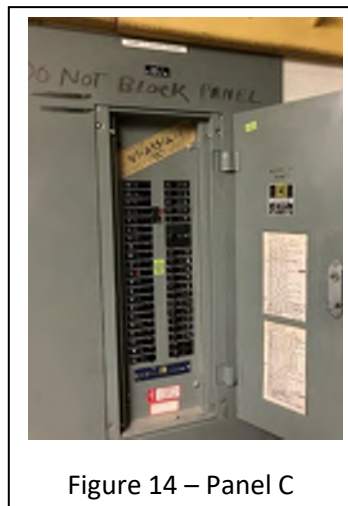
Figure 14 – Panel C

Most of the branch panelboards in the Vo-Tech Building are at capacity, with few spaces or spare breakers (Figure 14). One panelboard (M) was added in the 2000's for receptacles in the welding booths.

Electrical Distribution – Vo-Tech: The existing 277/480 volt, 3-phase 800-amp rated switchboard should be adequate for continued service. There are only a few spare switches in the distribution sections of the board, but unless there are major additions to the shops, additional devices should not be necessary. However, it is recommended that the four original branch panelboards be replaced with larger capacity panelboards, i.e. 66 circuits. This will allow for any future equipment needs.

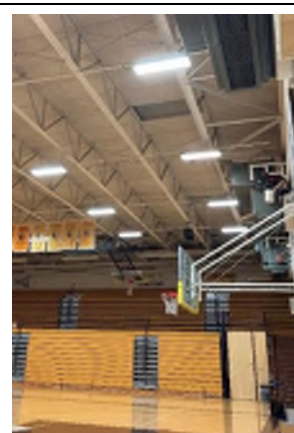
Figure 17 – Gymnasium Lighting

The Gymnasium lighting consists of suspended 4-foot T-5 fluorescent fixtures with wire guards (Figure 17). Most of the exit signs in the building are steel housings with stencil faces that have been converted to LED. Emergency egress lighting units are located on corridor and egress pathway walls throughout the facility.

Lighting: Replacement of fluorescent fixtures with LED fixtures and controls in classrooms, corridors, gymnasiums, cafeteria, Vo-Tech and other areas is recommended. The energy savings combined with improved occupancy sensors and dimming controls is substantial. There is an added benefit of increased life, which will help reduce maintenance costs. The surface wraparound fixtures will be replaced with similar style fixtures with onboard LED's. The 2x4 fluorescent troffers could be replaced with new LED flat panel or direct/indirect fixtures. The existing exit signs may be reusable, but it may be more advantageous to replace them with combination exit signs with emergency egress heads. Rebates are available from Northwestern Energy and NCAT to help offset the cost of replacement.

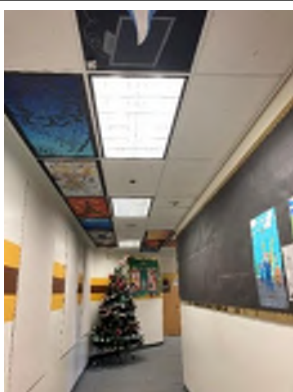
Figure 15 – 2x4
Troffers in Post 1980
Areas

Lighting: Most of the lighting in the post 1980 portions of the main building consists of two and four-lamp, T8, 2x4 fluorescent troffers (Figure 15). In the original school and the early additions, much of the lighting is a surface wraparound type with acrylic lenses (Figure 13) or recessed 1x4 troffers. The building has been equipped with occupancy sensors. The Administration Area was recently remodeled and upgraded LED troffers with dimming.

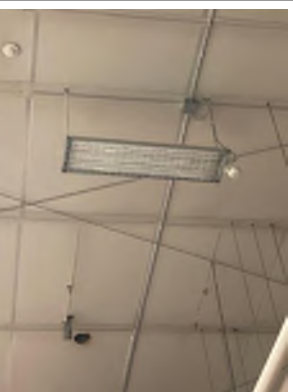
Figure 18 – Vo-Tech
Shop Lighting

The lighting in the Vo-Tech shop areas consists of four-foot-long, suspended T5 HO industrial fluorescent with wire guards and integral motion sensors (Figure 18)

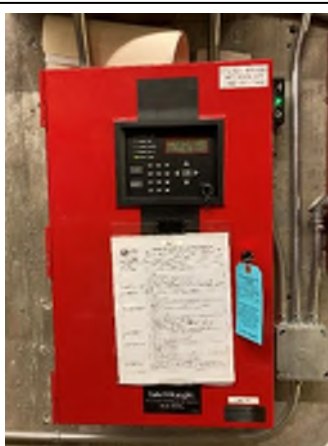
Figure 19 – Fire Alarm Control Unit in Main Building

The Fire Alarm System in the main building is a Silent Knight Model 5820XL (Figure 19). The Control Unit(s) is located in the Electrical Room. It is fairly new; probably not more than 10 years in service. There are several smoke detectors in the building, mostly in the corridors and for release of magnetic door holders (Figure 21), elevator return and equipment protection. Several HVAC fans have integral mounted duct type smoke detectors and are wired for shutdown. There are manual pull stations at exit pathways, horn/strobes in virtually every occupied room.

The International Fire Code requires a manual detection system with voice evacuation for this type of facility. It may be possible to add voice evacuation, but usually it is not cost effective. Upgrading to a new fire alarm system with voice evacuation, speakers and strobes in both buildings is recommended. The Vo-Tech building may require additional speaker/strobes because of the higher ambient noise levels.

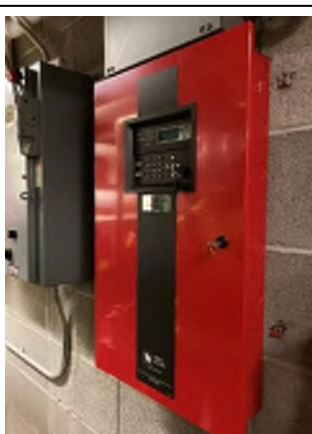
Figure 20 – Fire Alarm Control Unit in Vo-Tech Building

The Fire Alarm System in the Vo-Tech building is a Silent Knight Model SK-5208 (Figure 20). It is also a newer Control Unit. There are several heat detectors placed in the shops (Figure 18 left of the lighting fixture) and lower ceiling areas, manual pull stations at each exit and horn/strobes in all occupied rooms.

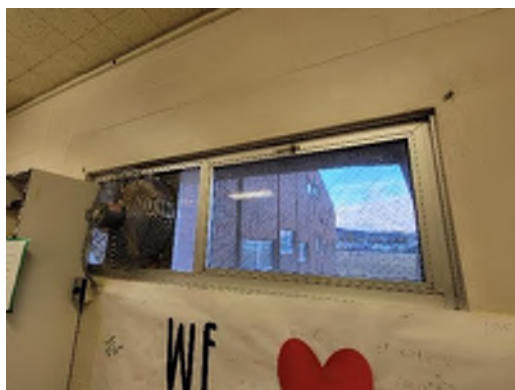
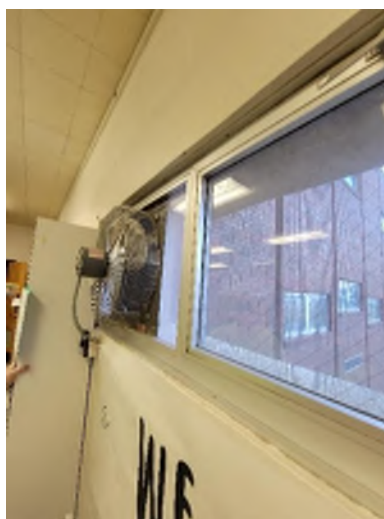
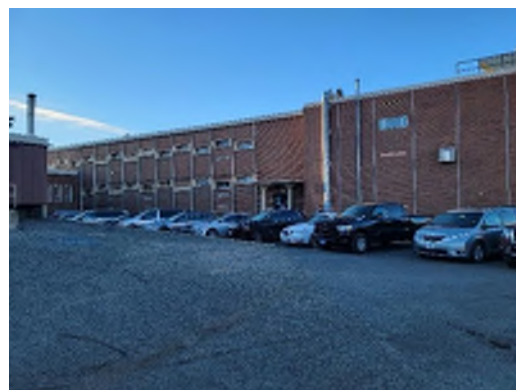
Aluminum Single Pane: The main building was constructed with non-thermally broken aluminum frame windows with single pane glazing. These windows should be replaced with a better window system.

Aluminum Single Pane: All the single pane non-thermally broken aluminum windows should be replaced with thermally broken frames and double pane low-e glazing. **(High Cost, Medium Priority)**

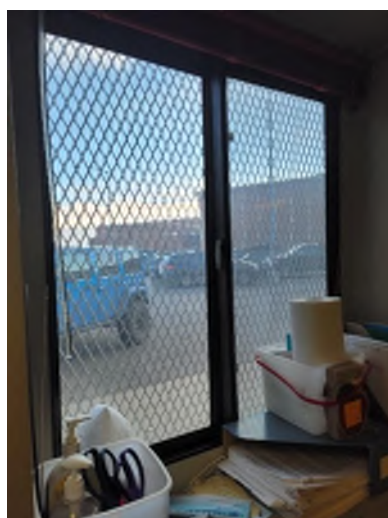
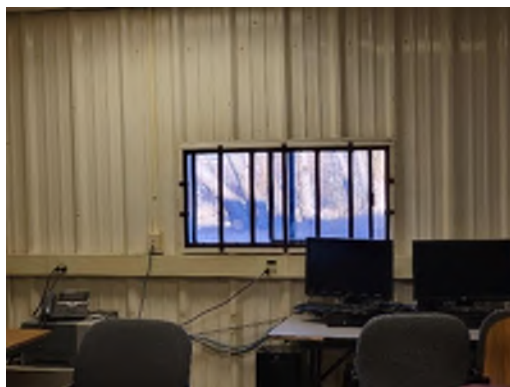
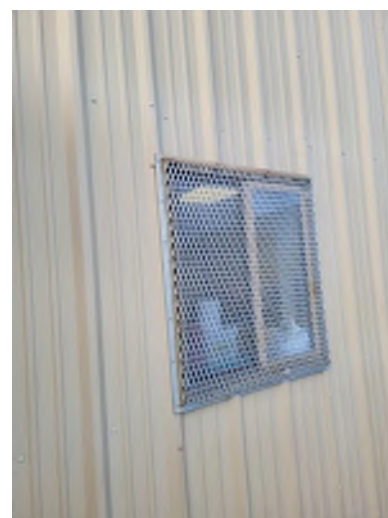
Shop Windows: The shop windows appear to be double paned but with the protective caging in front are hard to fully inspect. These windows should be replaced but are not a high priority.

Shop Windows: Replace all shop windows with thermally broken frames and double pane low-e glazing. **(Low Cost, Low Priority)**

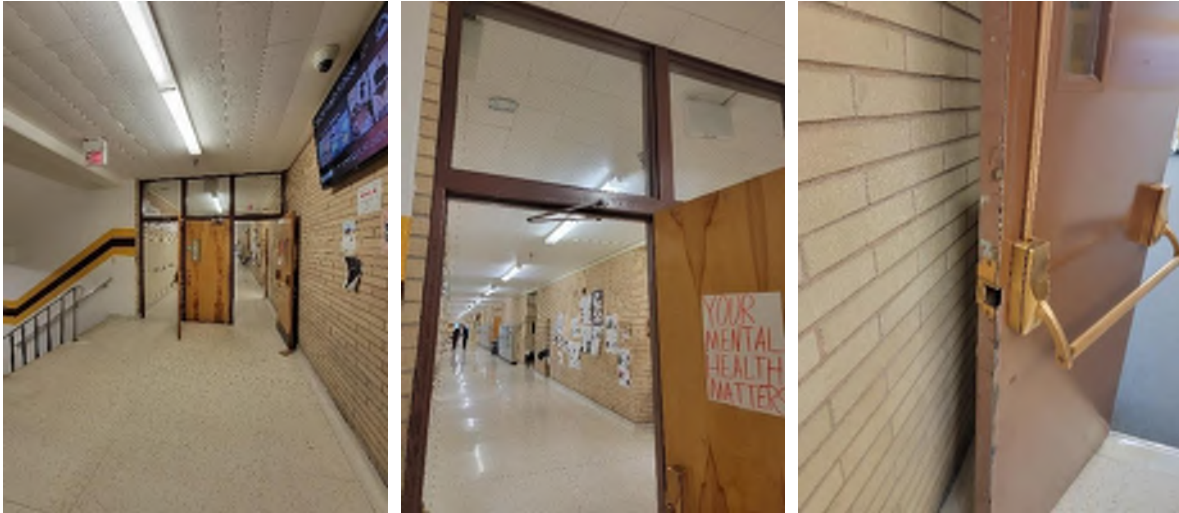
Interior Doors: Most of the interior doors are in good shape. However, on the north classroom stair tower there are fire doors on each of the three levels that have been beaten up, the hardware has broken or been removed. All five of the doors at each landing needs to be

replaced but the triple door set is also interfering by swinging into the exit path of the stair. These doors need to be rebuilt and set further back to create a door niche.

Interior Doors: Replace all the doors at the stair landing and install with mag holds. The triple doors need to be rebuilt further back to verify they don't encroach on the stair exit width. **(Medium Cost, High Priority)**

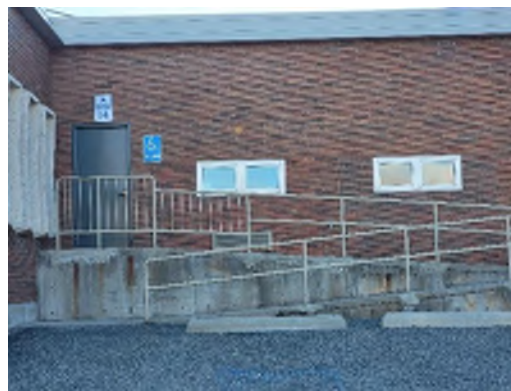
Exterior Doors: There are a few exterior doors that are heavily used and take a beating from the students. These doors are always getting maintained and should be looked having a Level 4 Maximum Duty doors and frames installed.

Exterior Doors: Replace all exterior main entrance doors with a maximum duty Level-4 door system. **(Medium Cost, High Priority)**

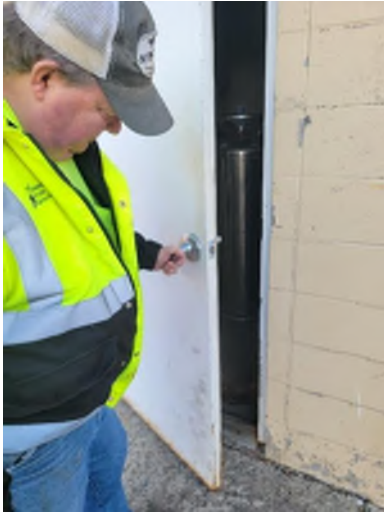
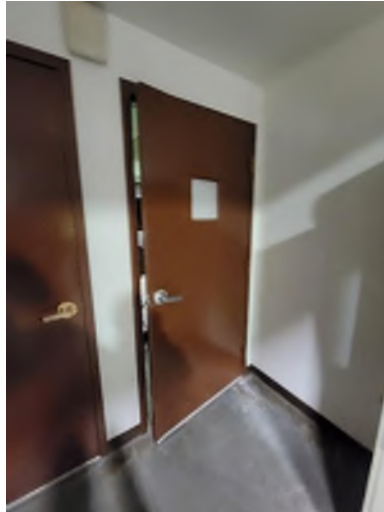
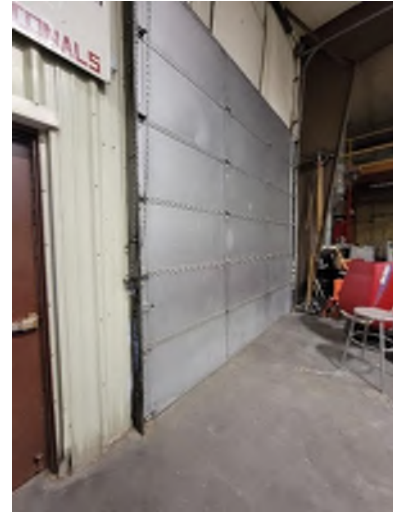
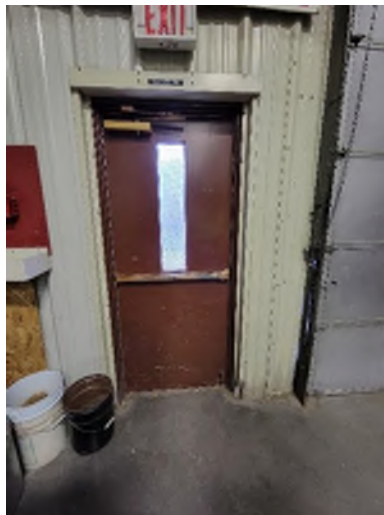
Shop Doors: All of the shop doors are well beyond their useful life this includes all the overhead doors, exterior man doors, and interior doors.

Shop Doors: Replace all shop doors including hollow metal insulated level 4 exterior doors, Insulated sectional overhead doors and hollow metal level 4 interior doors. **(High Cost, High Priority)**

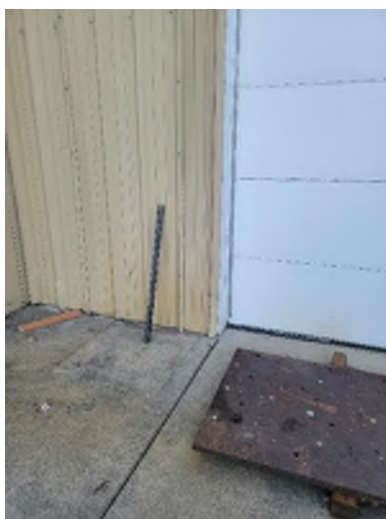
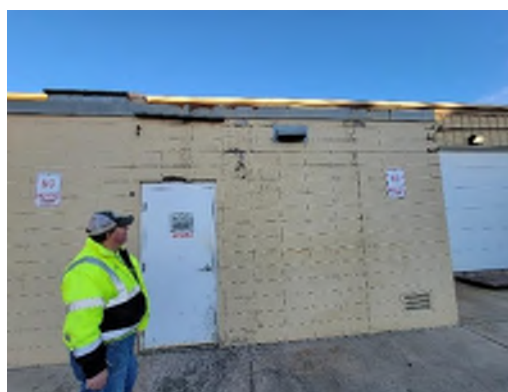
Shop Building: The shop building is a metal building system. There has been a lot of damage to the metal panels around the overhead doors. This should be renovated in the future.

Shop Building: Replace the damaged metal wall panels at the shop and repaint all exterior cladding including CMU. **(Medium Cost, Low Priority)**

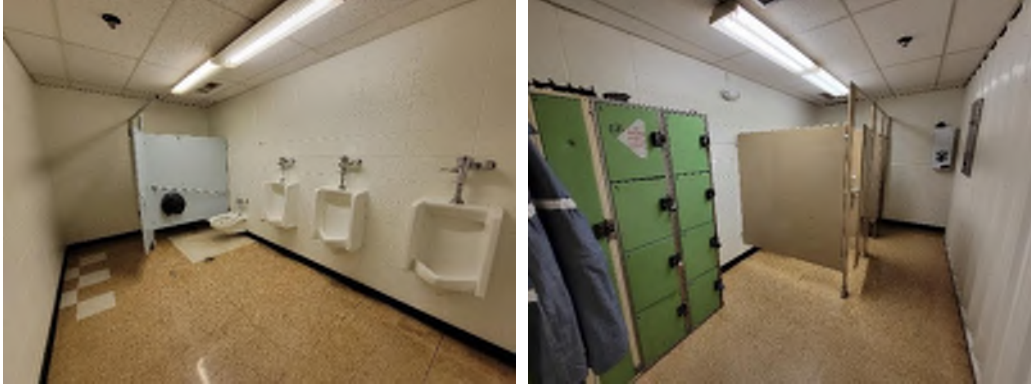
Shop Building: There is currently no ADA restrooms located in the shop building. At some point accessible facilities in this building should be added.

Shop Building: Make a men's and women's restroom facility accessible in the shop building.
(Medium Cost, Medium Priority)

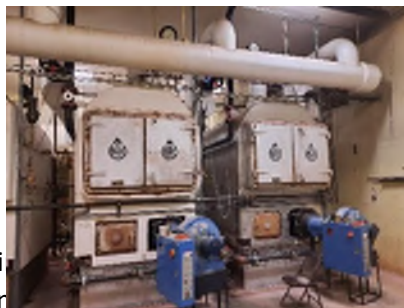
Heating System: The building heating system is (1) of (2) steam systems in the district. The boiler plant consists of (3) National Steel Boiler Model AC-6615 w/IC Power Burners. Boilers rated for 6,250 lbs./hr. At time of the inspection, (2) of the (3) boilers were operational. These units are estimated to have an operational efficiency of 45-55%. The boiler plant has had sufficient capacity to expand with the building. The boilers originally generated domestic hot water for the building via a ceiling mounted storage tank with integral hot water coil. This tank and coil have been abandoned in place. The boiler room combustion air system does not meet current code.

Heating: Convert the building heating system from steam to hot water. Remove all associated steam piping within the building and replace with a new hydronic distribution system. The boilers should be replaced with a modular high efficiency boiler plant utilizing high efficiency condensing boilers that meet the districts standards. The boiler room upgrade should include updated distribution pumps, air management devices (air vents and system air separator) and remove the abandoned equipment to create maintenance or additional building storage space.

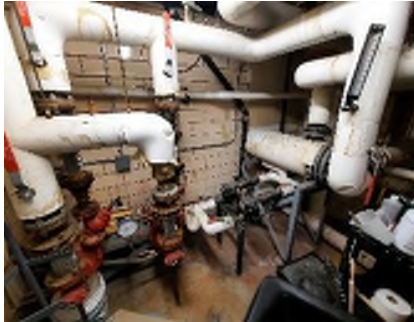
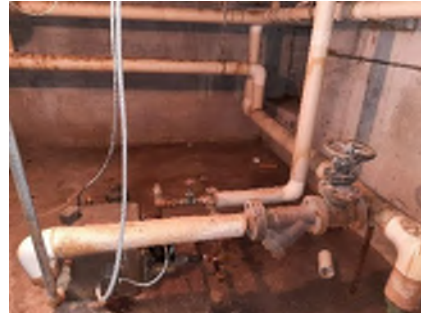
Some of the piping is starting to fail, primarily the

condensate piping but also sections of the steam. Steam traps in the system are being replaced on an as-needed basis however, at several condensate receivers, steam was venting from the unit vents indicating non-operational traps.

Seven different condensate receivers return water back to the boiler feed system located in the boiler room. The receivers are older and with only one noted exception, original to the building. Several associated pumps have been replaced. Replacement pumps are becoming hard to obtain due to age.

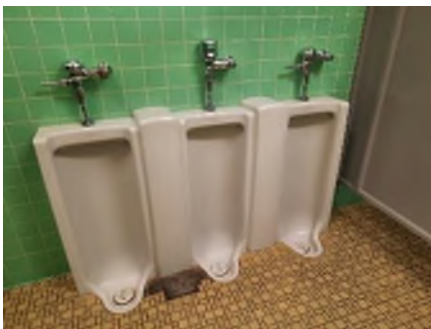
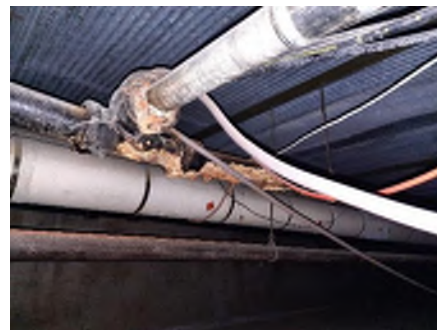
Building plumbing fixtures are older with various chips and stains but are still operational. HPS staff has replaced some fixtures as needed in the building.

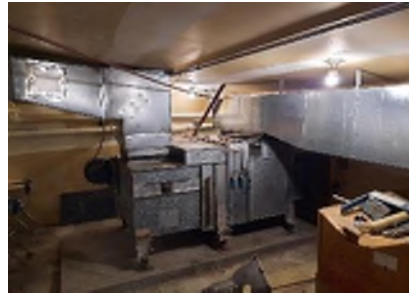
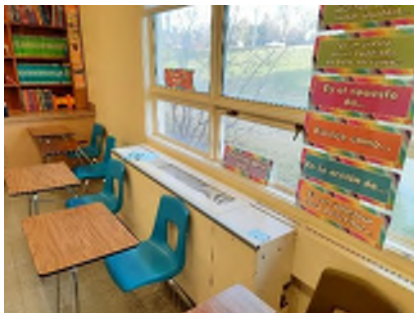
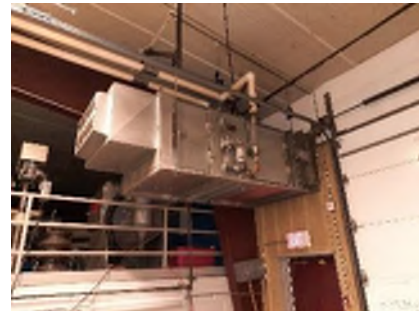
Ventilation: The building ventilation system in the original building is (2) air handling units each connected to two shop spaces. The air handlers are Tjerlund gas fired units that have been converted to hot water when the gas heating sections failed.

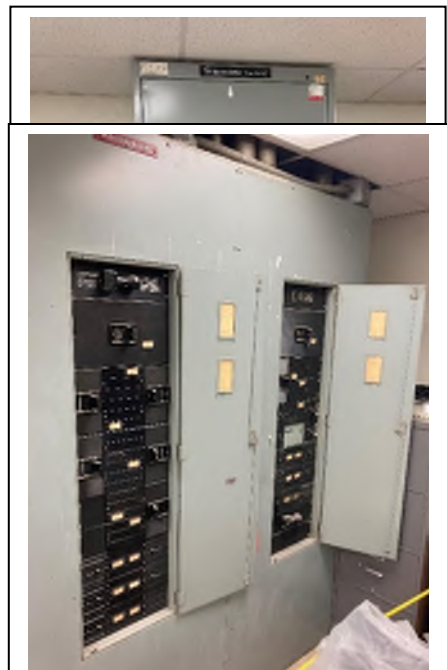
Figure 5 – Old Main Switch Board (OMSB)

Beginning with the Old Main Switchboard (Figure 6), much of the original 1950's vintage electrical distribution equipment in the school is still in use and much of it is

obsolete. Breakers from this era are not always reliable and on occasion fail to trip or are impossible to reset if they are tripped. It may be possible to obtain replacement parts from specialty manufacturers that rebuild components, but comes without a UL Label, can be expensive and possibly unreliable.

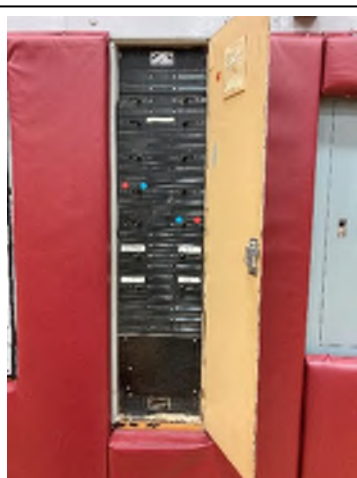
Figure 7 – Gymnasium
Distribution Board

The sub-distribution boards in the original building areas are of the same vintage as OMSB. They are Distribution Board #1 (Figure 11), #3 (Figure 8), and the Gymnasium (Figure 7). One of the distribution boards, #3, has had recent issues where replacement parts were difficult to obtain. Continued use of this equipment could result in the need for an emergency replacement the next time there is a problem with a breaker.

Main Building Electrical Distribution: The original 1200 amp, 120/208 volt, 3-phase switchboard should be removed and replaced with a new switchboard. This would also include replacement of all sub-distribution boards and branch panelboards in the original school areas. The new panelboards will be sized with at least 25% spare capacity and will accommodate the extra circuits required for additional classroom receptacles.

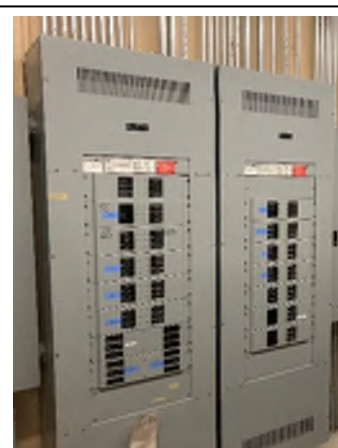
Figure 9 – Distribution
Board SL

Distribution Board SL (Figure 8) is located in the Science Wing Addition. It is 2-sections and contains (24) 100-amp frame breakers, (2) 100-amp spaces, (3) 225-amp frame breakers and (1) 225 amp space. The (3) 225-amp breakers feed panelboards for the Science Wing. The remaining breakers feed mostly mechanical equipment loads. The distribution board is in good condition, but I.D. labeling is very poor, and many loads are not identified at all.

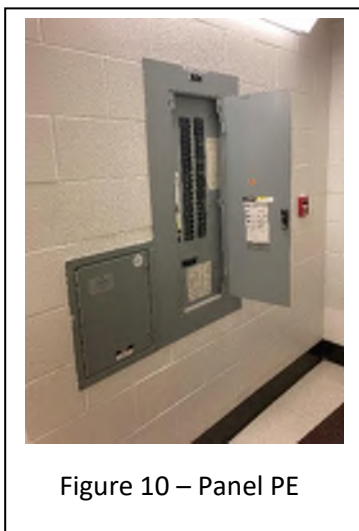
Figure 10 – Panel PE

Panel PE (Figure 10) is a newer 125-amp branch panelboard that was installed in the 1997 PE addition. There is a transient voltage surge suppressor adjacent. It is a 42-circuit panelboard that serves mostly convenience receptacles, small mechanical, equipment loads and lights. There are only a few spare breakers. There are smaller distribution boards in the original building area, such as Panel BP in the Boiler Room (Figure 12), that are at the end of their useful

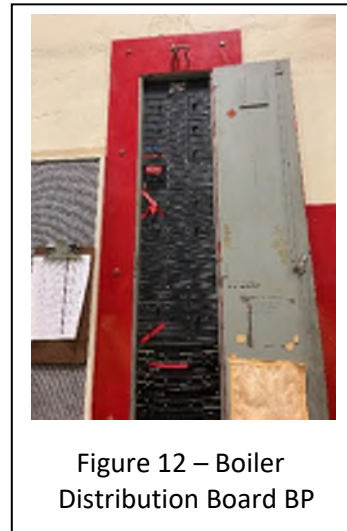
Figure 12 – Boiler Distribution Board BP

life, with the same issues addressed earlier; and an estimated (9) original branch panelboards in similar condition. None of this equipment should be relied upon for much longer, as it will be more difficult to maintain and to protect equipment safely.

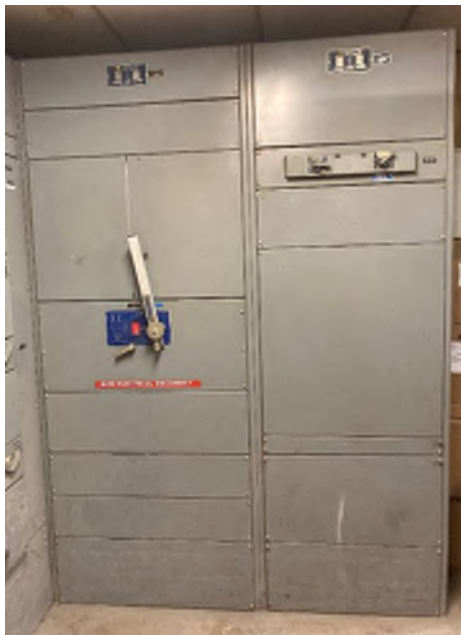
Figure 13 – Vo-Tech
Switchboard Sections 1 & 2

The Main Switchboard is located in the northwest corner of the building. (Figure 13). It consists of 4-sections and is rated at 1200 amps, 120/208 volts, 3-phase. Section 1 contains the incoming lugs and metering equipment. Section 2 houses the main disconnect switch, which is a Bolted pressure style. These types of switches used to be common and have gradually been replaced with electronic trip style circuit breakers. Bolted pressure switches contain a threaded shaft that rotates after the switch blades close. A 3-phase switch has six clamped hinged joints at the contact points. The switches remain closed during most of their existence. A factory applied lubricant in the mechanism becomes glue-like over time causing an incomplete movement of the switch blades and then arcing. Regular maintenance and exercise can help extend the life of the switch and ensure that it will operate properly. Bolted pressure switch manufacturers recommend that a maintenance program be established with an accredited service provider. Unfortunately, there are very few service providers in the area.

Vo-Tech Building Electrical Service: Strong consideration should be given to replacing at least Sections 1 and 2 of the main switchboard, and Sections 3 and 4 if the bus bars are not compatible with replacement switches. The bolted pressure switch is a liability due to its age and uncertain condition. It would be best to install a new 1000 amp main, metering enclosure

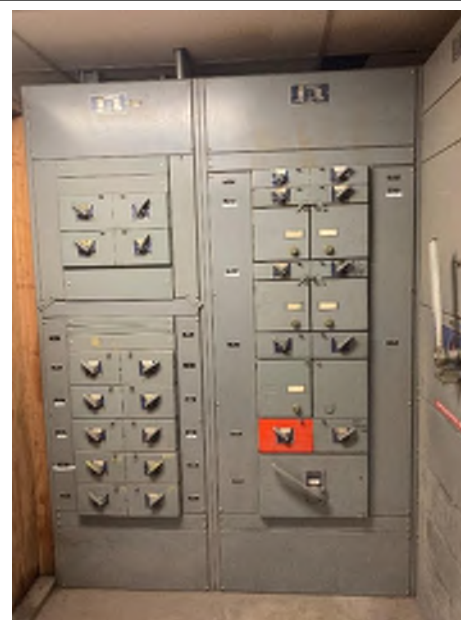
Figure 14 – Vo-Tech
Switchboard Sections 3 & 4

Section 3 (Figure 14) contains several Square D QMB Saflex fusible switches. They are obsolete, but replacement switches may be available, depending on the type of bus bars in the switchboard. There are three twin 30-amp switches for exhaust fans and mechanical equipment and motor starters, one twin combination 60-amp switch and motor starters for a dust collector and unit heater, one twin combination 100-amp switch and motor starters for air compressors and a 400 amp switch for bus duct service to welders. Section 4 (also Figure 14), contains 14, 100 amp fusible disconnect switches for branch panelboards and plug-in bus ducts. There are two spare disconnects and two available spaces.

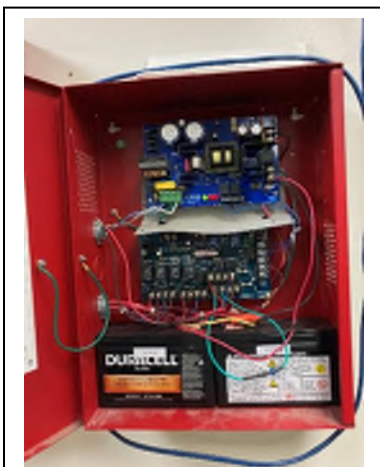
Figure 14 – Fire Alarm Control Unit

The Fire Alarm System in the main building is a Bosch FPD-7024. The Control Unit(s) is located in the Electrical Room. It is fairly new; probably not more than 10 to 12 years in service. There are some smoke in the building for release of magnetic door holders, some in the elevator lobby and shaft. Several HVAC fans have integral mounted duct type smoke detectors (in the Science Wing) and are wired for shutdown. There are manual pull stations at exit pathways, horn/strobes in virtually every occupied room.

The International Fire Code requires a manual detection system with voice evacuation for this type of facility. It may be possible to add voice evacuation, but usually it is not cost effective. Upgrading to a new fire alarm system with voice evacuation, speakers and strobes is recommended.

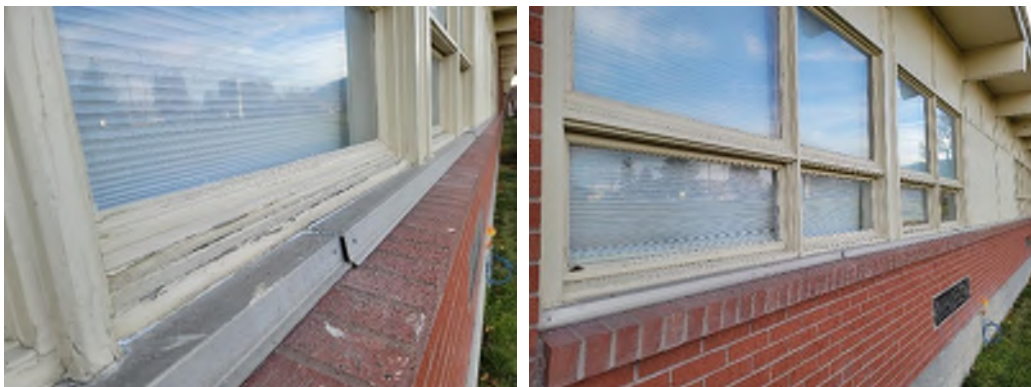
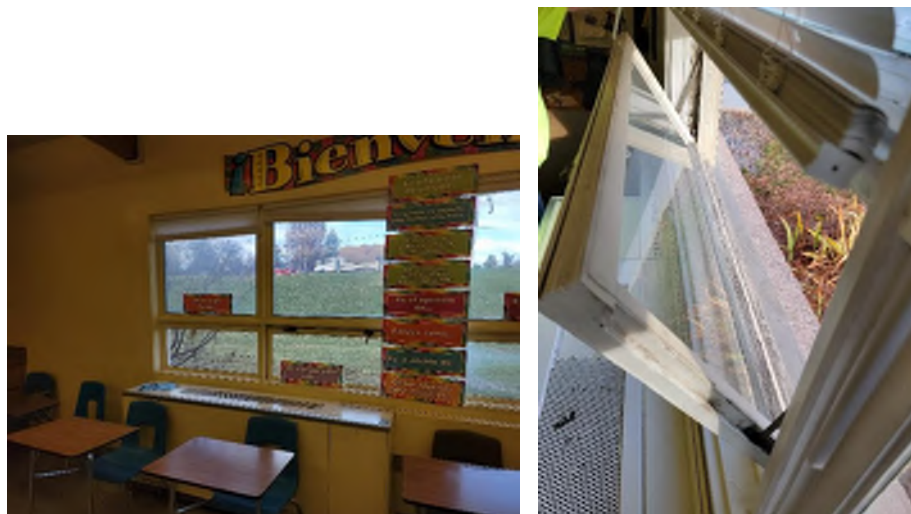
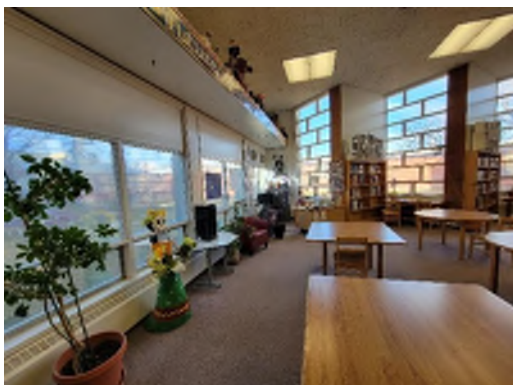
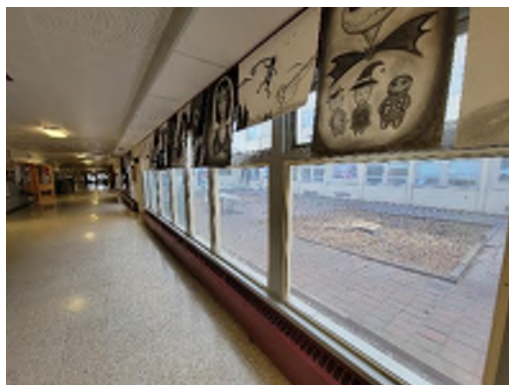
Exterior Wood Frames Windows: The vast majority of the windows in HHS are old wood Framed windows with single pane glazing. These windows are all well past their useable life and need replacement.

Exterior Wood Frames Windows: These windows should all be replaced with thermally broken aluminum windows with double paned low-e glazing. **(High Cost, High Priority)**

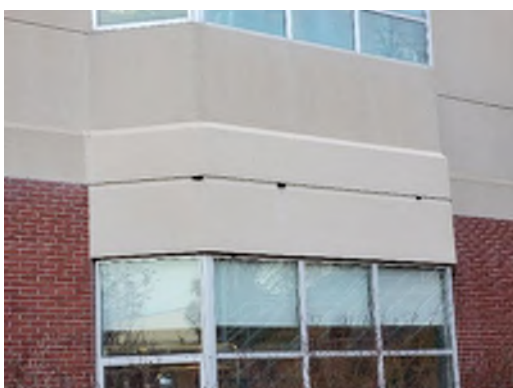
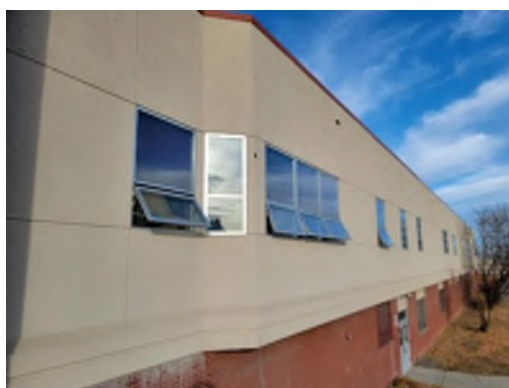
Exterior Aluminum Windows: The new science wing does have aluminum framed double paned windows. The section of these that are operable are allowing water to enter the building during a rain.

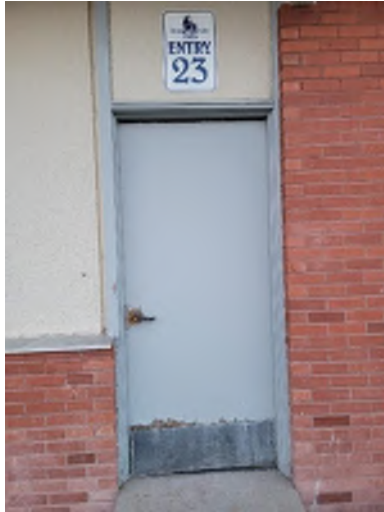
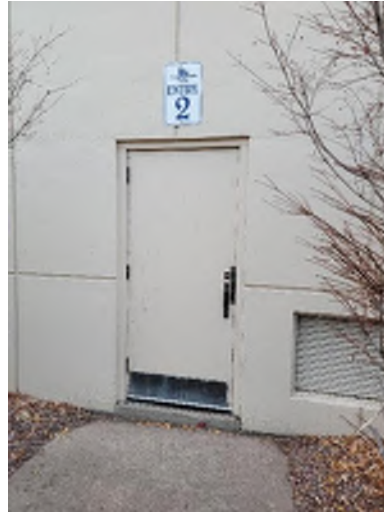
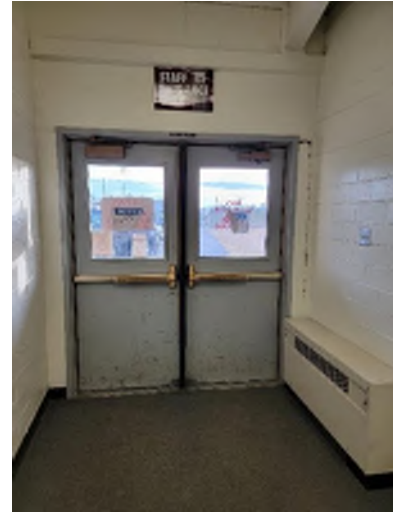
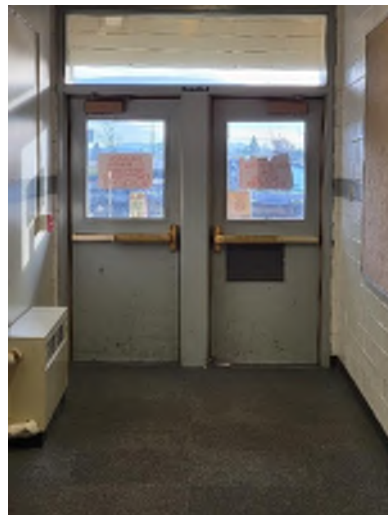
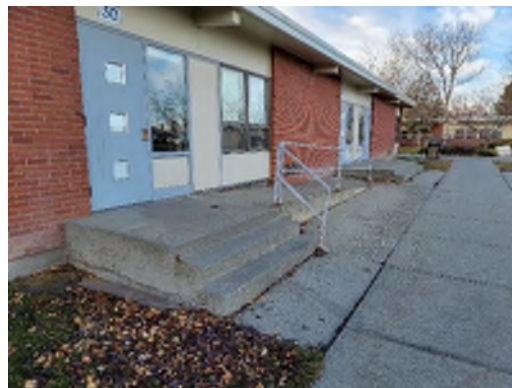
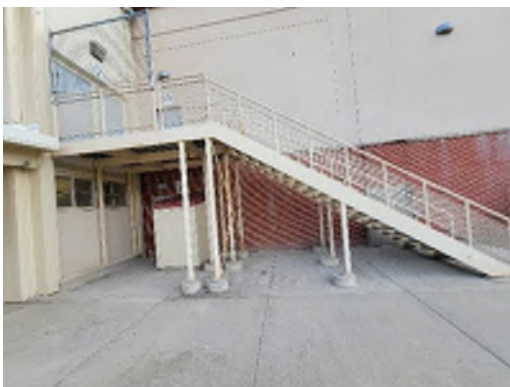
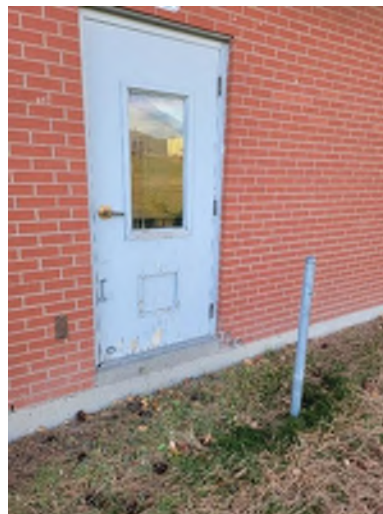
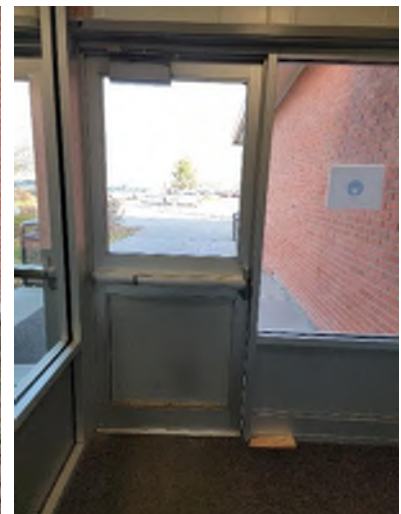
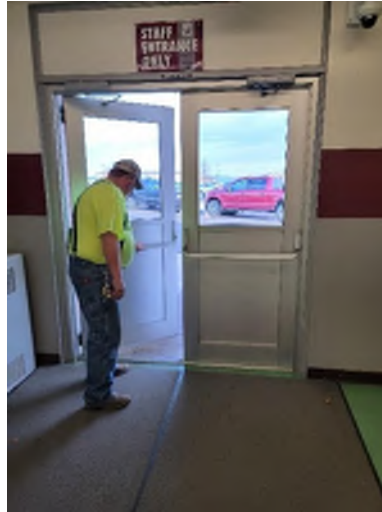
Main Building Exterior Doors: All but a few of the exterior door that were recently replaced during the safety and security project are beyond their useful life and are requiring a lot of maintenance to keep them operational. It is recommended that all these doors should be replaced.

Main Building Exterior Doors: The old exterior doors should be replaced with thermally broken Aluminum Framed System. **(High Cost, Medium Priority)**

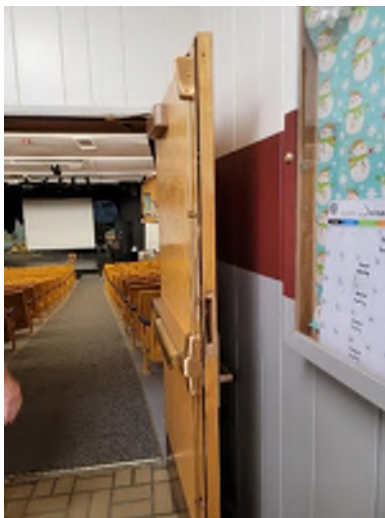
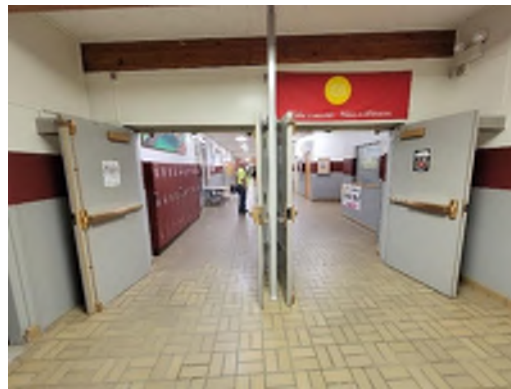
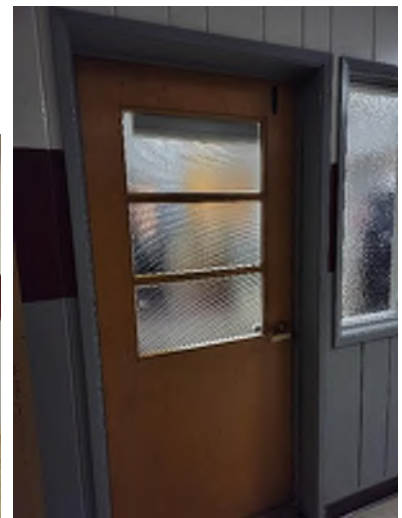
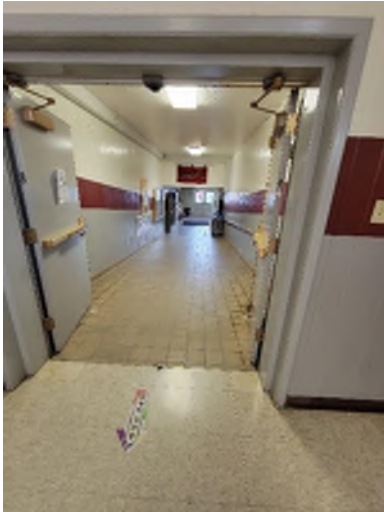
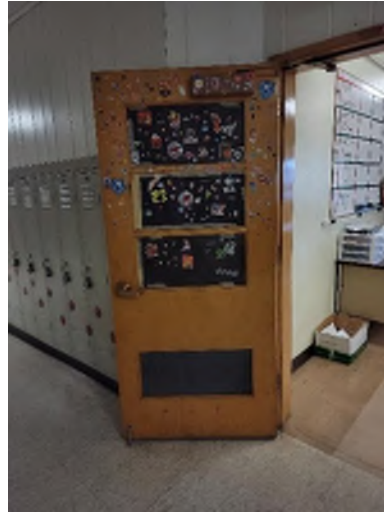
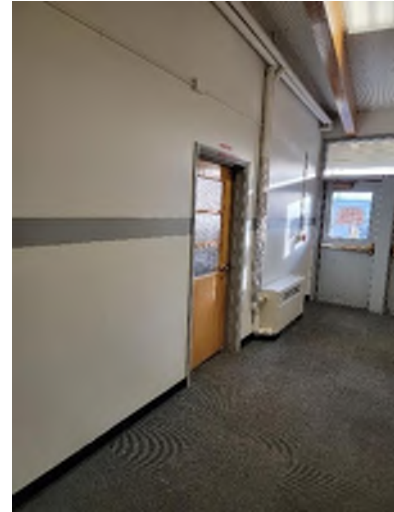
Main Building Interior Doors: Except for in the science wing and where the renovations work was conducted after the fire, the rest of the interior doors, frames, and hardware need being replaced.

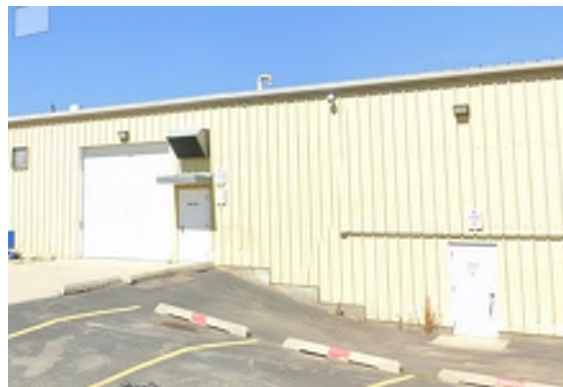
Shop Outbuilding Exterior Man Doors: The exterior man doors have deteriorated past their usefulness and need to be replaced.
