Helena School District Deferred Maintenance Report

January 31, 2022

RE: Deferred Maintenance Review
Helena Public Schools
Final Report

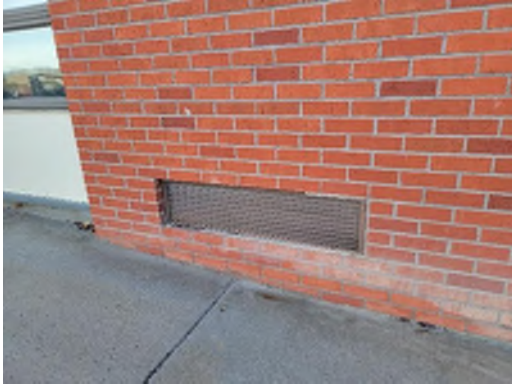
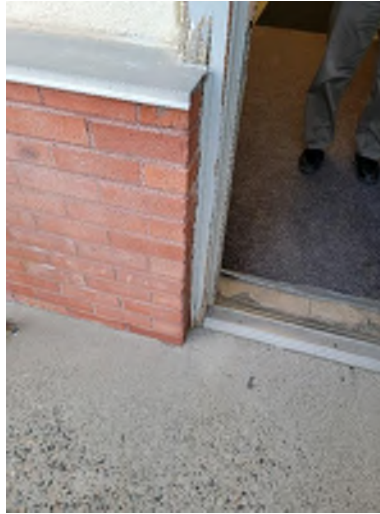
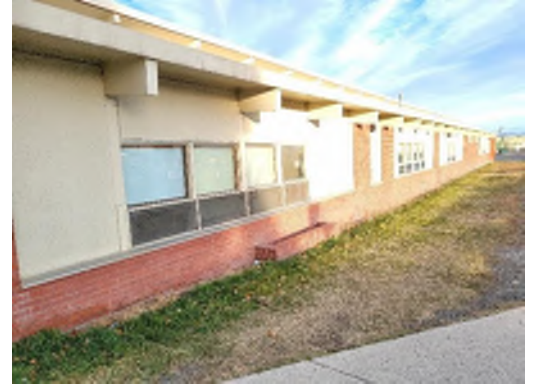
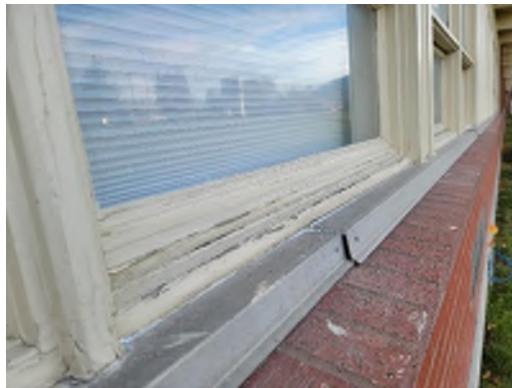
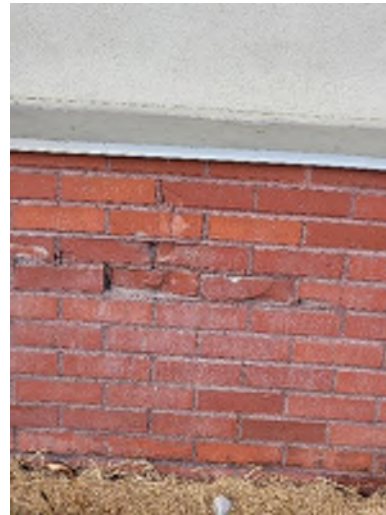
Masonry: The masonry on the exterior of the building is in good shape, but there us about 5 to 10% of the mortar joints that need to be repointed.

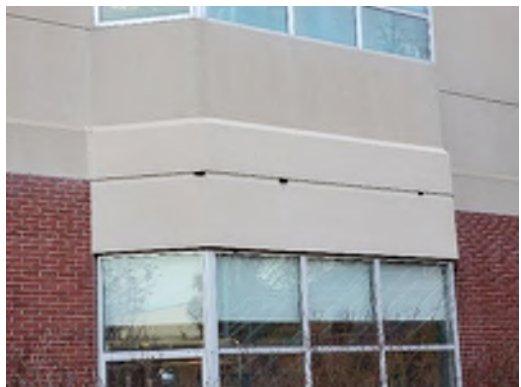
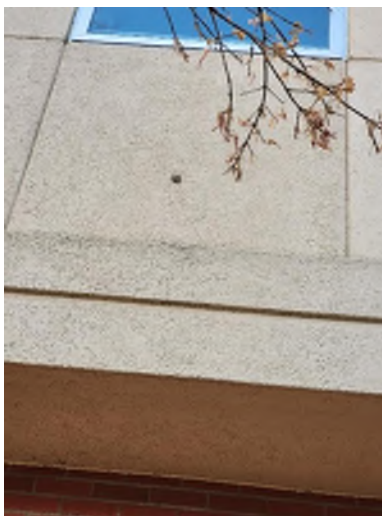
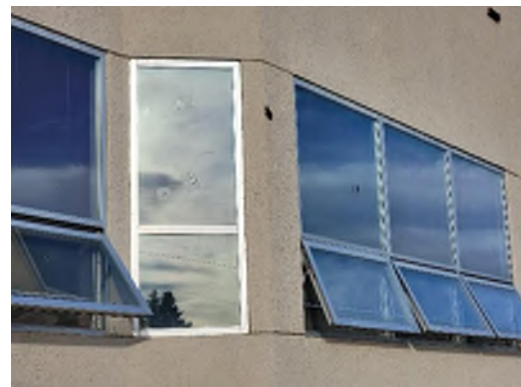
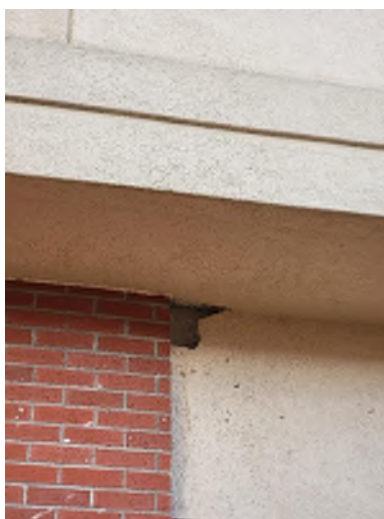
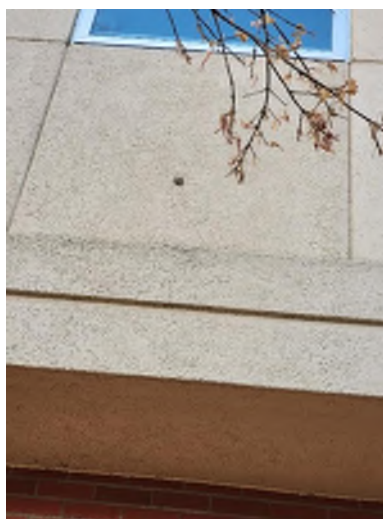
EIFS: The External Insulation and Finish System that was used on the Science Addition has a lot of birds making their nests in the walls. These need to be patch as maintenance, but the best way to fix the issue is to replace the exterior system with either a metal lath-based stucco system or some other cladding system.

EIFS: It will be ok to patch the holes of from the birds as they are made. However, the permanent fix is to replace the EIFS system with a better-quality cladding system. **(High Cost, Medium Priority)**

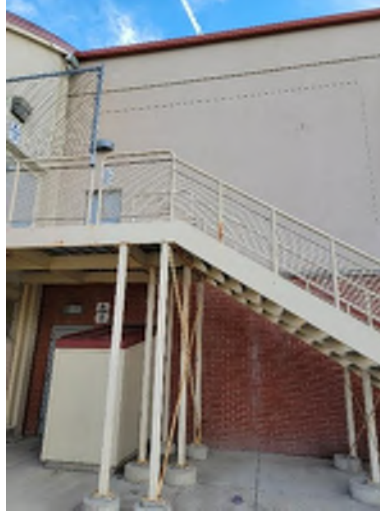
Metal Stair from Gym Second Floor: The metal stairs coming out of the Gyms second floor is rusting and needs to be repainted. In addition, the guardrails do not meet the current code and it would be recommended that these get rebuilt for better fall protection.

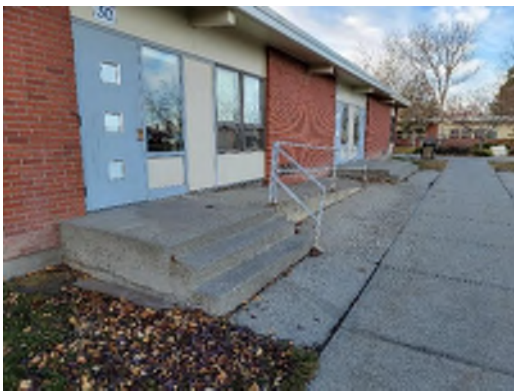
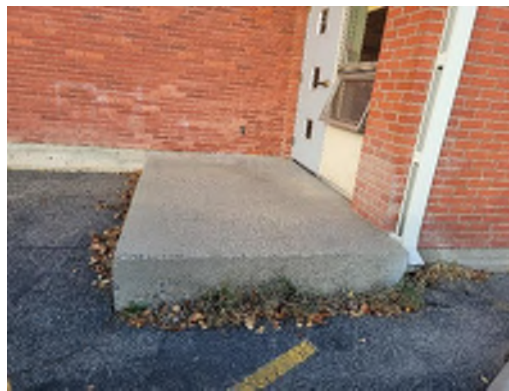
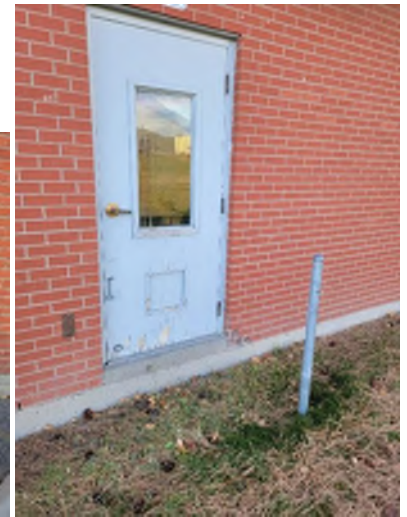
Concrete Stoop, Steps, and Railing: There are three (3) locations on the north side of the lunchroom that need to be rebuilt with code compliant steps and railing. There is also one (1) man door on the north classroom that needs a stoop.

Concrete Stoop, Steps, and Railing: Replace Concrete and railing at all these locations. **(Low Cost, High Priority)**

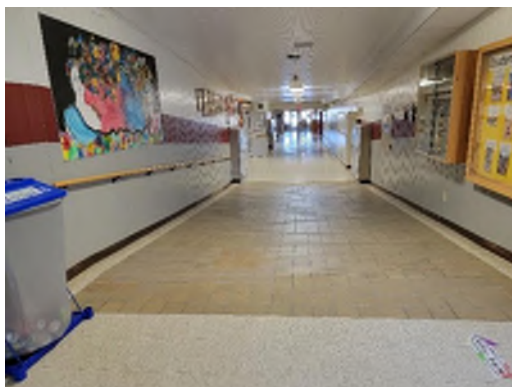
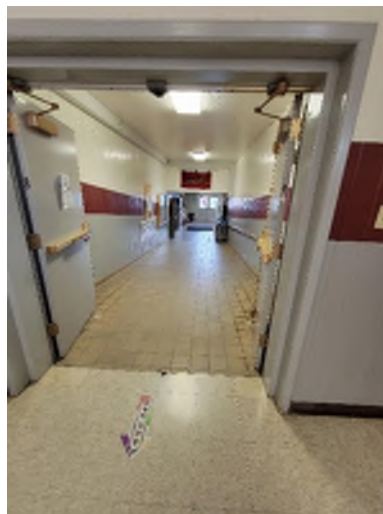
Interior Ramps: There are five (5) interior ramps that are way too steep to meet the ADA requirements. They are also missing the necessary handrails. Because of the existing conditions only three (3) of these ramps can easily be extended to reduce the slope of these and get them closer to the 1:12 slope. We would also recommend installing new handrails on all the ramps.

Interior Ramps: Add handrailing to all 5 ramps. Extend the 3 ramps that can be. **(High Cost, Low Priority)**

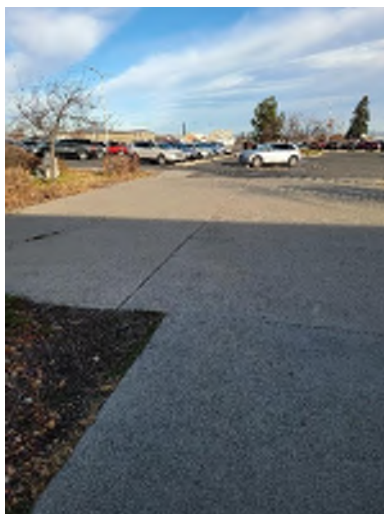
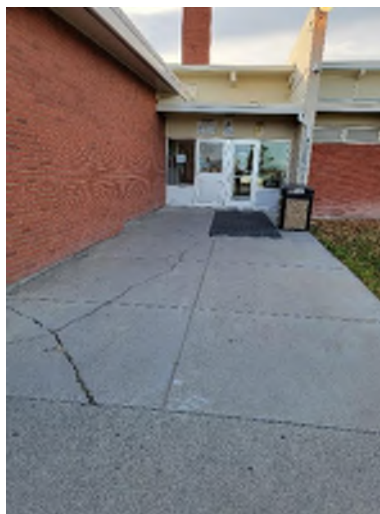
ADA Parking: The cross slope of the ADA parking spot is over the 2% and there are a few panels that have a larger than ¼" step creating a tripping hazard. These should eventually be fixed.

ADA Parking: The cross slope of the ADA parking spot is over the 2% and there are a few panels that have a larger than ¼" step creating a tripping hazard. These should eventually be fixed. **(Medium Cost, Low Priority)**

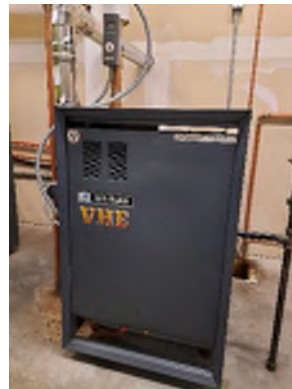
Heating: The building is a hot water heating system. The heating water is generated in the upper-level equipment room which is equipped with (3) Weil McLain Model VHE-6 Cast Iron Boilers. The boiler room is equipped with wall mounted combustion air. The system has (2) Taco in-line circulation pumps to distribute the heating water to the perimeter wall mounted fintube radiation and (2) roof mounted air handling units. The circulation pumps for these systems were installed with the boilers.

Heating: The boiler room upgrade should include updated distribution pumps, air management devices (air vents and system air separator), and boilers replaced to the district standard.

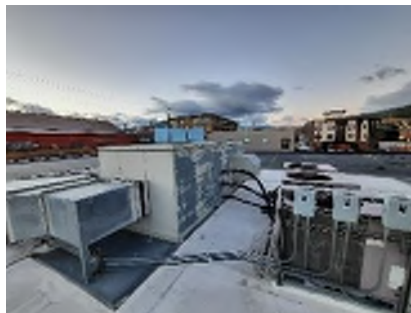
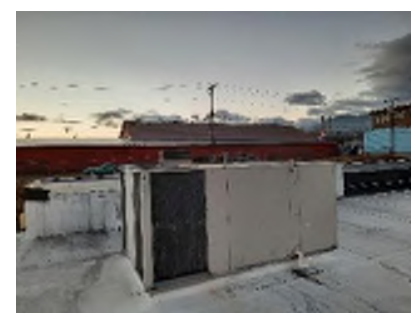
Ventilation: The building classroom spaces are served with (2) roof mounted air handling units. One of the units is a Temtrol exterior air handler, the other unit is a Lennox light commercial unitary rooftop unit. In addition to these two units there is a ceiling mounted fan coil.

Ventilation: Replace all room mounted equipment. The installed equipment has met its service life.

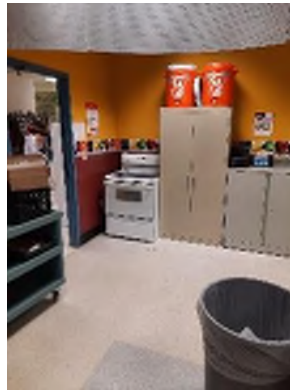
Kitchen equipment (ranges, ovens, and dishwashers) are not equipped with required hoods.

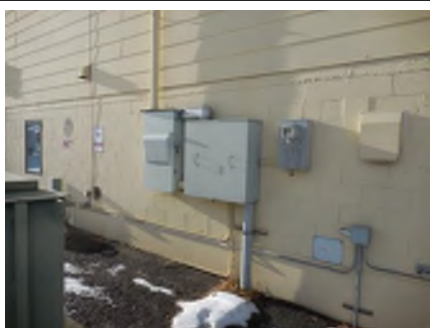
Figure 2 – Utility Co. Metering Enclosure, Meter and Main Disconnect

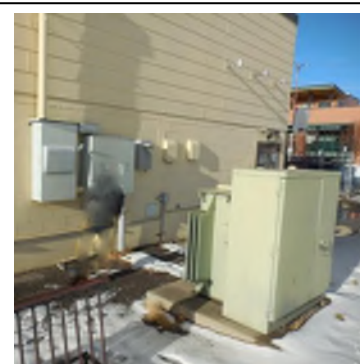
Figure 1 – Pad Mounted Transformer, Main Disconnect and Metering

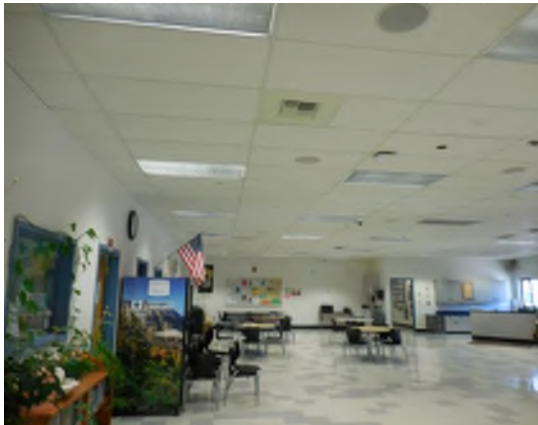
Figure 7 – Open Classroom Area Lighting

Lighting: Most of the lighting in the building consists of 2x4 fluorescent troffers with miniature “egg crate” louvers (Figure 7). Storage rooms and mechanical rooms have four-foot long, surface mounted fluorescent fixtures with acrylic wraparound lenses. The fixtures appear to be in good shape.

Lighting: Replacement of fluorescent fixtures with LED fixtures and controls is recommended. The energy savings combined with improved occupancy sensors and dimming controls is

substantial. There is an added benefit of increased life, which will help reduce maintenance costs. Rebates are available from Northwestern Energy and NCAT to help offset the cost of replacement.

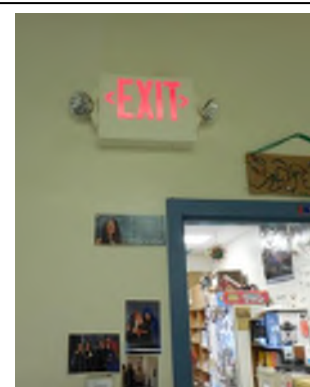
Figure 8 – Combination Lighting & Exit Sign

Exit and Egress Lighting: Exit signs are LED with emergency battery packs. Some are combined with emergency lighting heads (Figure 8). It appears that the quantities and locations are in compliance with Codes.

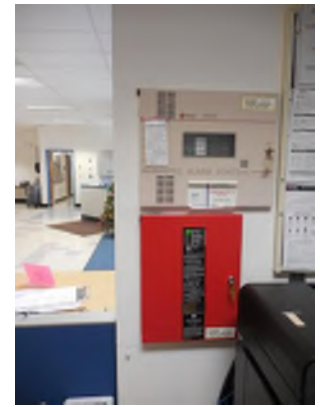
Figure 9 – Fire Alarm Control Unit

Current Codes require a voice-evacuation fire alarm system for K-12 Educational Occupancies. The Simplex 4001 control unit is obsolete and consideration should be given to replacement with a new control unit which would then add the voice evacuation features. The main sprinkler system valve(s) should be monitored since they have that capability and the system is in place.

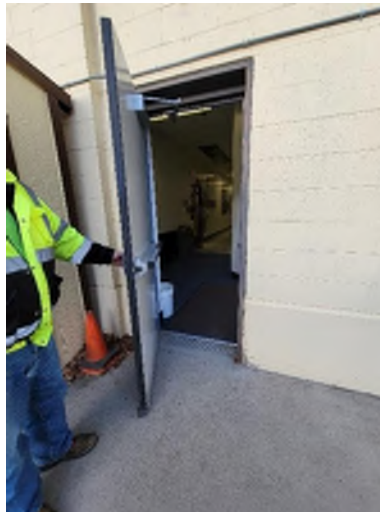
Exterior Doors: The Exterior doors are all in need of being replaced. The doors and frames were not galvanized, and the bottoms are rusting out and the hardware is requiring maintenance constantly to keep them functioning.

Exterior Doors: Replace all exterior doors and frames with new galvanized hollow metal frames and galvanized hollow metal insulated level 4 doors. **(Medium Cost, Medium Priority)**

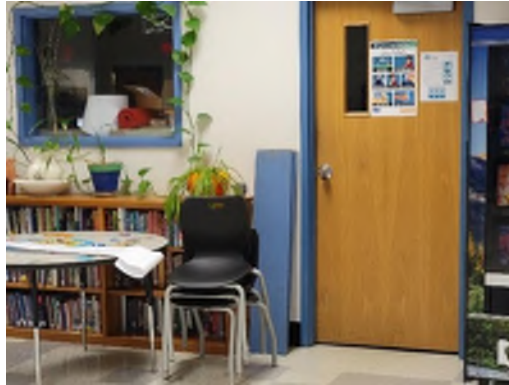
Interior Doors: Most of the interior doors have knobs. This is a life safety and ADA accessibility issue that should be updated.

Interior Doors: Replace all interior doorknobs with lever sets. **(Medium Cost, High Priority)**

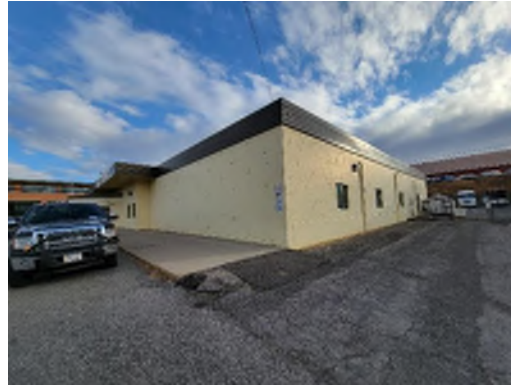
Masonry: The exterior of the PAL building is concrete masonry units. The CMU itself is in really good shape. The painting could use a new coat to help ensure it is weather tight.

Masonry: Repaint the exterior CMU. **(Medium Cost, Low Priority)**

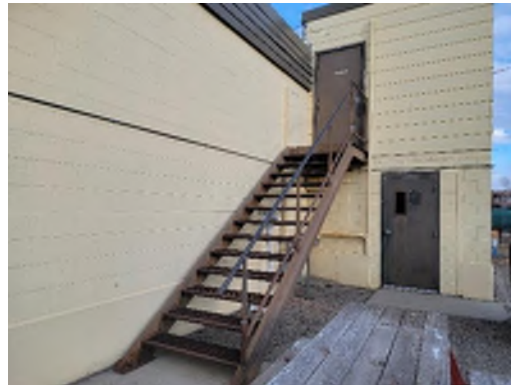
Exterior Stair: There is an exterior metal stair that accesses the mechanical space up above. The railing on this stair is not an approved Guard Railing and should be updated to have better fall protection.

Exterior Stair: Replace the metal railing to a guard railing 42" tall and to not allow a sphere larger than 4" from being able to pass through it. **(Medium Cost, High Priority)**

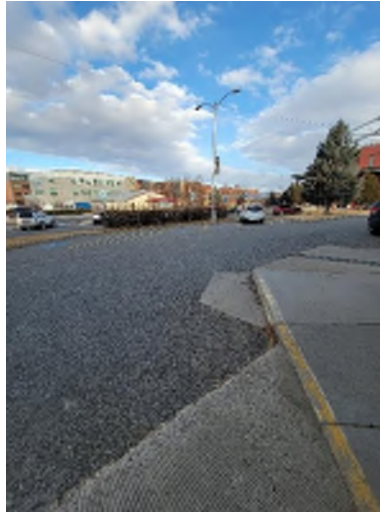
Parking: The parking spot at PAL does not conform to the ADA slope requirements. The site should be regarded and built to meet the necessary accessible accesses into the building.

Parking: To meet the necessary slope and grade from the parking to the building, there will need to be some regrading, and the ADA parking spot sill need to be raised by at least one foot. **(High Cost, Medium Priority)**

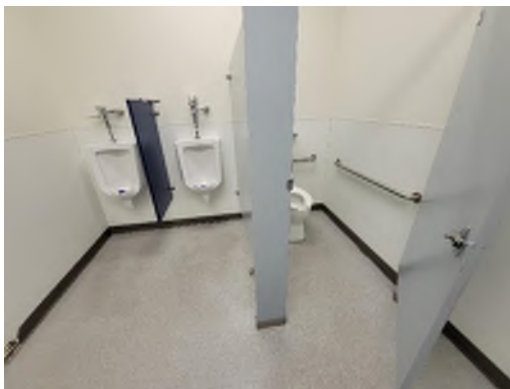
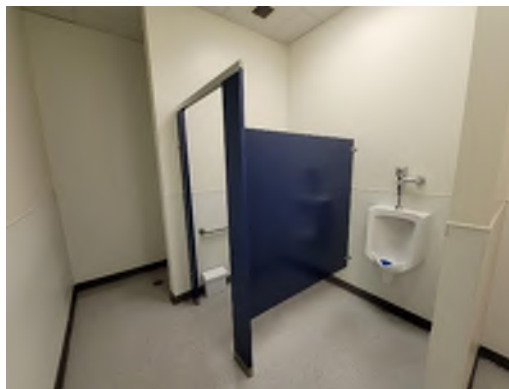
Restrooms: There is not currently a compliance ADA accessible restroom in the building. It would be recommended to take one men's and one women's restroom and renovate them to meet the accessible clearances.

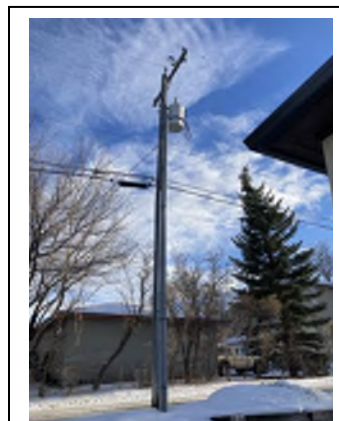
Figure 1 – 50 KVA Pole Mounted Transformer

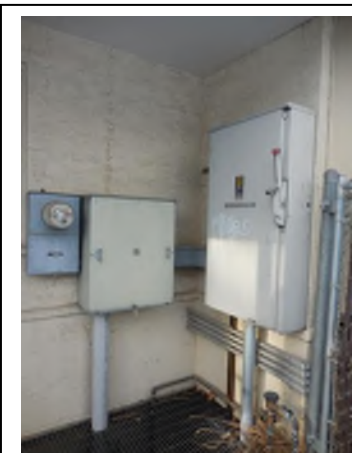
Figure 2 – Utility Co. Metering Enclosure, Meter and Main Disconnect

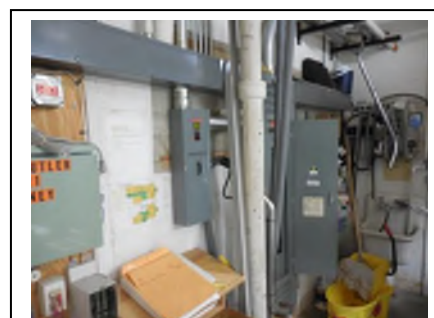
Figure 3 – Wireway, Panel A and Panel B Sub-Feed Breaker

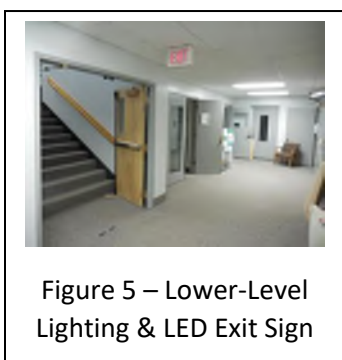
Lighting: Most of the lighting in the building consists of 2x4 fluorescent troffers with acrylic lenses (Figure 5). Storage rooms and mechanical rooms have four foot long, surface mounted fluorescent fixtures with acrylic wraparound lenses. The fixtures appear to be in good shape.

Figure 5 – Lower-Level Lighting & LED Exit Sign

Lighting: Replacement of fluorescent fixtures with LED fixtures and controls is recommended. The energy savings combined with improved occupancy sensors and dimming controls is substantial. There is an added benefit of increased life, which will help reduce maintenance costs. Rebates are available from Northwestern Energy and NCAT to help offset the cost of replacement.

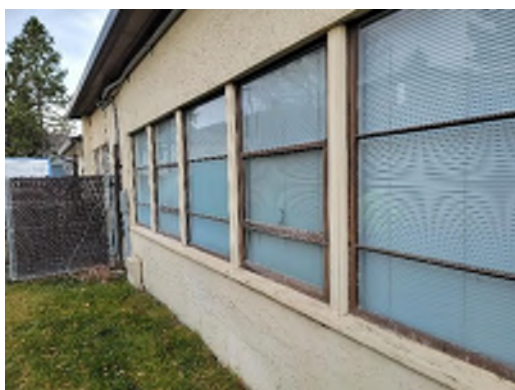
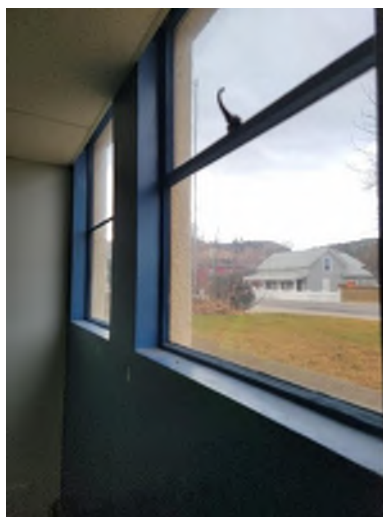
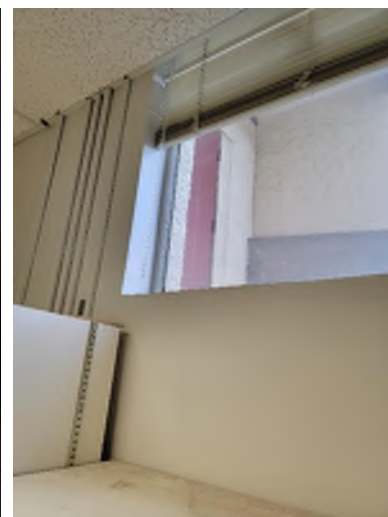
Metal Windows: All but two of the existing windows are old steel frames with single pane glazing. These are very old not efficient window systems and all should be replaced.

Metal Windows: These windows should all be replaced with thermally broken aluminum windows with double paned low-e glazing. **(High Cost, High Priority)**

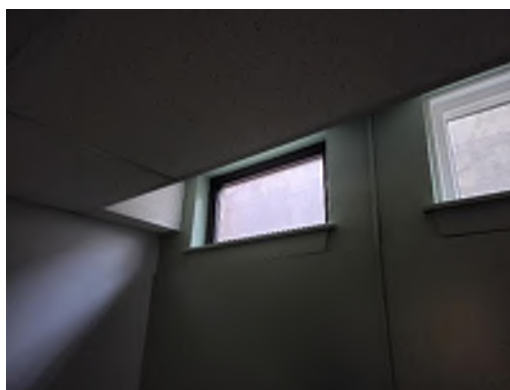
Vinyl Windows: Two of the windows in the basement were replaced with Vinyl windows. This are in good shape and will not require work at this time.

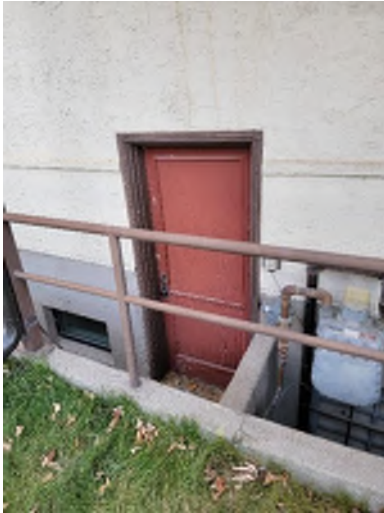
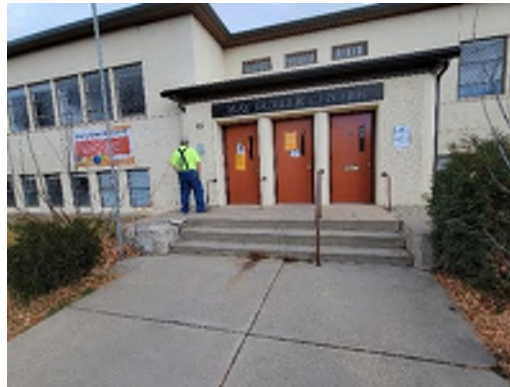
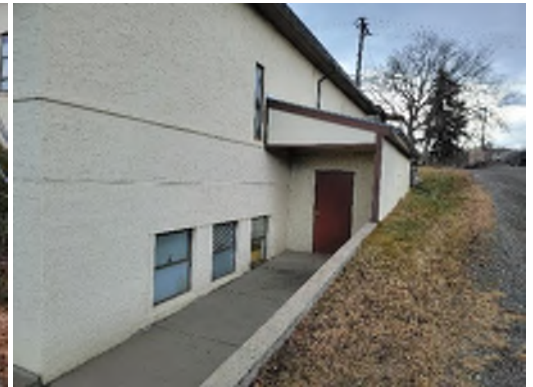
Exterior Doors: There are three different types of Exterior doors; There is an old wood door into the basement and needs being replaced. Four hollow metal doors that are also beyond their

useful life and appear to be rusting at the base. There is also a newer set of aluminum double doors installed off the parking lot that is in good shape.

Exterior Doors: The wood doors should be replaced with new insulated hollow metal door and hollow metal frame. The entrance and stair Hollow Metal doors should be replaced with aluminum glass storefronts. **(Medium Cost, Medium Priority)**

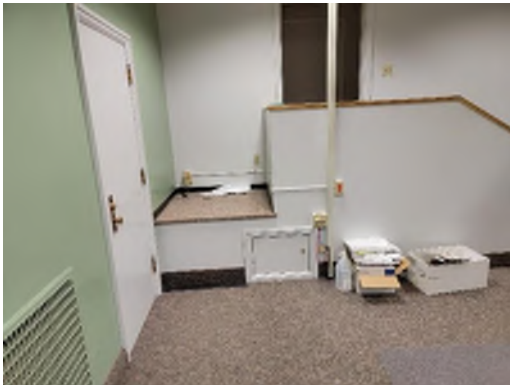
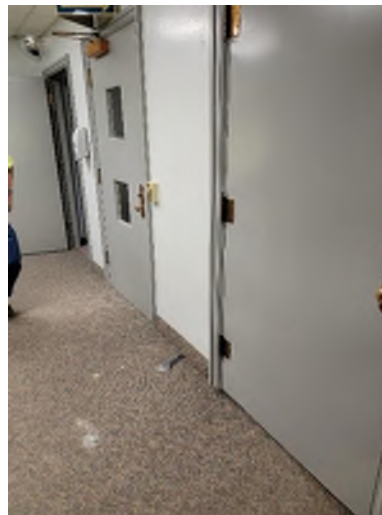
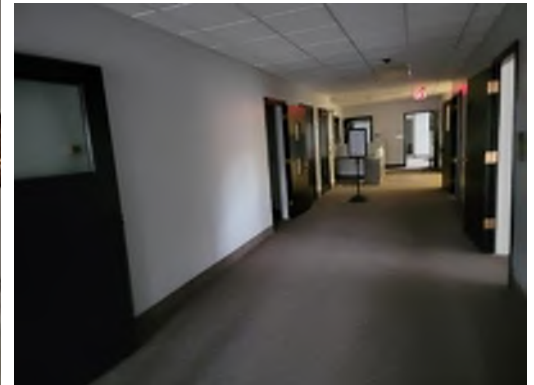
Interior Doors: The corridor doors have been replaced with newer doors and hardware. However, most of the interior office doors are older and have knobs that should be replaced with lever sets to meet current life safety and ADA requirements.

Interior Doors: Replace all the interior doorknobs with new lever sets. **(Medium Cost, Medium Priority)**

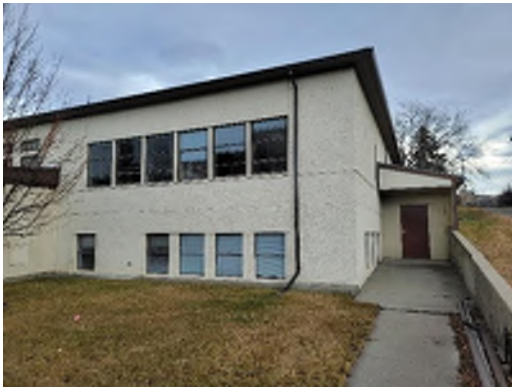
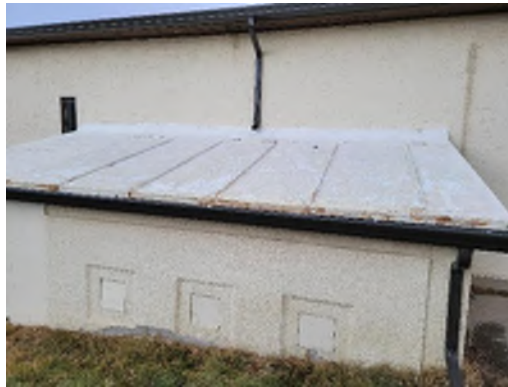
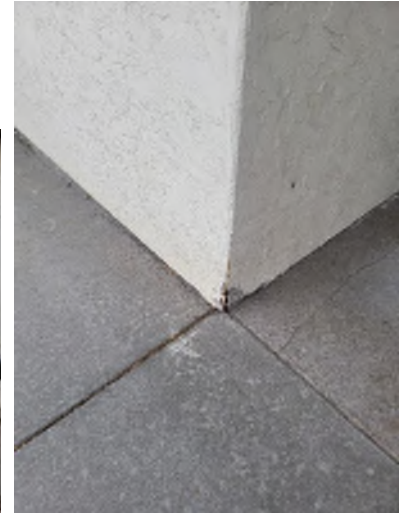
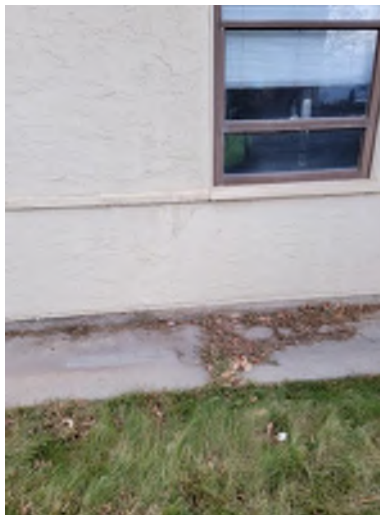
Stucco: The exterior finish of this building is a cement stucco finish. There are a few areas that could be patched, but overall the finish is in good condition and does not need maintenance currently.

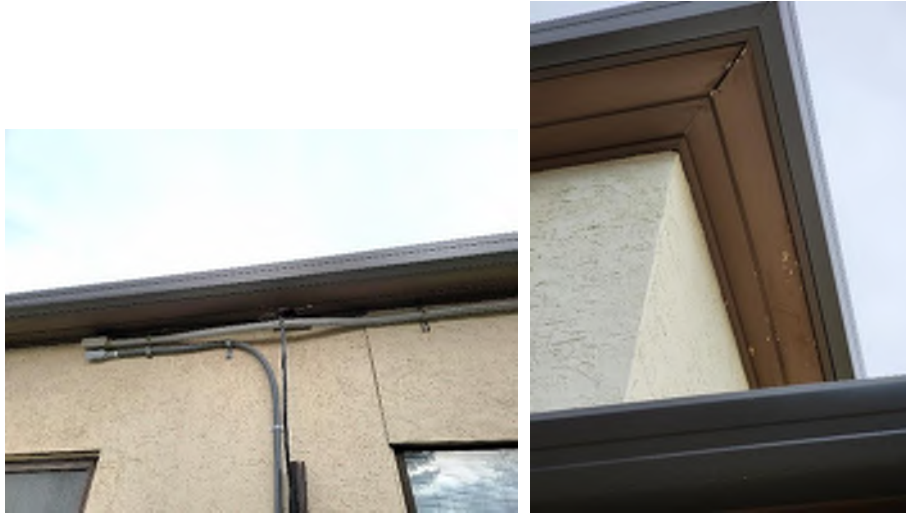
Soffits: The soffits are wood and need to be replaced in many locations. We are recommending they get replaced with a vented metal soffit.

Soffits: The soffit should be replaced with a vented metal soffit. **(Low Cost, Medium Priority)**

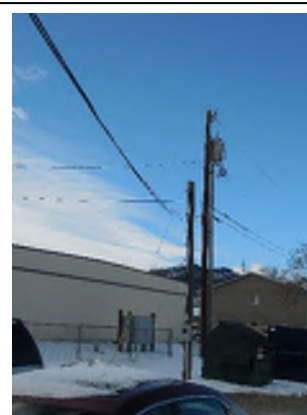
Figure 1 – 167 KVA Pole Mounted Transformer. Modular Building Service Equipment Beyond

Electrical Service: The building service is derived from a 7.2 kV single phase primary distribution line on a utility pole located in the parking lot west of the building off of N. Cooke Street. There is a 167 kVA utility company oil filled transformer on the pole (Figure 1). The secondary service characteristics are 120/240 volts, single phase, three wire with an estimated nominal 600-amp rating. The service conductors drop down the pole in a 4-inch conduit and continue underground to the main building where they rise into a metering enclosure (Figure 2). There is a second drop from the pole to the adjacent Information Technology Building. The conductors appear to be rated for 400-amperes. The service terminates in a pedestal mounted metering cabinet with a meter adjacent (Figure 3).

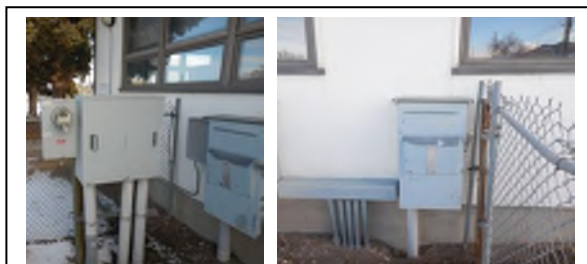
Figure 2 – Main Building Utility Co. Metering Enclosure, Meter and Main Disconnects

The service conductors for the school exit the metering enclosure and terminate in a wireway with two 400-amp main disconnect switches on the adjacent wall. The highest recorded demand over the last two years from Northwestern Energy was 33.4 KW in December 2020. The demand readings are

consistently in the 20 to 30 KW range during the heating months, and around 15 KW in the cooling months. This might change however, since the building usage is changing to an office. Based on the peak reading, the calculated demand is about 218 amps, leaving approximately 45-50% of spare capacity after applying a 0.8 power factor and the demand at 125% per NEC Article 230.87.

Electrical Service: The two existing main service disconnects should be replaced with a new single main disconnect. The service does not necessarily need to be upgraded to 3-phase, but if central AC is installed later, then 3-phase will become necessary. A 600-amp electrical service would be sufficient.

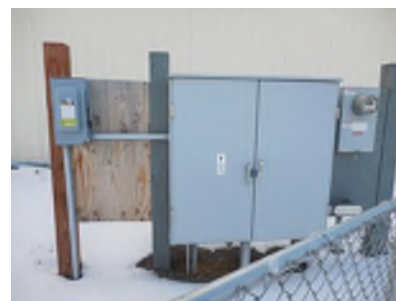
Figure 3 – Metering Cabinet and Meter for Information Technology Building

The service conductors for the Information Technology Building exit the back of the metering enclosure into a wireway with three 200-amp main breakers and one 100-amp mounted on the back side of the metering cabinet (Figure 4). The highest recorded demand over the last two years from Northwestern Energy is 43 KW in November 2019. Based on this value, the calculated demand is about 280 amps, leaving approximately 35-40% of spare capacity after applying a 0.8 power factor and the demand at 125% per NEC Article 230.87.

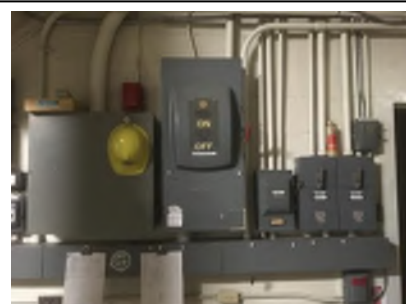
Figure 5 – Wireway in Basement with Disconnects for Panels A, B, C, D, G & N

Distribution: There are eight branch panelboards in the main building and four on the exterior walls of the Information Technology Building. None of the panelboards are obsolete. However, the main building does not have a main distribution board. Instead there is a wireway in the basement boiler room (Figure 5) with multiple conductor taps for panels A, B, C, D, G and N. All are fed from one of the 400-amp main disconnects on the building exterior. This type of arrangement is difficult to service, maintain, isolate problems or add equipment. The remaining panels in the building, E and F (Figure 6) are located in a storage room near the gymnasium and once served loads in a kitchen. They are fed from the other main disconnect of the building exterior. The Information Tech building has only the outdoor panelboards. Each of the four building modules is served by one of the panels. There are no known maintenance issues with this arrangement.

Electrical Distribution: Replacement of the wireway and tapped disconnects in the basement with a 600-amp distribution board is recommended. The board could include capacity for future air conditioning. All of the existing 1-phase panels will be reconnected to the new distribution board with individual circuit breakers. If the service is upgraded to 3-phase, then the single-phase panel feeders will be connected in a staggered phase configuration so as to prevent phase imbalances. Panel B should be removed and replaced with a new panelboard in a location that is more amenable for maintenance and troubleshooting.

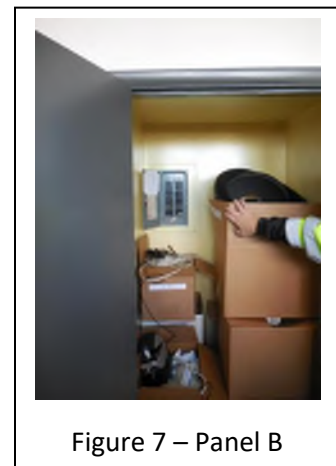
Figure 7 – Panel B

In the main building many of the panelboards are full and a new 42 circuit panelboard (G) was recently installed in the Basement Boiler Room. About half of the circuit breakers appear to be spares. One of the panelboards, B (Figure 7), is located in a storage closet near the east end of the building. Access is blocked due to boxes being stored in the closet.

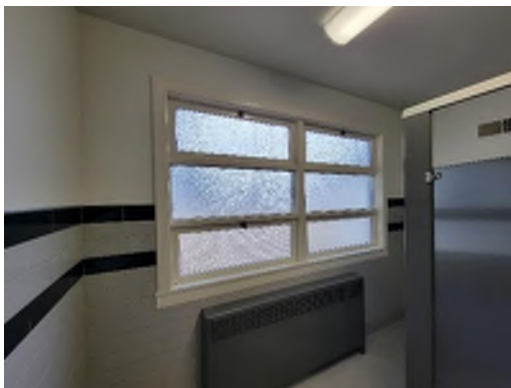
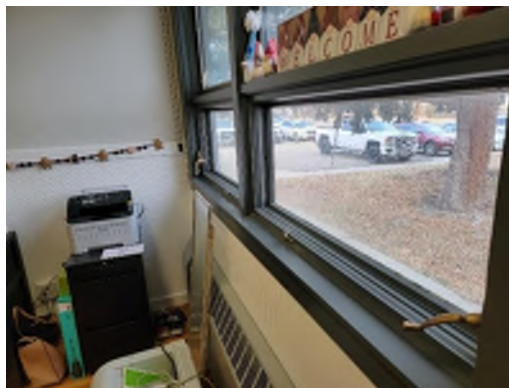
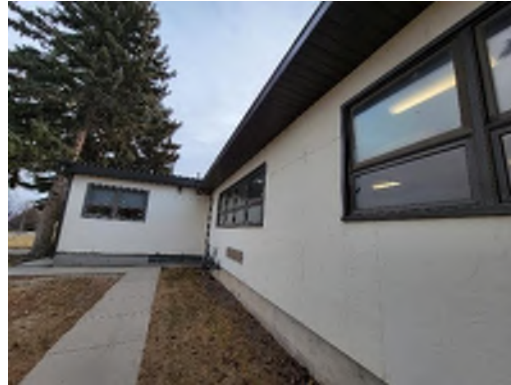
Main Building Windows: The windows in the main school building appear to be aluminum clad wood windows with single pane glazing. These are well past their useful life and needs to be replaced.

Main Building Windows: Replace all the existing aluminum clad wood windows with single pane glazing. The new system should be thermally broken aluminum framed windows with double pane low-e glazing. **(High Cost, Medium Priority)**

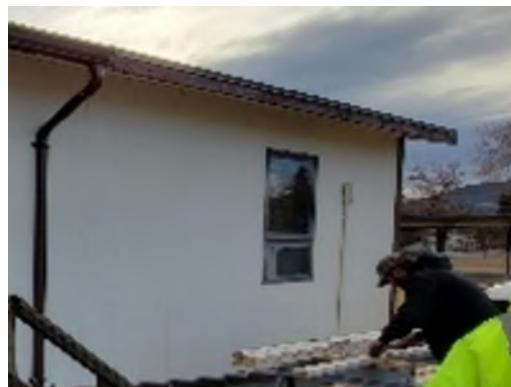
Small Outbuilding Windows: The small outbuildings windows are Single Pane glazed and aluminum windows. These windows need replacement.

Small Outbuilding Windows: Replace the Single Pane glazed and aluminum windows with new thermally broken aluminum framed windows with double pane low-e glazing. **(Low Cost, Low Priority)**

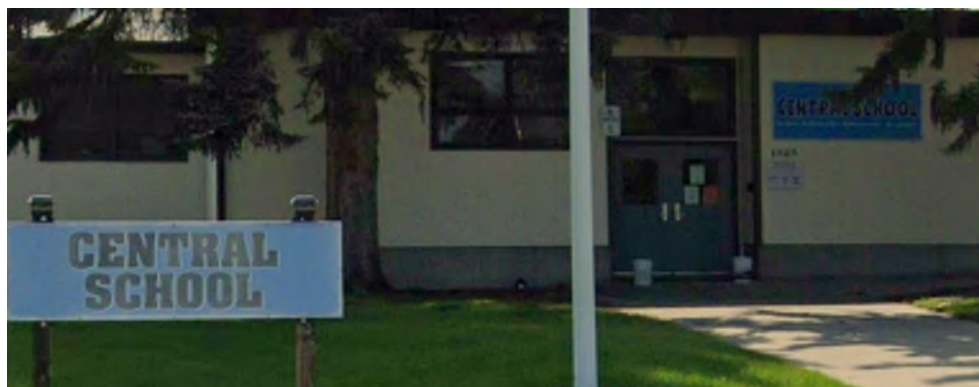
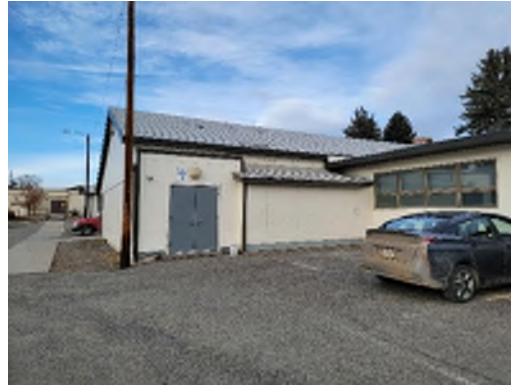
Main Building Exterior Doors: The exterior doors at Lincoln are older Hollow Metal Doors and are also in need of being replaced.

Main Building Exterior Doors: Replace the five exterior man doors with new galvanized insulated Hollow metal doors and frames. **(Medium Cost, Low Priority)**

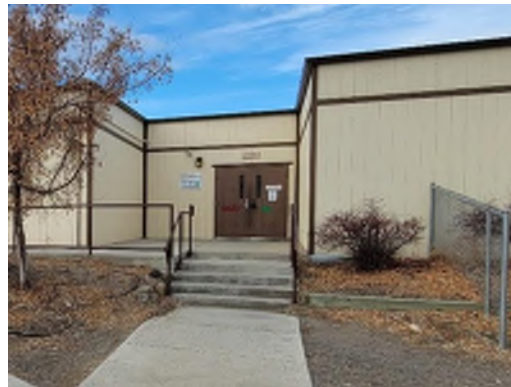
IT Outbuilding Doors: The doors on the IT outbuilding are in good shape for the time being. While there is currently no work required at this time.

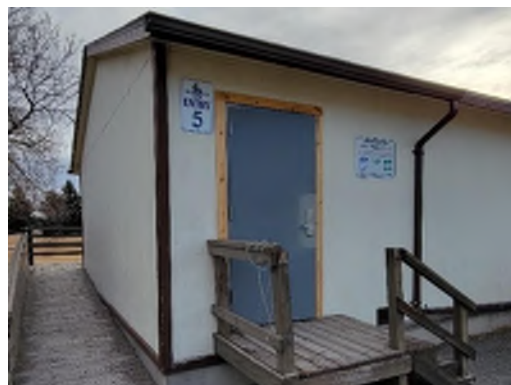
Small Outbuilding: The small outbuildings exterior doors have recently been replaced and appear to be in good condition.

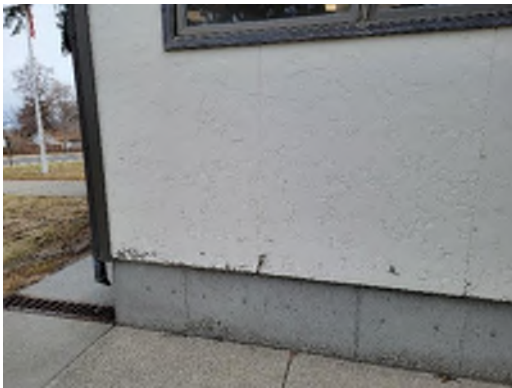
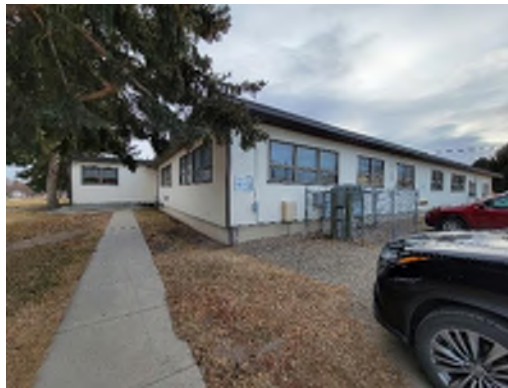
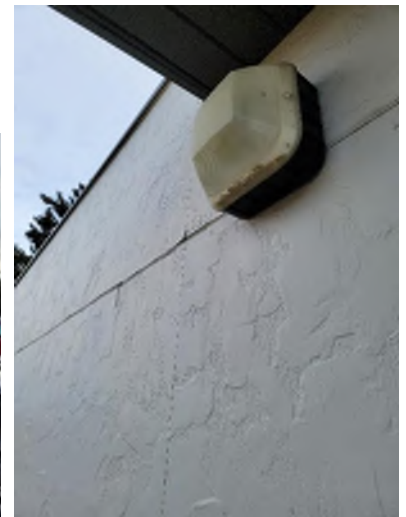
Main Building Cladding: The exterior on the Lincoln Building is a prefinished panel and is in dire need of being replaced.

Main Building Cladding: Replace all prefinished paneling with a more durable fiber panel or metal paneling. **(High Cost, Medium Priority)**

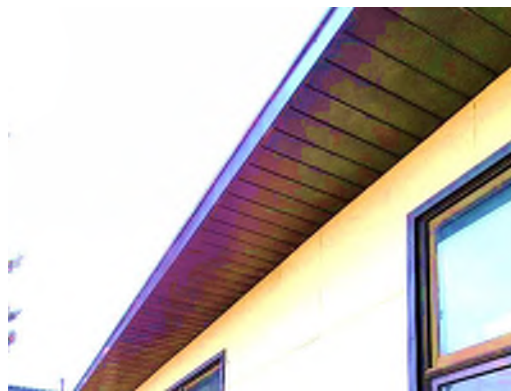
Main Building Soffits and Fascia: The soffit and fascia of the main building are all metal and they appear to be in good shape.

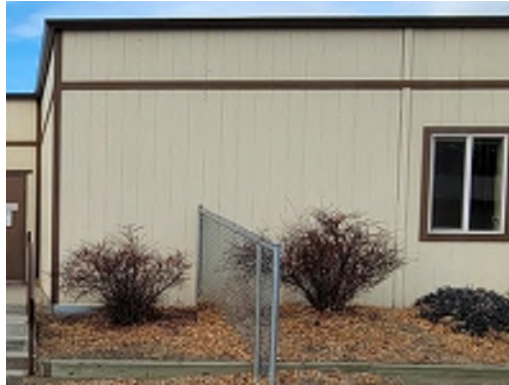
IT Outbuilding Siding: The IT outbuildings siding is modular T111 and while not a great material for durability, its condition is still in good shape and not in need of maintenance currently.

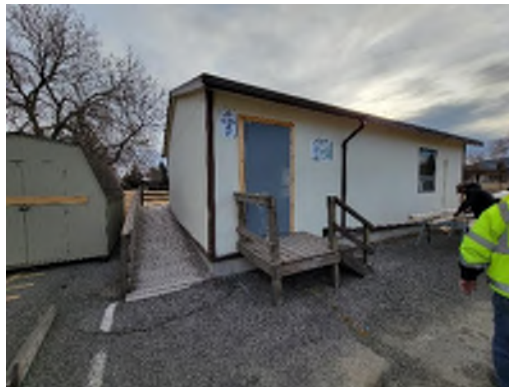
Small Outbuilding Siding: The small outbuilding modular is also T111 however this siding on the older building is in worse space and should eventually be replaced.

Small Outbuilding Siding: The small outbuilding modular is also T111 however this siding on the older building is in worse space and should eventually be replaced. **(Medium Cost, Low Priority)**

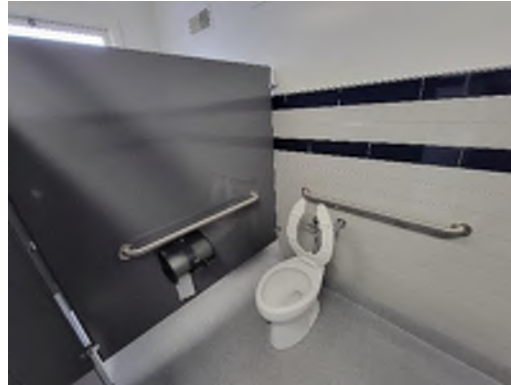
ADA Restrooms: The two main restrooms were refinished this last year and are close to being accessible, but there is a need to remove the main door into the restroom and add vertical grab bars.

Main Building ADA Restrooms: Remove the Door so the door access meets ADA clearances into the main restrooms. Add vertical Grab Bars. **(Low Cost, High Priority)**

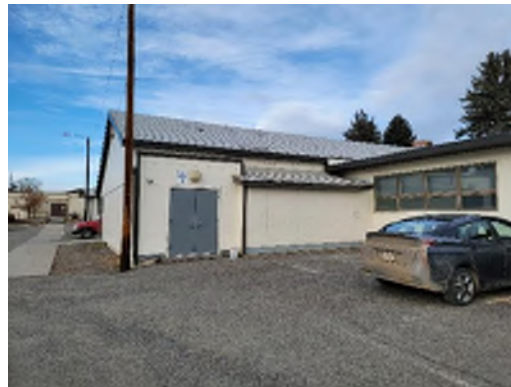
ADA Parking: There is no ADA parking that has good access to any of the buildings. With the large public use this building has, this will need to be fixed.

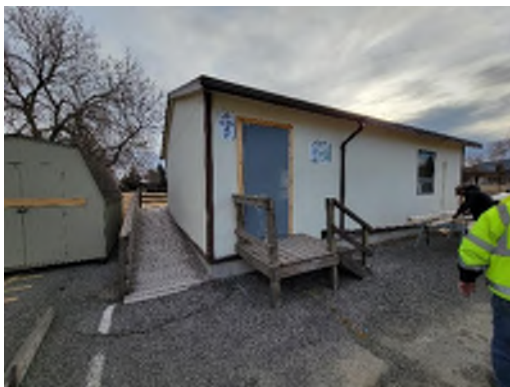
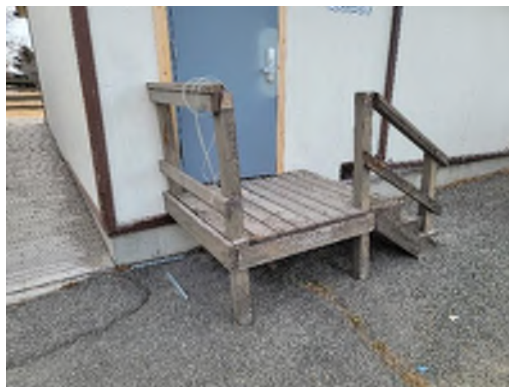
Small Outbuilding Ramp and Stair: The ramp and stair on the small outbuilding is beyond repairable and is a hazard. These systems need to be replaced.

Small Outbuilding Ramp and Stair: Replace the ramp and stair system on the small outbuilding.
(Medium Cost, High Priority)

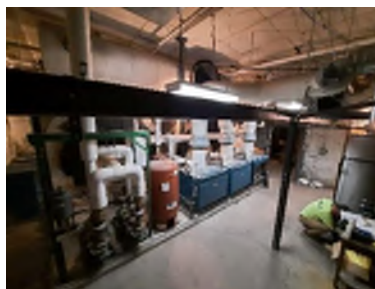
Heating: The building utilizes (3) Burnham cast iron sectional boilers Model 810B-WI to generate heated water for the building. These boilers were installed to replace the (2) locomotive engine heating boilers that are abandoned in the equipment room. At the time of the inspection only 2 of 3 boilers were operational.

Heating: Replace the cast iron sectional boilers if the building is going to be restored to occupied status. If the building is going to remain as a storage facility consideration should be given to continuing to use the existing hydronic heating system or adding gas fired unit heaters to the gymnasium space to provide reduced temperature space heat.

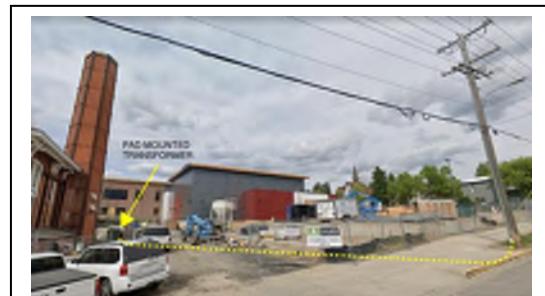
Figure 1 – Primary Electrical Service

Electrical Service: The building service is derived from a 12.47 kV three phase primary distribution line on a utility riser pole located on 7th Avenue southeast of the building (Figure 1). The primary runs underground and then up into a pad mounted transformer located off the northeast corner of the building. The secondary service characteristics are 120/208 volts, three phase, four wire with a nominal 320 amp rating. The service conductors are in a 3-inch conduit underground from the transformer and up to a meter/main (Figure 2).

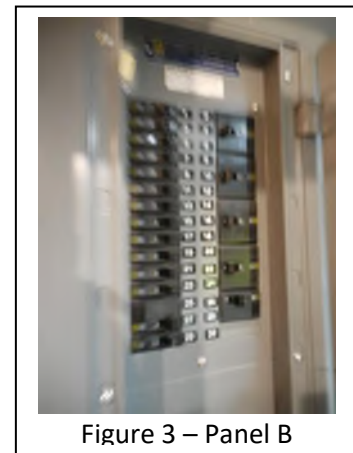
Figure 3 – Panel B

Distribution: There are two Square D NQO style panelboards. They are labeled as “A and B”. Disconnect A feeds Panel A located on the main level. Panel A could not be accessed due to it being blocked by furniture. Panel B is located in the basement boiler room and services mainly mechanical equipment. It has very little space for future circuit breakers.

Electrical Distribution: The current building needs are being met by the existing panelboards. Future conversion to occupied space will require a new 600 amp to possibly 800 amp main distribution board if air conditioning is needed.

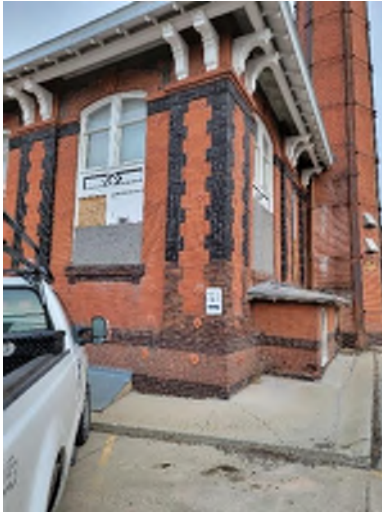
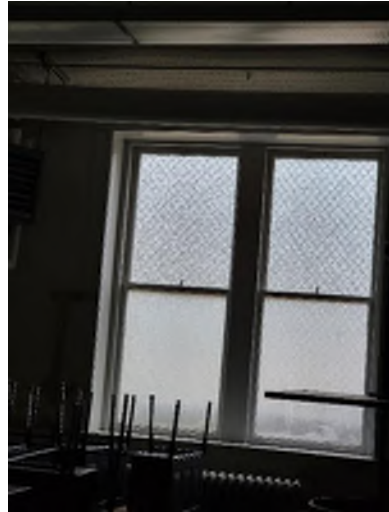
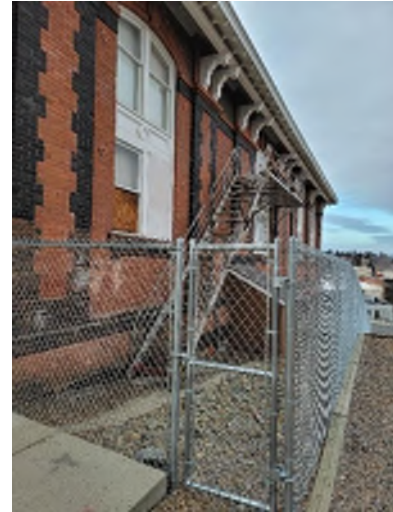
Original Wood Windows: All of the windows on the 7th Avenue Gym are old single pane framed windows. Because of the location of the building and the fact that it is no longer actively used a lot of the windows were boarded up.

Original Wood Windows: These windows need being replaced, but the building is on the Historic Registry and will require historically accurate custom replacement windows. I would recommend an aluminum clad wood window with double pane low-e glazing. **(High Cost, High Priority)**

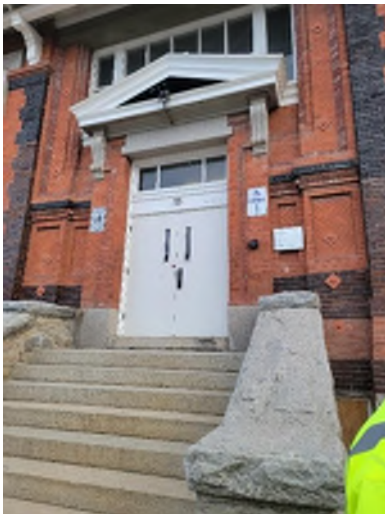
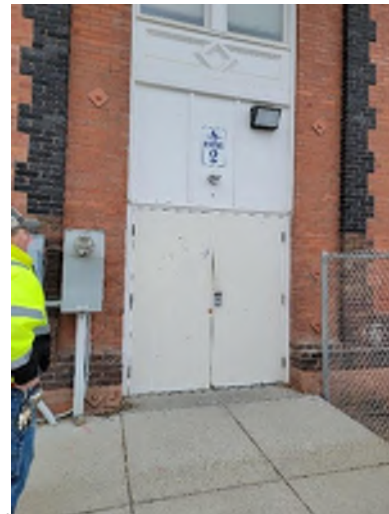
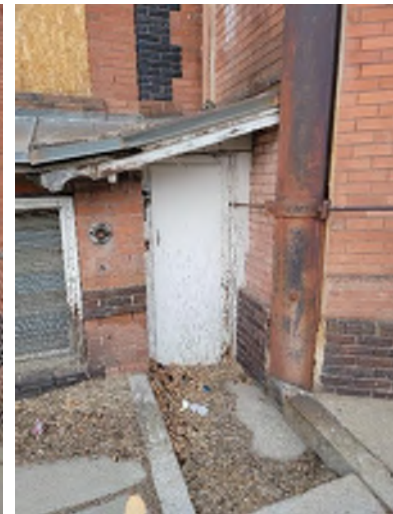
Exterior Doors: While the doors are not original to the building, all appear needing to be replaced, as they are well beyond their useful life.

Exterior Doors: It would be recommended to replace the doors with a more historically accurate exterior door and hardware system. **(Medium Cost, Medium Priority)**

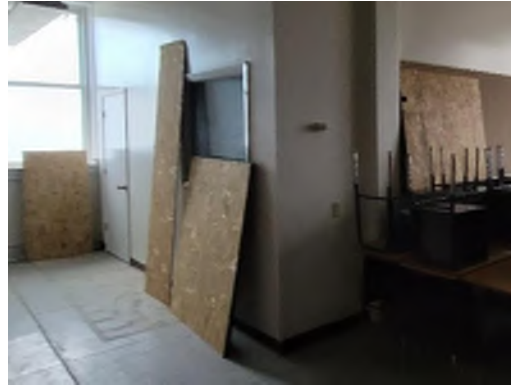
Interior Doors: The interior doors are original to the building, and all have knobs and the hardware needs to be updated.

Interior Doors: Replace the interior doors with historically accurate wood panel doors have lever sets in place of the knobs. **(Medium Cost, Low Priority)**
