Helena School District Deferred Maintenance Report

January 31, 2022

RE: Deferred Maintenance Review
Helena Public Schools
Final Report

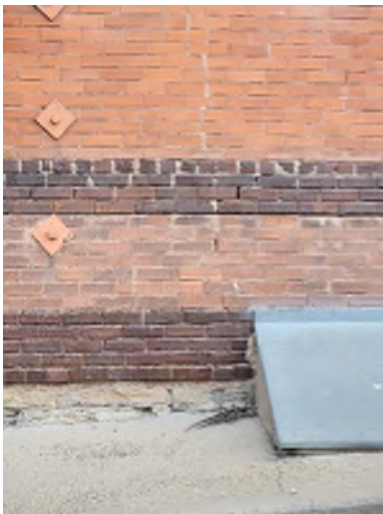
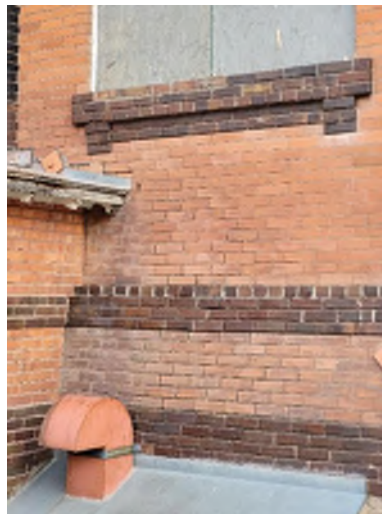
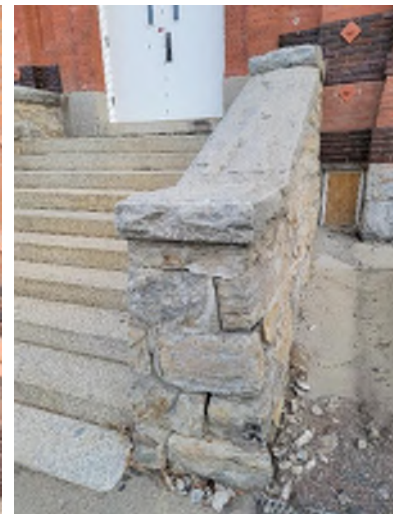
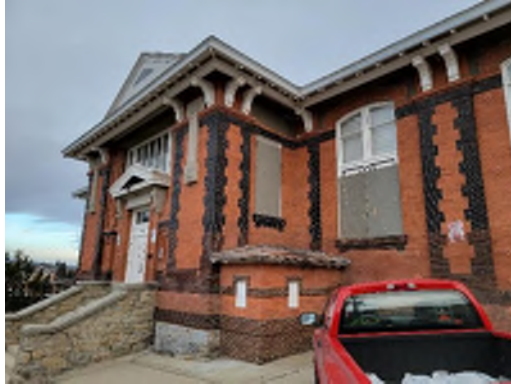
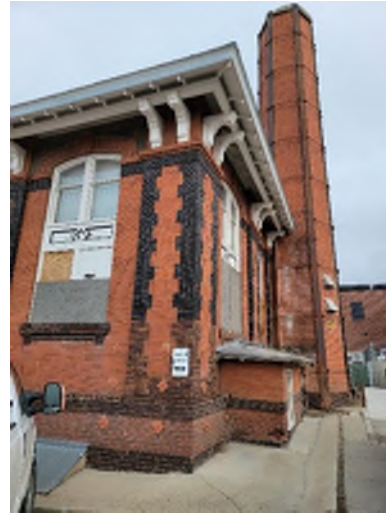
Masonry: The masonry on the 7th Avenue Gym, while beautiful, needs maintenance. All the mortar joints are cracked and need updated. It appears that reinforcing plates were added to the exterior at some point and it is questionable if they meet seismic requirements. The stack on the building will most likely need substantial seismic renovation.

Masonry: Restoration of the masonry will require repointing all the mortar joints and require seismic upgrades be made to the building. It is extremely hard to estimate the cost for this work, but it will be high. **(High Cost, High Priority)**

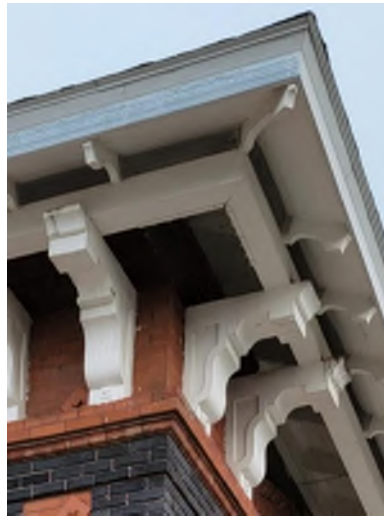
Cornice, Fascia, Soffit: The cornice, fascia and soffit work on the 7th avenue gym is also beautiful and worth preservice, but it is all wood and in need of restoration.

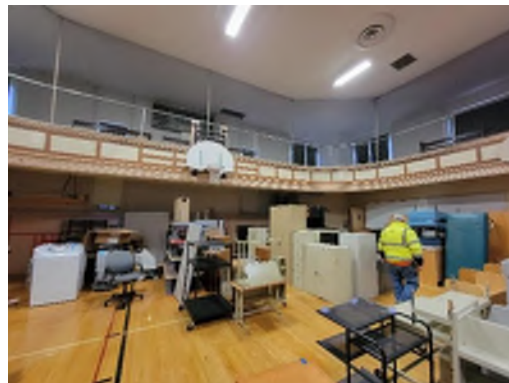
Second Floor Track: The second-floor track has been condemned and is unsafe. This system will need structural retrofits if it is going to be made functional again.

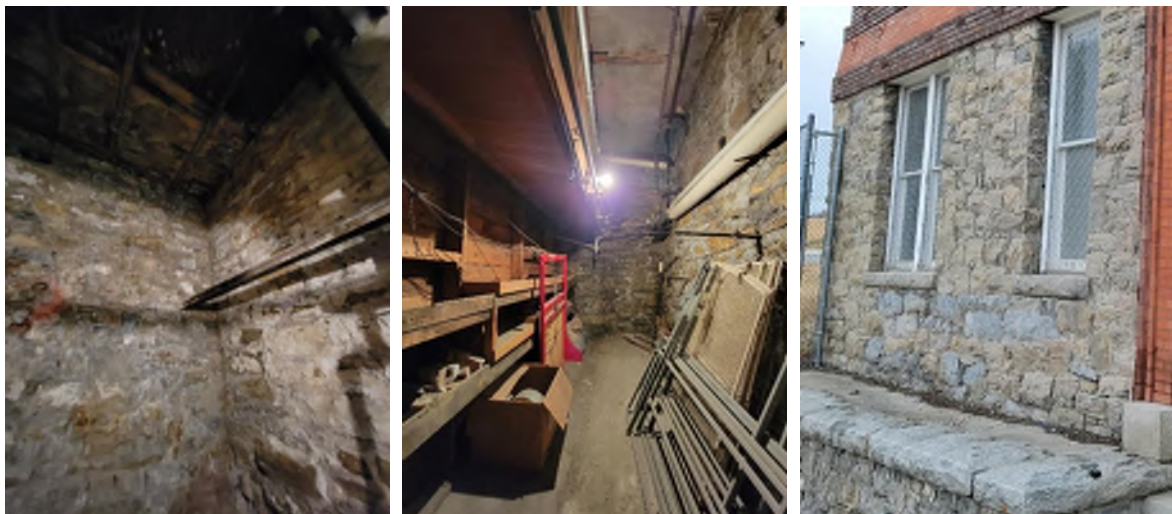
Rubble Foundation: The foundation work on the 7th Avenue Gym is a rubble stone foundation system and needs to be restored and reinforced to meet seismic and strength requirement.

Rubble Foundation: Restore and reinforce the rubble stone foundation and walls. This will likely require structural seismic Reinforcement. **(High Cost, High Priority)**

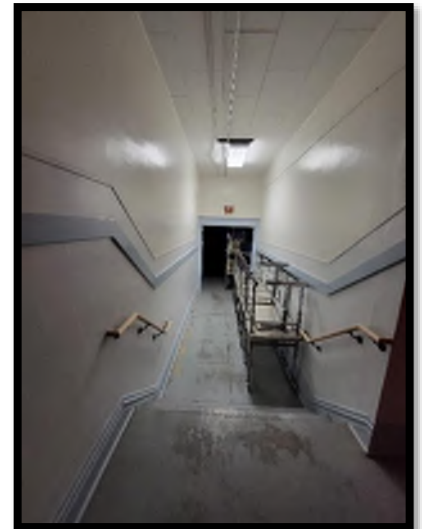
Accessible Routes: There is only an accessible route to the main gym floor. There is no accessibility to the second level track or the basement. A lift will need to be added and a ramp will be needed to access the basement lower area. It would be possible to remove one of the two main stairs and create access lift to all three levels.

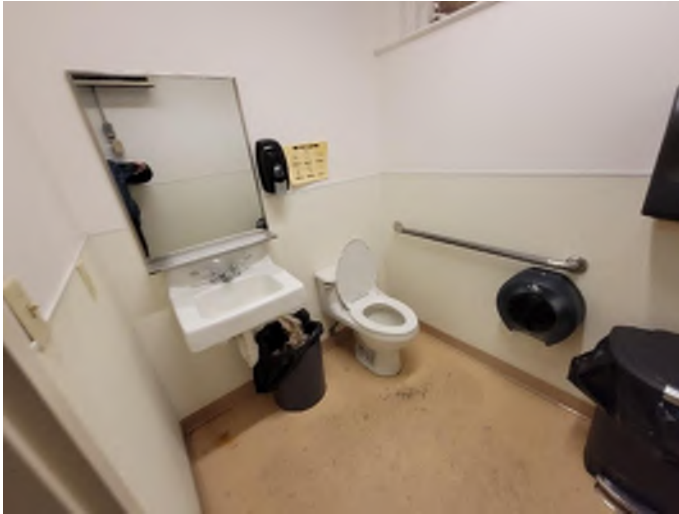
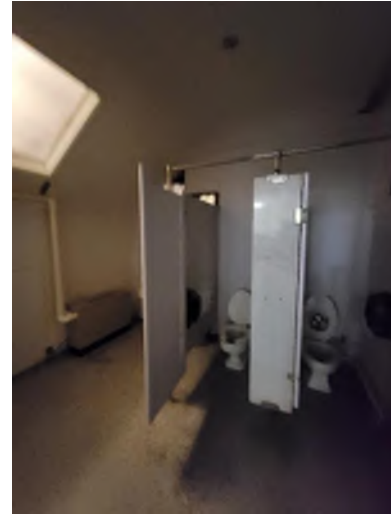
Restrooms: The restroom on the main level will require some minor modifications to bring it into accessible clearances. I would also recommend creating accessible facilities in the basement.

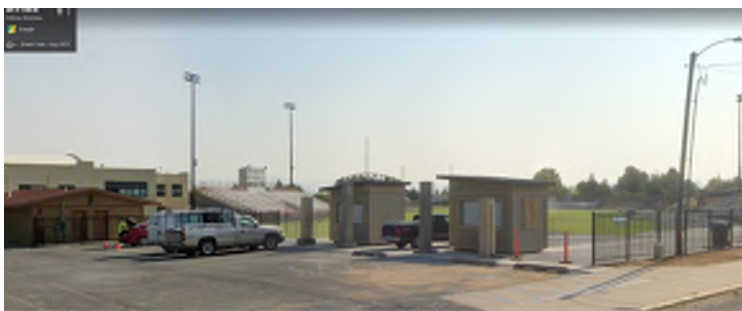
Figure 1 – Utility Lighting Pole with Service Drop to Concessions Building

Electrical Service: There are three services at Vigilante Stadium. There is a utility company pad mounted transformer on each side of the stadium between the edge of the playing field and the running track, and another underground service drop from a pole on the west end for a Concessions building and two ticket booths (Figure 1). The Concession building service is 120/240 volts, single-phase, three-wire, 200 amps. It is direct metered with no demand meter.

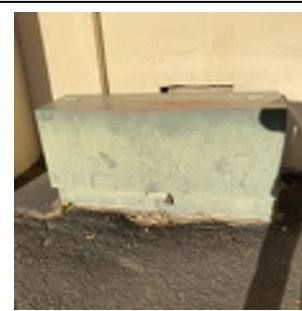
Figure 2 – Primary Junction Can at Helena Middle School

The service to the transformers is underground but it is not clear where it originates. It may come from the north, since there is a primary junction can near the transformer pad for Helena Middle School, but this is unconfirmed. (Figure 2).

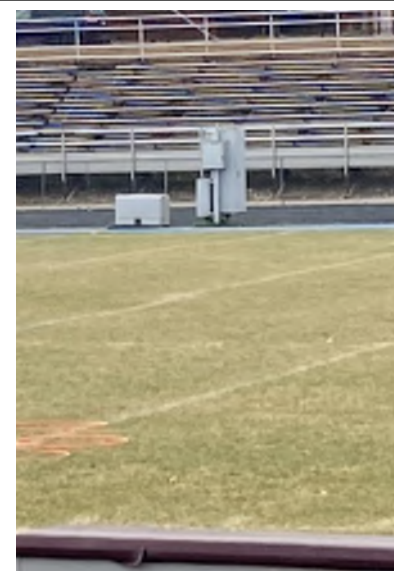
Figure 3 – Transformer & Pedestal on South Side of Field

The underground primary terminates in north pad mount transformer, then continues to the transformer on the other side of the field (Figure 3). Adjacent to the transformer on the north side, is a pedestal mounted metering enclosure, a meter, a main distribution board with (2) 200A disconnect switches for the lighting poles, a load center and a 100 amp disconnect switch for the press box and storage room load centers (Figure 4). The secondary service characteristics are 120/240 volts, single phase, three wire with a nominal 400 amp rating. The highest recorded demand over the last two years from Northwestern Energy was 37.8 KW in November, 2020 for the South side meter. The demand readings are consistently in the low to mid 30's KW range during the months when the stadium lighting is used. Based on the peak reading, the calculated demand is about 250 amps, leaving approximately 30-35% of spare capacity after applying a 0.8 power factor and the demand at 125% per NEC Article 230.87. The peak demand for the North side meter could not be obtained, but is believed to be similar.

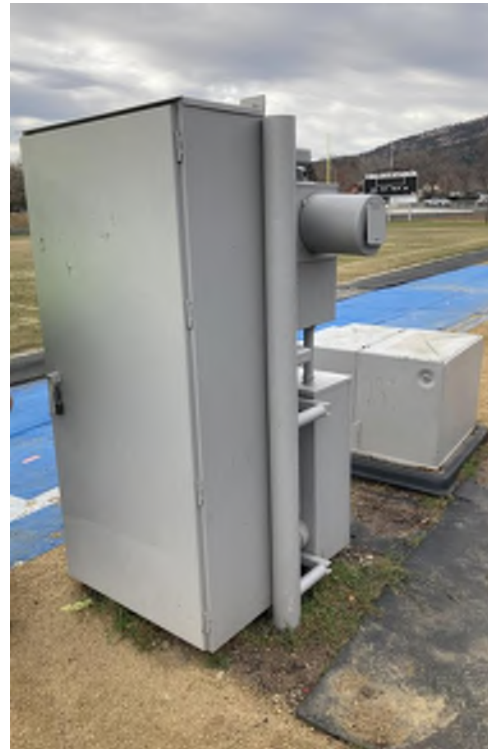
Figure 4 – Service Pedestal with Main Distribution Board, Metering Cabinet, Meter and Utility Co. Pad Mounted Transformer on North Side of Field

Distribution: There are service pedestals at both the North and South sides of the stadium with Main Distribution Boards that have two, 200 amp fusible disconnect switches inside; one for each lighting pole. At the North side, there is a third 100 amp disconnect switch on the opposite side of the Distribution Board (Figure 5) that serves a load center in the Press Box and another in the storage room under the stadium. There is a load center adjacent to the 100 amp disconnect with a 100 amp main breaker. It serves 20 amp receptacles inside of the enclosure and a 50 amp outlet.

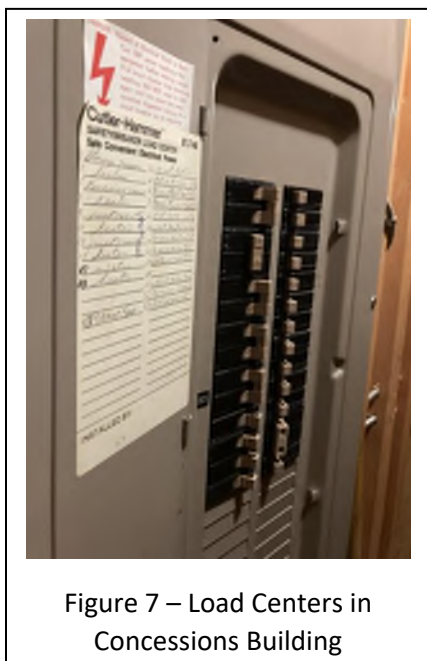
Figure 7 – Load Centers in Concessions Building

The underground service for the Concessions Building rises to a meter/main breaker assembly on the South end of the building. The Meter/Main feeds a 42 circuit load center in the Concessions Building (Figure 7) and small load centers in the Ticket Booths. The Concessions Building contains fixed electric heat, fluorescent lighting, a small water heater and receptacles for soda refrigerators, a popcorn machine and a few small appliances. There are no grills or cooktops. There are two public restrooms at the south end of the building with similar electric unit heaters and lights. The ticket booths are newly constructed and did not appear to be finished during the time of the site visit. Both contained just a small number of receptacles and a few 4-foot LED strip lights. There did not appear to be provisions for any heating.

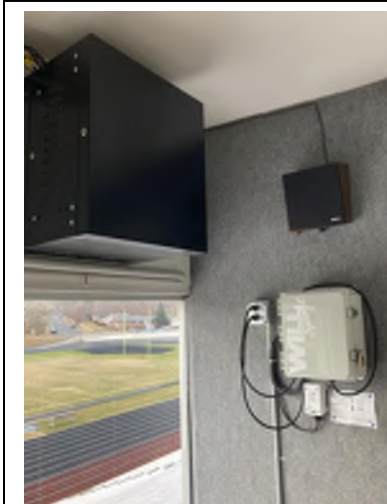
Figure 8 – Data Rack Enclosure
in Press Box

The Press Box has a small data rack and a few outlets available for communications (Figure 8). Data has also been extended into the new Ticket Booths. No deficiencies have been reported.

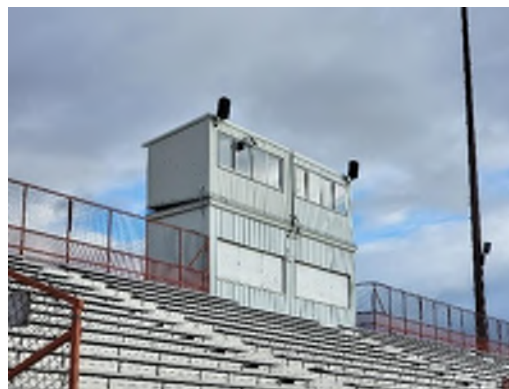
Grandstand Crow's Nest: The only windows on the Crows Nest appear to be Metal Single Pane Sliders. As this building is only utilized during sporting events and not actively heated it is not recommended to replace them.

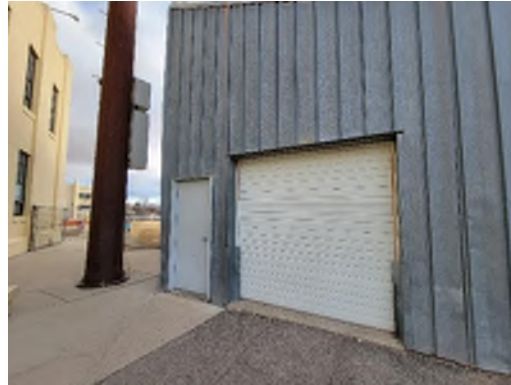
Grandstand: There are only a few doors on the grandstand under the seating and is used for storage. Both the overhead door and man door are heavily used during football and track and have some damage to prove it. They should be replaced in the future as they are being abused.

Grandstand: Replace both the man door and the overhead door on the storage under the grandstand in the future. **(Medium Cost, Low Priority)**

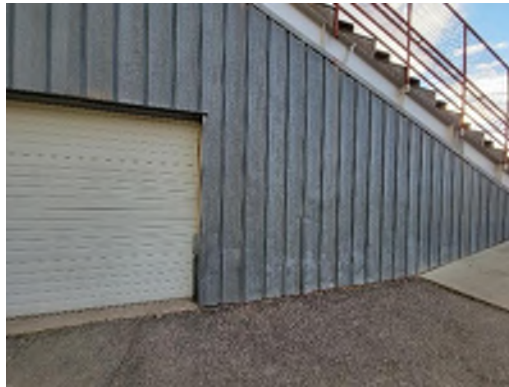
Grandstand: There is metal siding on the storage structure which is dented and damaged. If there is a point that moisture begins to enter the building this siding should be replaced.

Grandstand: Replace the Metal Siding with a more durable material that will not get as damaged in future use. **(High Cost, Low Priority)**

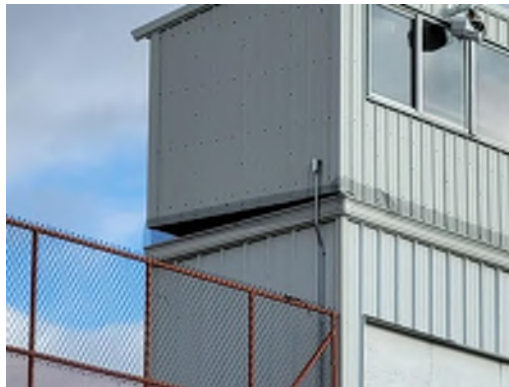
Crow's Nests: The siding on the crow's nest is Metal Delta Rib and in good condition.

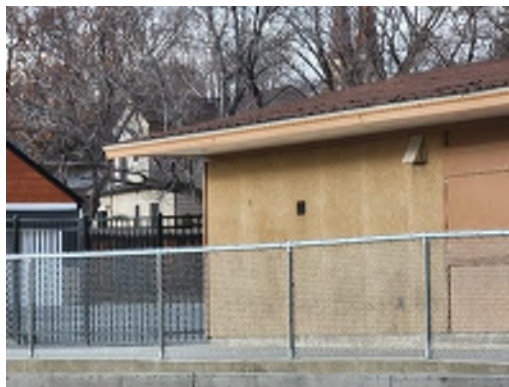
Concession: The concession building is prefinished panels and is on the list of projects to be renovated with fiber cement siding that match the new ticket booths.

Concession: Replace the prefinished panels with fiber cement siding that match the new ticket booths. **(Medium Cost, Low Priority)**
